Job Information

Job #:	94291				Date:	May 15, 2018
Priority:	_	Authorized OT:	No	Authorized by:

Name:	ConAgra		Reason:	
Contact:		Motor#:		PO#:
Application:	_	Special notes:

Manufacturer:	Ram Industries	Enclosure :	Open Drop Proof (ODP)
Serial#:	W20002010081-BL	Model#:	N3KBXX244PVHW Z
Service Factor:		Frame:	449TDZ
Horsepower/kW:	437	Rated RPM:	3570
Rated Amps:	482	Rated Voltage:	460
Phase:	3	Cycles:	60
Special design:	No

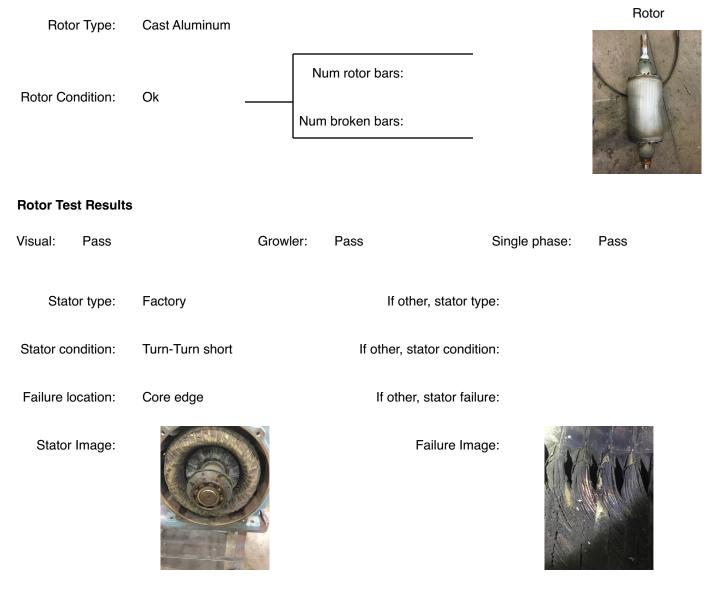
AC Electrical Inspection (Continued)

Winding color:	Still has color	Winding	g image	Winding Therma	I Protection:	No
Winding condition :	Solid				N	lot
Winding Thermal Protection DE:	_				Avai	lot ilable
Winding Thermal Protection ODE:	_					
Stator test results:	Rewind					
Megs incoming: Bad		Surge incoming:	Bad	Hi-pot in	icoming: E	Bad
Winding Resistance In	coming					
Phase	es A to B	Phases B to C	Phase	es C to A	Resistive im	balance
Incoming						
Leads/jumpe	ers: Ok		Lead jur	nper Image. :		
If other, leads/jumpe	ers:				Nc Availi	ot able

ODE EB worn, Windings shorted at edge of slots
