Job #:	94566				Date:	August 1, 2018
Priority:	-	Authorized OT:	No	Authorized by:

Name:	Harrison Entergy Partners		Reason:	
Contact:		Motor#:		PO#:
Application:	_	Special notes:

Manufacturer:	Emerson	Enclosure :	Totally Enclosed Non-Ventilated	Enclosure Type image
Serial#:	J2-30083458GT-04	Model#:	00-00365P	
Service Factor:		Frame:	326T	
Horsepower/kW:	50	Rated RPM:	1775	
Rated Amps:	112/56	Rated Voltage:	230/460	
Phase:	3	Cycles:	60	
Special design:	No

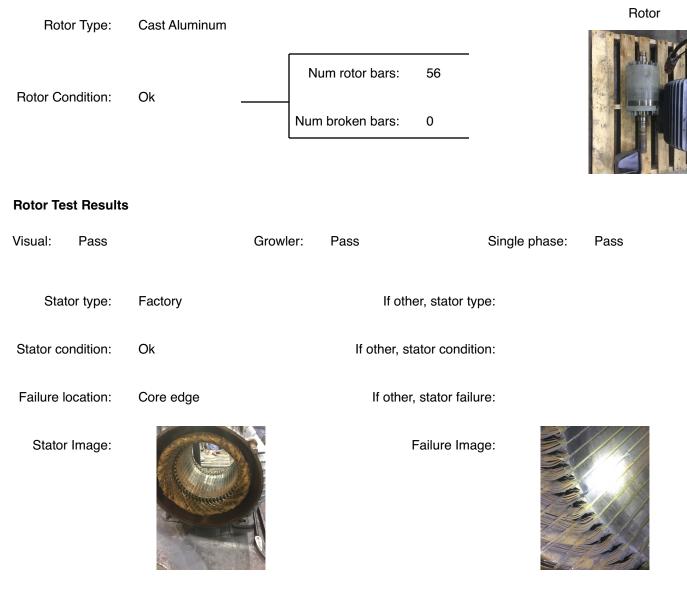
AC Electrical Inspection (Continued)
