Job Information

Job #:	94588			Date:	August 13, 2018	
Priority:	_	Authorized OT:	No	Authorized by:

Name:	Riceland Foods		Reason:	
Contact:		Motor#:		PO#:
Application:	_	Special notes:

Manufacturer:	Baldor	Enclosure :	Totally Enclosed Fan Cooled
Serial#:	X1104	Model#:	
Service Factor:	1.15	Frame:	449TS
Horsepower/kW:	200	Rated RPM:	1190
Rated Amps:	225	Rated Voltage:	460
Phase:	3	Cycles:	60
Special design:	No

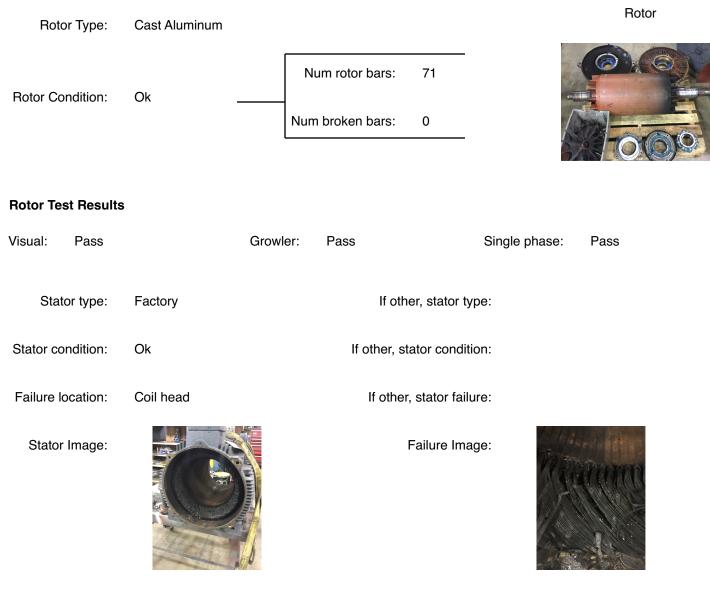
AC Electrical Inspection (Continued)

Winding color:	Painted	Winding	g image	Winding Therma	I Protection:	No
Winding condition :	Charred				N	1-+
Winding Thermal Protection DE:	_				N Avai	lot Ilable
Winding Thermal Protection ODE:	_					
Stator test results:	Rewind					
Megs incoming: Bac	b	Surge incoming:	Bad	Hi-pot in	coming: B	lad
Winding Resistance I	ncoming					
Pha	ses A to B	Phases B to C	Phase	es C to A	Resistive im	balance
Incoming						
Leads/jump	oers: Ok		Lead jun	nper Image. :		
If other, leads/jump	pers:				Nc Availa	ot able

ODE worn, Windings grounded

Water inside motor housing
