AC Recondition Repair Report

Hillcrest Camshaft
5502 West 65th Str
Little Rock, AR

| 1. Job Number | 97723 |

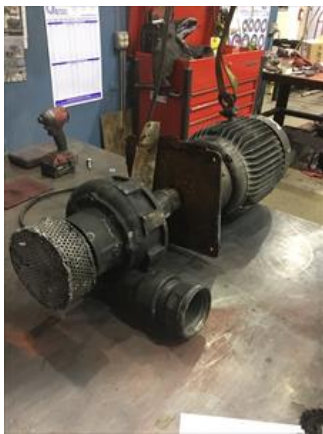
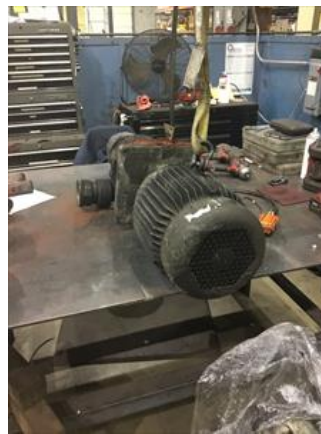
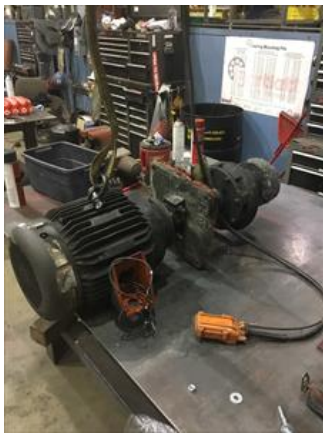
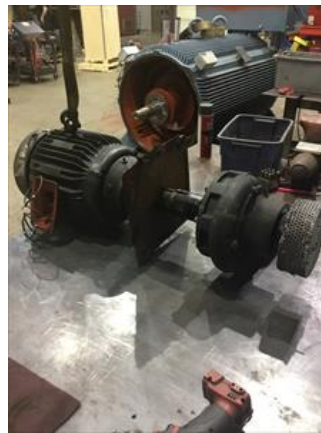
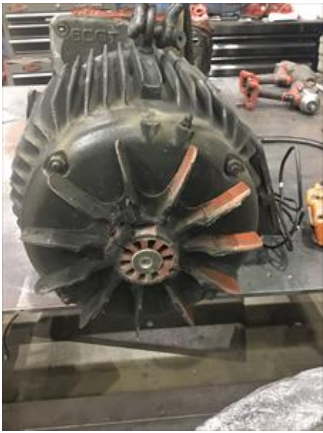
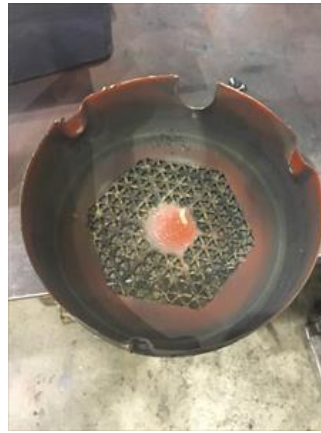
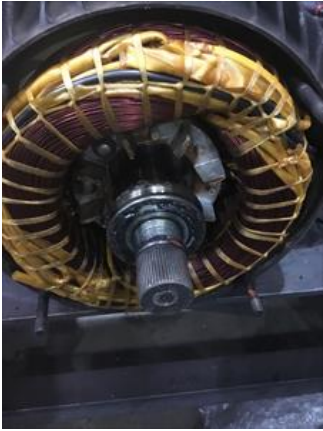
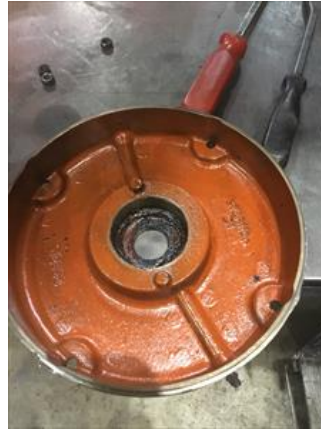
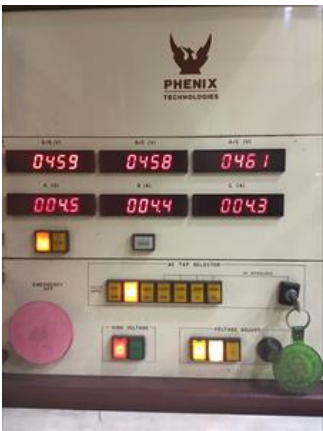
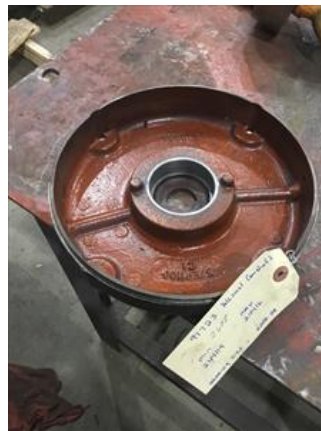
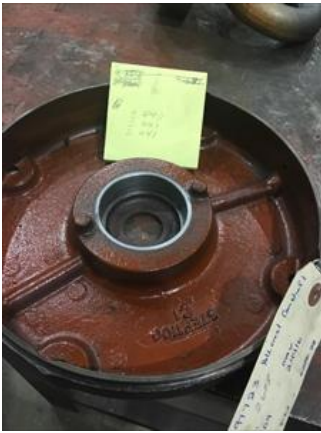
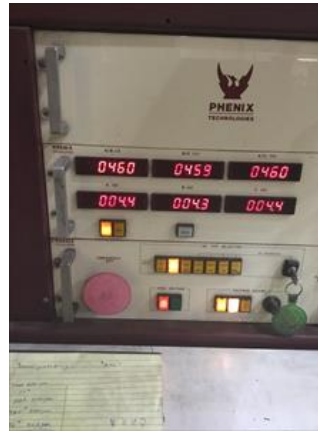
67.	Cause of Failure
68.	Comments
69.	Service Technician
<div style="text-align: right;"> O.D.E bearing housing. Terrence Holland </div> <p><i>Housing fit too large and out of tolerance. Has excessive up and down play.</i></p> <p><i>Re-sleeve housing fit.</i></p>  	
Machine Fit Inspection Report

100.	DE Endbell Fit Insulated	
101.	DE Endbell Air Seal Fit	
102.	Initial Endbell Air Seal Fit Size	
103.	Finial Endbell Air Seal Fit Size	
104.	ODE Endbell Fit	(F) Fail
	<i>ODE shaft has excessive up and down play. Bearing play is excessively loose in the housing and machine work is required.</i>

Replaced ode bearing and re-sleeved end bell housing fit. Motor test ran good.
