AC Recondition Repair Report

Community Water System (12207)
299 Lakeshore Drive
Greers Ferry, AR 72067

1. Job Number	97845
2. Report Date	02/04/2021
3. Customer	Community Water

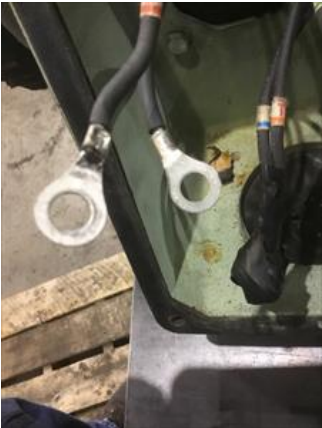
21. Lead Condition	(P) Pass	
22.	Lead Markings	T1-T12	
23.	Lug Size, Condition, and Type		P67

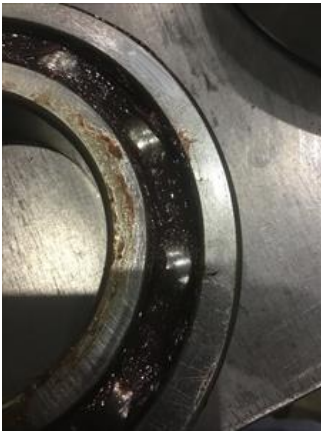
24.	Winding RTD's		
25.	Winding Rtd's Condition		
26.	Shaft Run Out		
27.	Does Shaft Turn Freely	Yes	
28.	Does Shaft Have Visible Damage	no	
29.	Bearing Rtd's		
30.	Bearing Rtd's Condition		
31.	Contamination		P104
	Yes

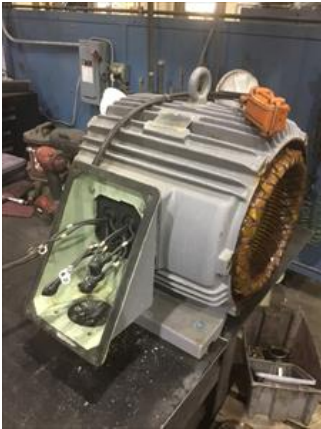
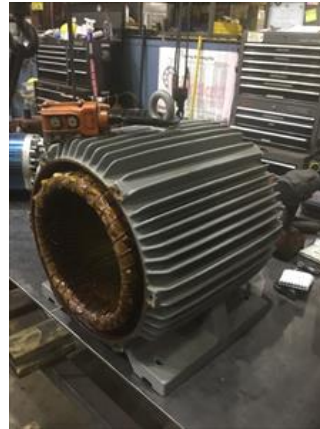
P106

32. Frame Condition

(P) Pass

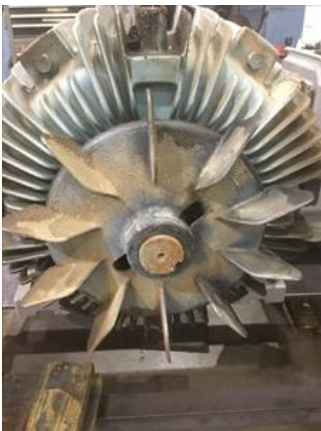
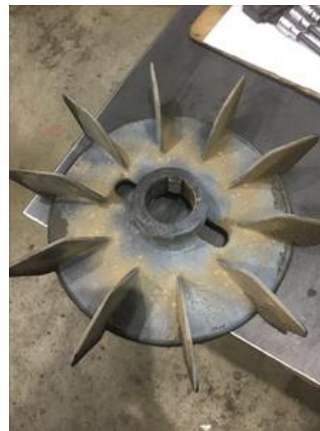
P109

33. Fan Condition

(P) Pass

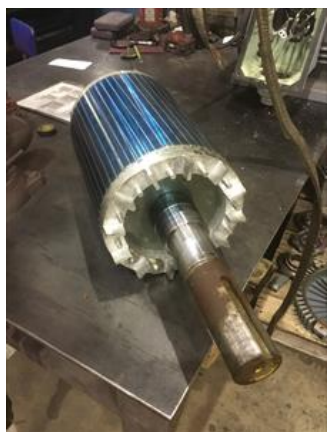
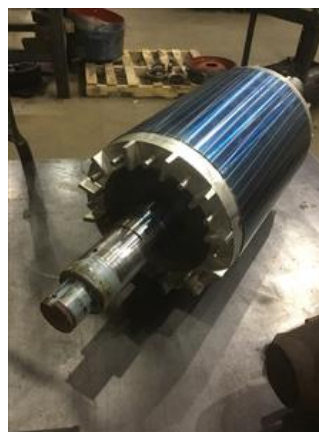
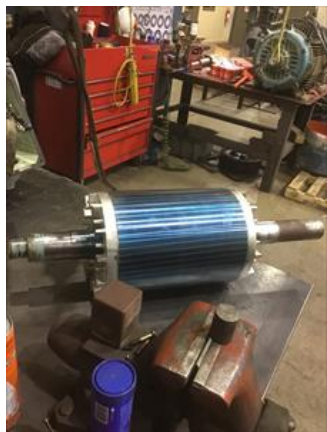
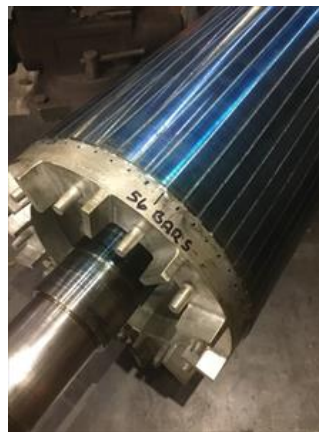
P50

49. Rotor Condition

(P) Pass

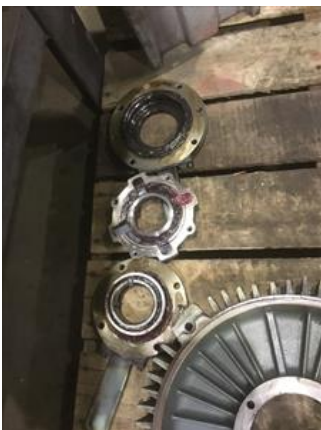
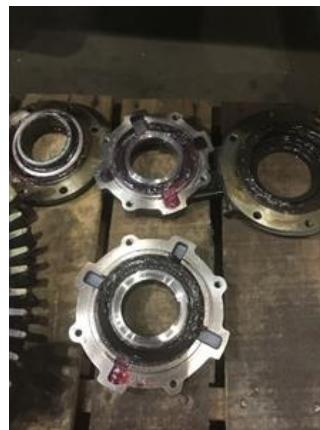
P80

☒ 59. Grease Condition

(F) Fail

☒ 60. Bearing Retainers

(Y) Yes

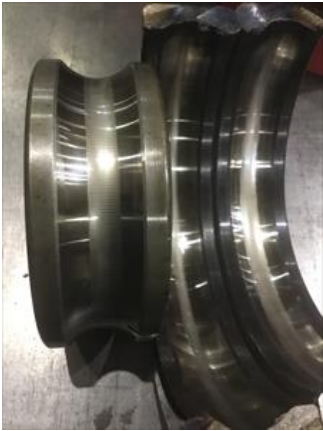
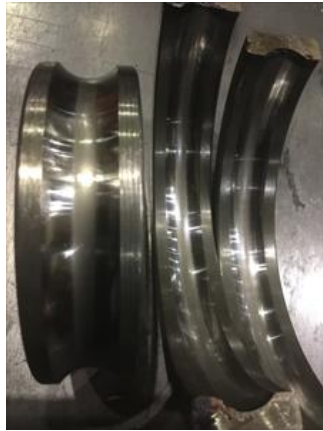
62.	DE Seal	(NA) Not Applicable
63.	DE Seal Type/Size	
64.	ODE Seal	(NA) Not Applicable
65.	ODE Seal Type/Size	
Root Cause of Failure		
66.	Component Failure	both bearings show extensive signs of fluting P2
<div style="display: flex; justify-content: space-around;">

67.	Cause of Failure <i>Fluting in both bearings caused premature bearing failure.</i>	
68.	Comments <i>Recommend shaft grounding device to alleviate the fluting in both bearings.</i>
