Job #:	94799				Date:	October 23, 2018
Priority:	_	Authorized OT:	No	Authorized by:

Name:	Name: Curwood			Reason:		
Contact:		Motor#:		PO#:		
Application:	_	Special notes:

Manufacturer:	BALDOR	Enclosure :	Totally Enclosed Fan Cooled	Enclosure Type image
Serial#:	F1710035621	Model#:	37E298R87261	
Service Factor:	1.15	Frame:	215TCZ	
Horsepower/kW:	7.5	Rated RPM:	1770	
Rated Amps:	17/9.5	Rated Voltage:	230/460	
Phase:	3	Cycles:	60	
Special design:	No

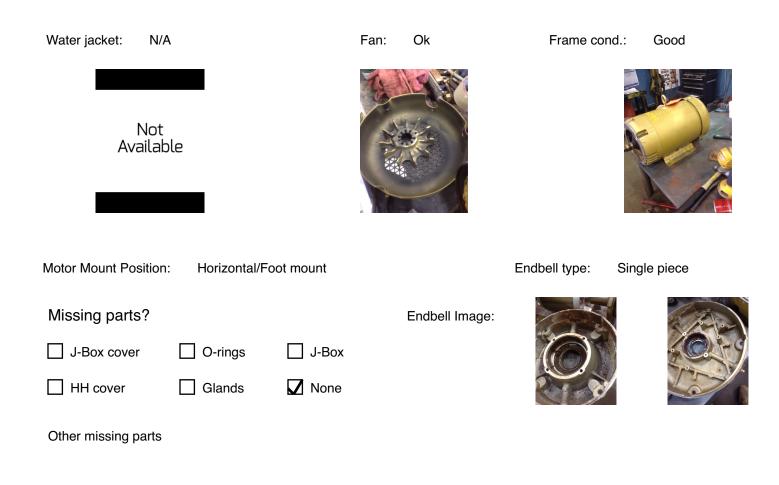
Brg. Image:

DE BEARING HAD NO LUBRICANT The Bearing WAS FULL OF RUST FROM WATER ODE Bearing HOUSING FIT BAD
