Job #:	95137				Date:	January 18, 2019
Priority:	_	Authorized OT:	No	Authorized by:

Manufacturer:	ALTAS COPCO	Enclosure :	Totally Enclosed Fan Cooled	Enclosure Type imag
Serial#:	333877C16001	Model#:	LSES200L-T	
Service Factor:	1.15	Frame:	200L	
Horsepower/kW:	37KW	Rated RPM:	3562	
Rated Amps:	65	Rated Voltage:	460	Ser al
Phase:	3	Cycles:	60	
Special design:	No

Mechanical Inspection

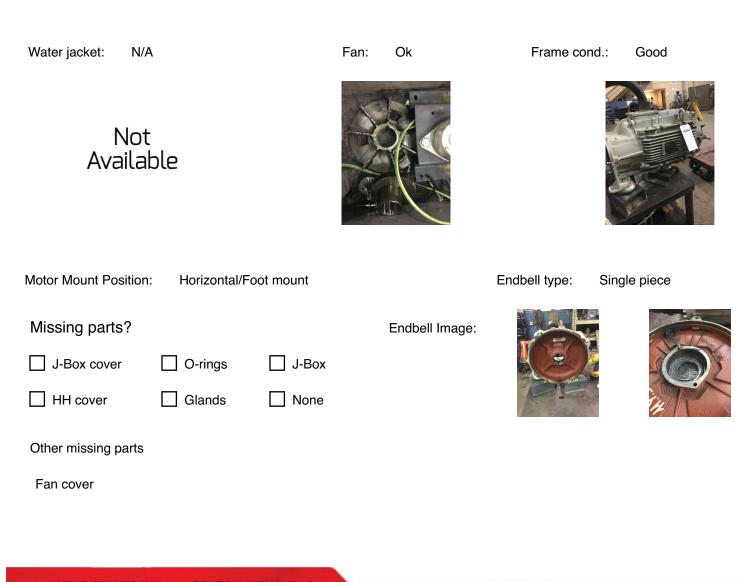
Brg. Image:

Ode bearing failed no grease need snap ring and bearing fit rebuilt
