### **Job Information**

Job #:	95244				Date:	February 18, 2019
Priority:	_	Authorized OT:	No	Authorized by:

Name:	Riceland Foods		Reason:	
Contact:		Motor#:		PO#:
Application:	_	Special notes:

Manufacturer:	Reliance	Enclosure :	Explosion-proof enclosures (EXPL/	Enclosure Type image
Serial#:	89MN444826	Model#:	P44G4826A	
Service Factor:	1.0	Frame:	X445T	
Horsepower/kW:	150	Rated RPM:	1785	
Rated Amps:	170	Rated Voltage:	460	
Phase:	3	Cycles:	60	
Special design:	No

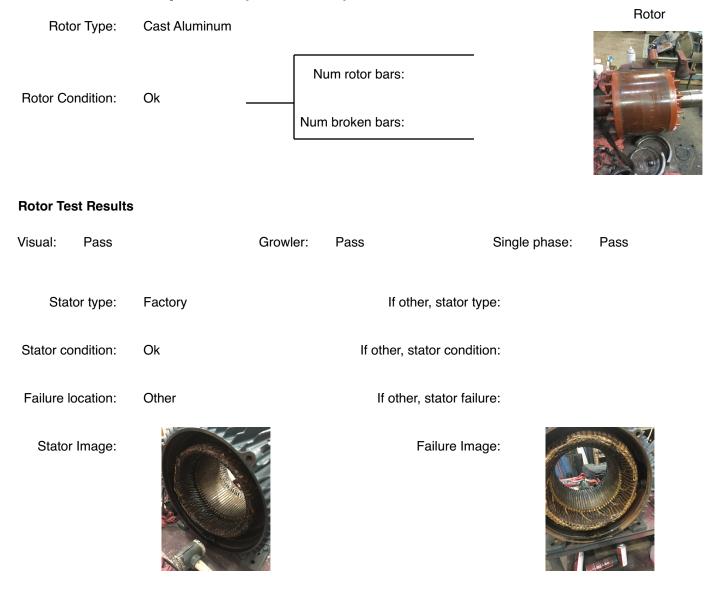
Winding co	olor:	Like new	Winding	g image	Winding Thermal	l Protectio	n: Yes
Winding conditi	ion :	Solid		E			Not
Winding Ther Protection		_	Not Available				
Winding Ther Protection O		_					
Stator test res	ults:	Salvageable					
Megs incoming:	G	bod	Surge incoming:	Good	Hi-pot ind	coming:	Good
Winding Resista	ance In	coming					
	Phas	es A to B	Phases B to C	Phase	es C to A	Resistive	e imbalance
Incoming	40.8	92	39.261	40.19	98	2.3	
Leads	s/jump	ers: Ok		Lead	d jumper Image. :		
If other, lead	s/jump	ers:				ŀ	Not Available
