# **Job Information**

Job #:	95283				Date:	February 28, 2019
Priority:	_	Authorized OT:	No	Authorized by:

Name:	Name: Saint Gobain		Reason:	
Contact:		Motor#:		PO#:
Application:	_	Special notes:

Manufacturer:	Toshiba	Enclosure :	Open Drop Proof (ODP)
Serial#:	1360	Model#:	B1254F1-F4-1S- HO1
Service Factor:	1.15	Frame:	444T
Horsepower/kW:	125	Rated RPM:	1785
Rated Amps:	290/145	Rated Voltage:	230/460
Phase:	3	Cycles:	60

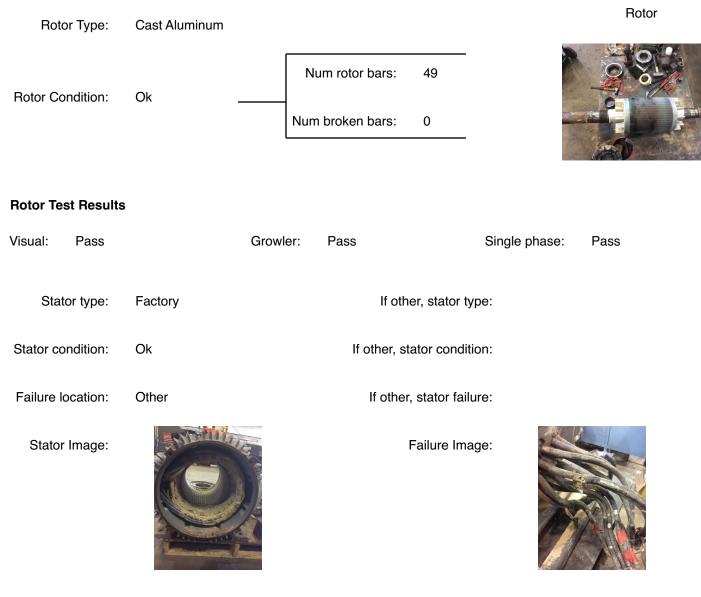
Number of leads:	9	Terminal Markings:		
Length of leads:	16inch	REF: NEMA Std Markings Identif	ls. MG 1-2009, Rev. 1- ied By Color:	2010, 2.41-Terminal
Size of leads:		1-Blue 2-White 3-Orange	5-Black 6-No color assigned 7-No color assigned	P1-No color assigned P2-Brown
Lead condition:	Bad	4-Yellow	8-Red	
Lug type:		Connections As Re	eceived:	
Lug Condition:	Good		Terminal	Lugs
Lug size:				
Lug Attachment:	Acceptable

The leads looked as though they have been smashed an there is bare wires showing. Recommend re-lead on wires,
