Job Information

Job #:	95309				Date:	March 2, 2019
Priority:	_	Authorized OT:	No	Authorized by:

Name:	Fosters Service Company		Reason:	
Contact:		Motor#:		PO#:
Application:	_	Special notes:

Manufacturer:	US	Enclosure :	Open Drop Proof (ODP)	Enclosure Type image	
Serial#:	5123473550001ST0 2	Model#:	7222-BEH		
Service Factor:	-	Frame:	404TPA	ZER	
Horsepower/kW:	100	Rated RPM:	1785		
Rated Amps:	114	Rated Voltage:	460		
Phase:	3	Cycles:	60		
Special design:	No

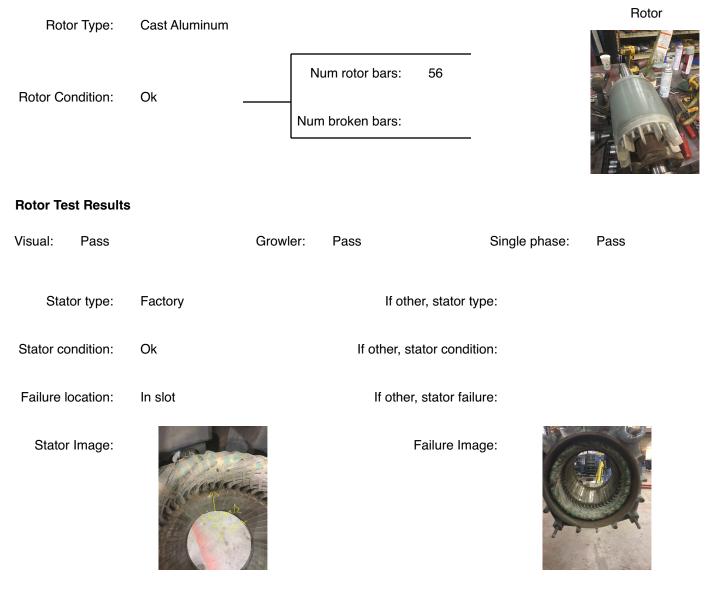
Stator is shorted at the edge of the slot. Found Abrasive wear in lower bearing due to inadequate lubrications or contamination ingress
