Job Information

Job #:	96043				Date:	September 30, 2019
Priority:	_	Authorized OT:	No	Authorized by:

Name:	Mohawk		Reason:	
Contact:		Motor#:		PO#:
Application:	_	Special notes:

Manufacturer:	Baldor	Enclosure :	Totally Enclosed Fan Cooled
Serial#:	A1510202030	Model#:	CAT#ECP4316T
Service Factor:	1.15	Frame:	365T
Horsepower/kW:	75	Rated RPM:	1780
Rated Amps:	171/85.9	Rated Voltage:	230/460
Phase:	3	Cycles:	60

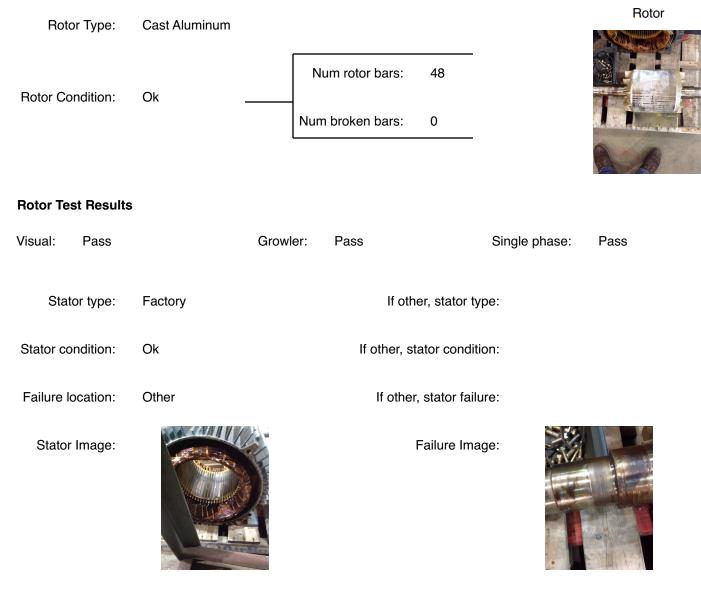
Winding color:	Still has color	Winding	g image	Winding Therma	I Protection: No
Winding condition :	Solid				
Winding Thermal Protection DE:					
Winding Thermal Protection ODE:	_				
Stator test results:	Salvageable				
Megs incoming:	Good	Surge incoming:	Good	Hi-pot in	coming: Good
Winding Resistance	Incoming				
Ph	ases A to B	Phases B to C	Phase	es C to A	Resistive imbalance
Incoming 0.	00	0.00	0.00		
Leads/jun	npers: Ok		Lea	d jumper Image. :	
If other, leads/jun	npers:				
Mechanical In	spection				
Inspect bolt holes and	fasteners. Validat	e correct fasteners.
