## **Job Information**

Job #:	96275			Date:	December 2, 2019	
Priority:	_	Authorized OT:	No	Authorized by:

Name:	Greenbrier Central		Reason:	
Contact:		Motor#:		PO#:
Application:	_	Special notes:

Manufacturer:	P&H	Enclosure :	Totally Enclosed Non-Ventilated
Serial#:	D6069200010	Model#:	ZFB150/4DF
Service Factor:		Frame:	132ME-2
Horsepower/kW:	32.5	Rated RPM:	3500
Rated Amps:	84/42	Rated Voltage:	230/460
Phase:	3	Cycles:	60
Special design:	Yes

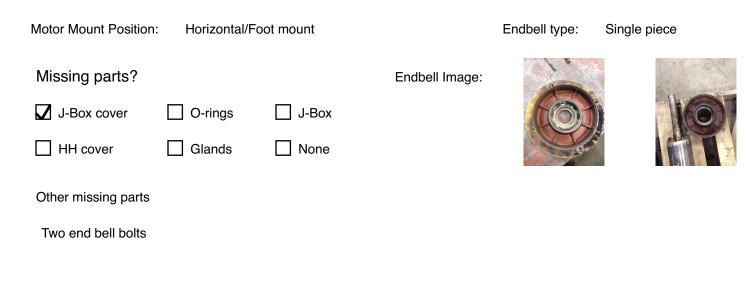
Frame cond.: Good
