Job #:	96328				Date:	December 11, 2019
Priority:	_	Authorized OT:	No	Authorized by:

Name:	Greenbrier central		Reason:	
Contact:		Motor#:		PO#:
Application:	_	Special notes:

Mechanical Inspection

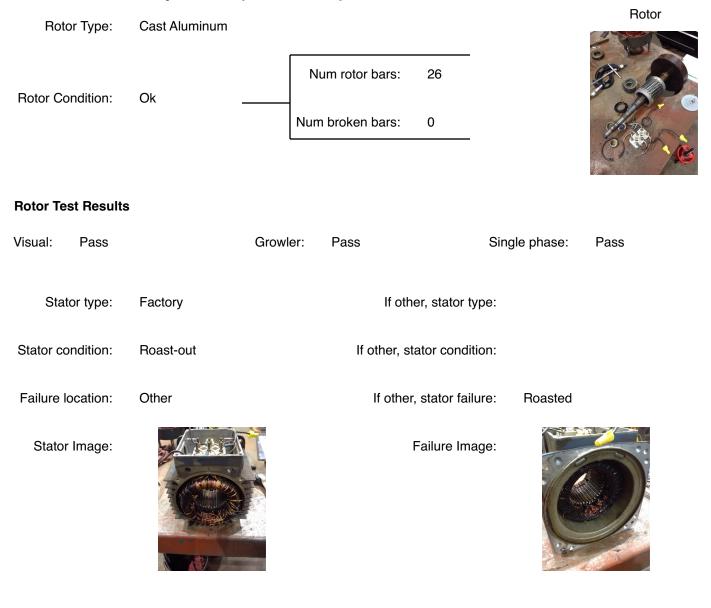
Number of leads:	6	Terminal Markings:		
Length of leads:	8"	REF: NEMA Stds Markings Identifi	s. MG 1-2009, Rev. 1- ed By Color:	2010, 2.41-Terminal
Size of leads:	16	1-Blue 2-White 3-Orange	5-Black 6-No color assigned 7-No color assigned	P1-No color assigned P2-Brown
Lead condition:	Good	4-Yellow	8-Red	
Lug type:	Copper	Connections As Rea	ceived:	
Lug Condition:	Good	ſ	Terminal	Lugs
Lug size:	Same			
Lug Attachment:	-
