Job Information

Job #:	96581				Date:	February 25, 2020
Priority:	_	Authorized OT:	No	Authorized by:

Name:	Sage V Foods		Reason:	
Contact:		Motor#:		PO#:
Application:	_	Special notes:

Manufacturer:	Fimet	Enclosure :	Totally Enclosed Fan Cooled
Serial#:	809600860	Model#:	
Service Factor:	1.15	Frame:	180m
Horsepower/kW:	22kw	Rated RPM:	1760
Rated Amps:	24.5/37	Rated Voltage:	760-830Y/440-48
Phase:	3	Cycles:	60

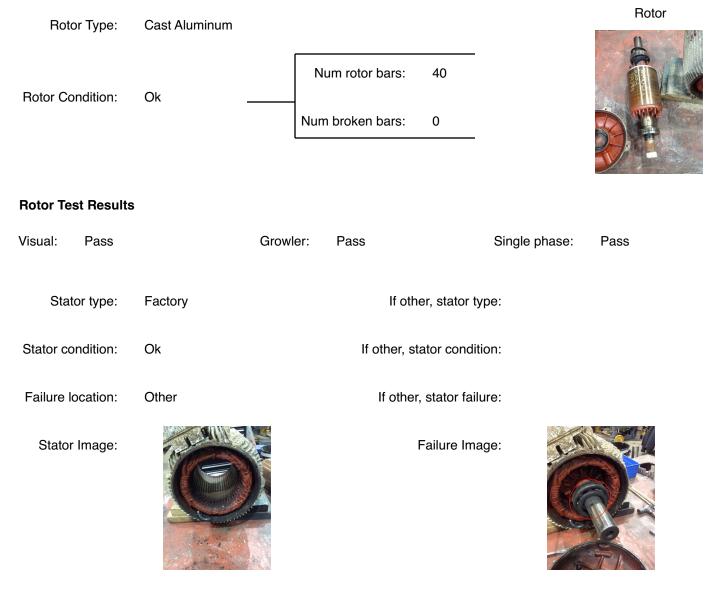
AC Electrical Inspection (Continued)
