## **Job Information**

Job #:	96669				Date:	March 17, 2020
Priority:	_	Authorized OT:	No	Authorized by:

Name:	Name: Arauco		Reason:	
Contact:		Motor#:		PO#:
Application:	_	Special notes:

Manufacturer:	Siemens	Enclosure :	Totally Enclosed Fan Cooled
Serial#:	L0010140 EV-5	Model#:	TYPE:RGZP
Service Factor:	1.15	Frame:	364T
Horsepower/kW:	60	Rated RPM:	1775
Rated Amps:	142.0/70.8	Rated Voltage:	230/460
Phase:	3	Cycles:	60

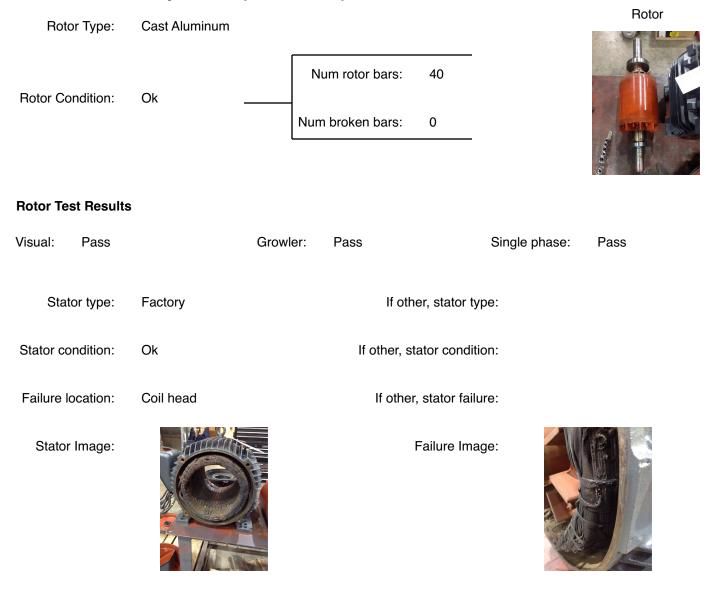
#### **AC Electrical Inspection (Continued)**

Windings are blown and one of the leads was open. Recommend new bearings and a rewind
