Job Information

Job #:	96819				Date:	May 6, 2020
Priority:	_	Authorized OT:	No	Authorized by:

Name:	Entergy WB		Reason:	
Contact:		Motor#:		PO#:
Application:	_	Special notes:

Manufacturer:	Limitorque	Enclosure :	Totally Enclosed Non-Ventilated	Enclosu	re Type image
Serial#:		Model#:	Туре: Р		
Service Factor:	1.0	Frame:	L56		
Horsepower/kW:	.7	Rated RPM:	1700		
Rated Amps:	4.6/2.3	Rated Voltage:	230/460		
Phase:	3	Cycles:	60		
Special design:	No				
Nameplate	DE	ODE	F1	F2	Тор

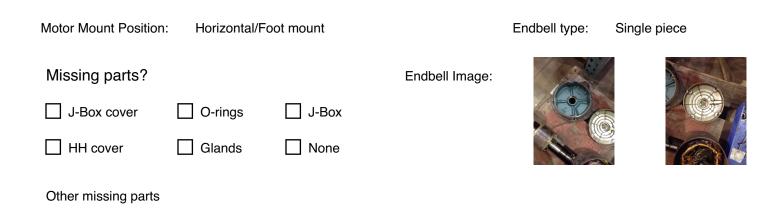
Water jacket: N/A Frame cond.: Good

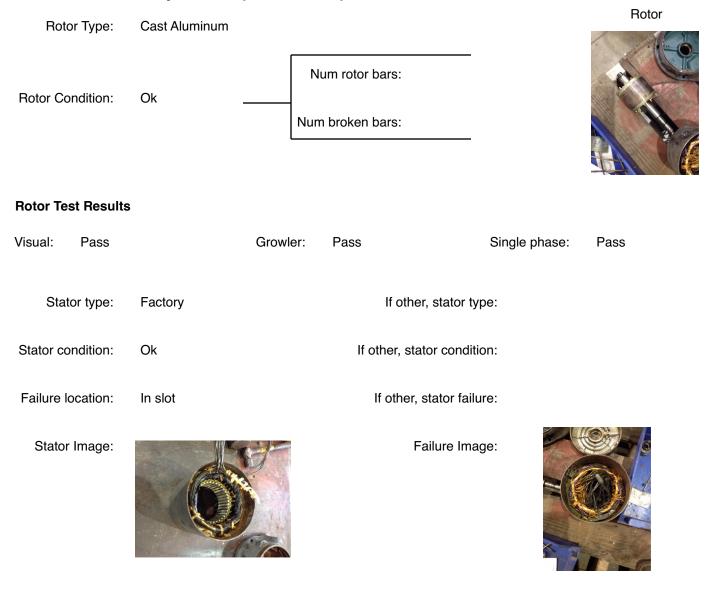
Leads are blown from the windings from over load. Recommend reconditioning and rewind
