Job Information

Job #:	96940					June 15, 2020
Priority:	_	Authorized OT:	No	Authorized by:

Name:	Process and Power		Reason:	
Contact:		Motor#:		PO#:
Application:	_	Special notes:

Manufacturer:	WEG	Enclosure :	Totally Enclosed Fan Cooled
Serial#:	11567983	Model#:	
Service Factor:	1.21	Frame:	250S/M-04
Horsepower/kW:	75	Rated RPM:	1775
Rated Amps:	222/111	Rated Voltage:	230-460
Phase:	3	Cycles:	60
Special design:	No

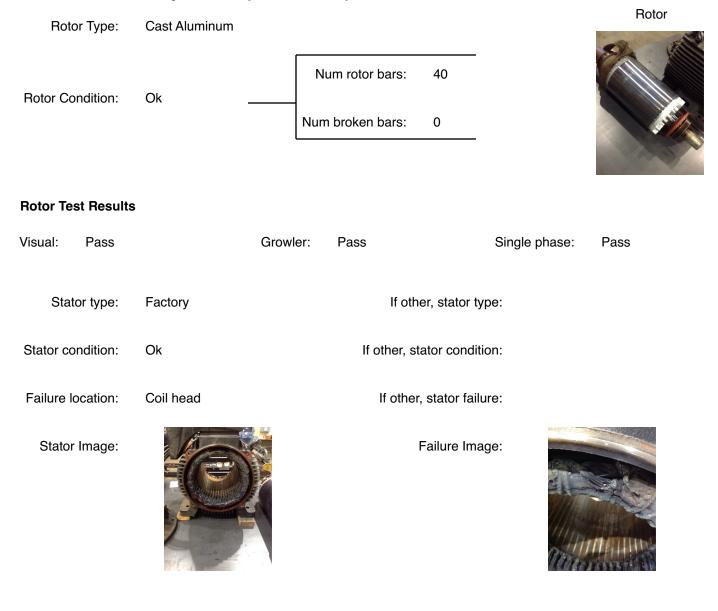
AC Electrical Inspection (Continued)

Winding color:	Painted	Winding	g image	Winding Therm	al Protection	: No
Winding condition :	Solid					
Winding Thermal Protection DE:	_					
Winding Thermal Protection ODE:	_					
Stator test results:	Rewind					
Megs incoming:	Good	Surge incoming:	Good	Hi-pot i	ncoming:	Good
Winding Resistance	Incoming					
Pha	ases A to B	Phases B to C	Phases	C to A	Resistive	imbalance
Incoming 0.0	00	0.00	0.00			
Leads/jum	pers: Ok		Lead	jumper Image.	:	
If other, leads/jum	pers:					
Mechanical Inspection						
Inspect bolt holes and	fasteners. Valida	te correct fasteners.				
Shaft Co	ndition: Good		Bearings	Retainer: Y	/es

Bearings show signs of contamination and the windings are blown. Recommend new bearings and rewind
