Job #:	97047				Date:	July 10, 2020
Priority:	_	Authorized OT:	No	Authorized by:

Name:	Delta Plastics		Reason:	
Contact:		Motor#:		PO#:
Application:	_	Special notes:

Manufacturer:	Baldor	Enclosure :	Open Drop Proof (ODP)
Serial#:		Model#:	
Service Factor:	1.0	Frame:	
Horsepower/kW:	150	Rated RPM:	1750
Rated Amps:	180	Rated Voltage:	460
Phase:	3	Cycles:	60
Special design:	No

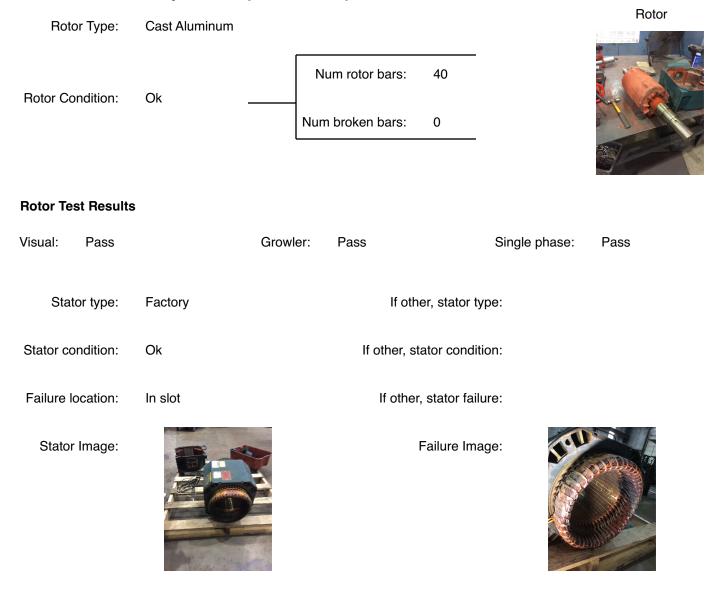
AC Electrical Inspection (Continued)

Winding color:	Dull black	Winding	g image	Winding Therma	I Protection:	Yes
Winding condition :	Solid		APPERENCE			
Winding Thermal Protection DE:	_					
Winding Thermal Protection ODE:	_				A starting of the start of the	
Stator test results:	Rewind					
Megs incoming: Go	bod	Surge incoming:	Good	Hi-pot in	coming:	Good
Winding Resistance In	coming					
Phas	es A to B	Phases B to C	Phase	es C to A	Resistive in	nbalance
Incoming						
Leads/jump	ers: Ok					
If other, leads/jump	ers:
