Job Information

Job #:	97146				Date:	August 5, 2020
Priority:	_	Authorized OT:	No	Authorized by:

Name:	Future Fuel Chemical		Reason:	
Contact:		Motor#:		PO#:
Application:	_	Special notes:

Manufacturer:	Reliance	Enclosure :	Totally Enclosed Fan Cooled
Serial#:		Model#:	
Service Factor:	1.15	Frame:	364TS
Horsepower/kW:	60	Rated RPM:	3565
Rated Amps:	66.3	Rated Voltage:	460
Phase:	3	Cycles:	60
Special design:	No

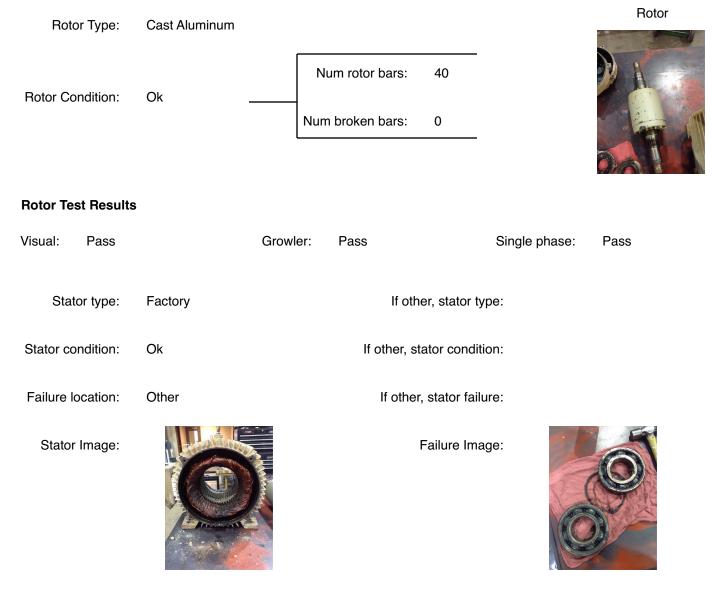
AC Electrical Inspection (Continued)
