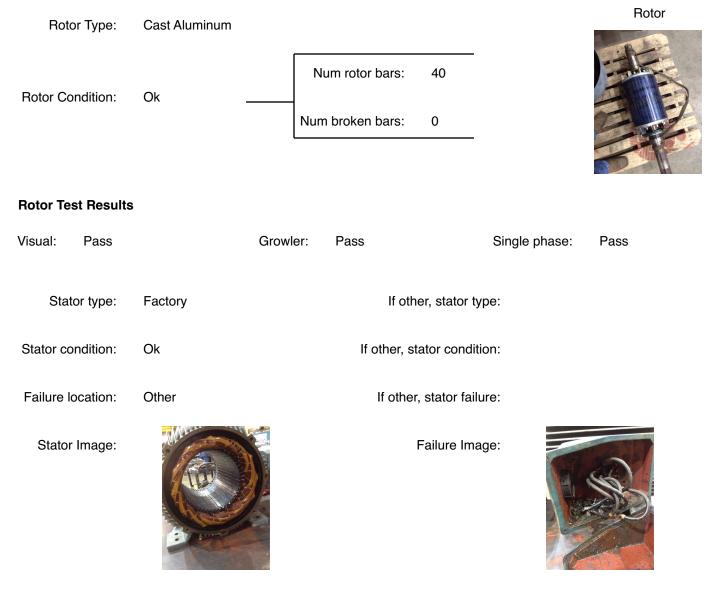
AC Electrical Inspection (Continued)

Number of leads:	6	Terminal Markings:		
Length of leads:	17.5	REF: NEMA Sto Markings Identi	ds. MG 1-2009, Rev. 1- fied By Color:	2010, 2.41-Terminal
Size of leads:		1-Blue 2-White 3-Orange	5-Black 6-No color assigned 7-No color assigned	P1-No color assigned P2-Brown
Lead condition:	Bad	4-Yellow	8-Red	
Lug type:		Connections As Re	eceived:	
Lug Condition:	_		Terminal	Lugs
Lug size:				
Lug Attachment:	_

Recommend reconditioning, new bearings, aegis ring, replace the leads, and machine work on DE end bell
