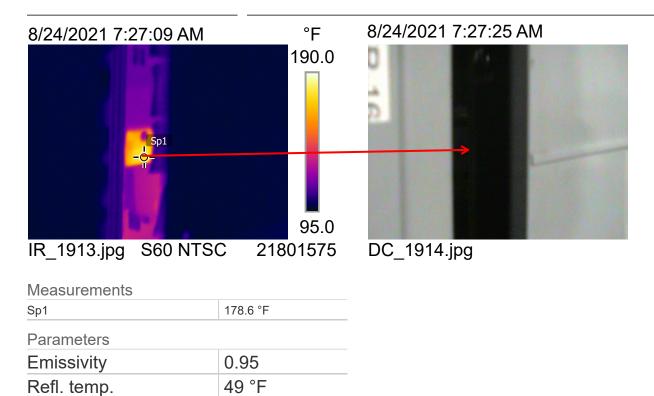
Infrared data indicates that 1 of the bus bars has a loose connection between the main breaker and the buss bar. Clean both bus bar surfaces and tight to correct torque.
