QualiTest IR Radiometric Survey Report

Atlantic Dry Ice Brandon, MS Ammonia Compressor MCC/Control Panels

Job Number	141364
Survey Date	12/10/19
Report Date	12/16/19

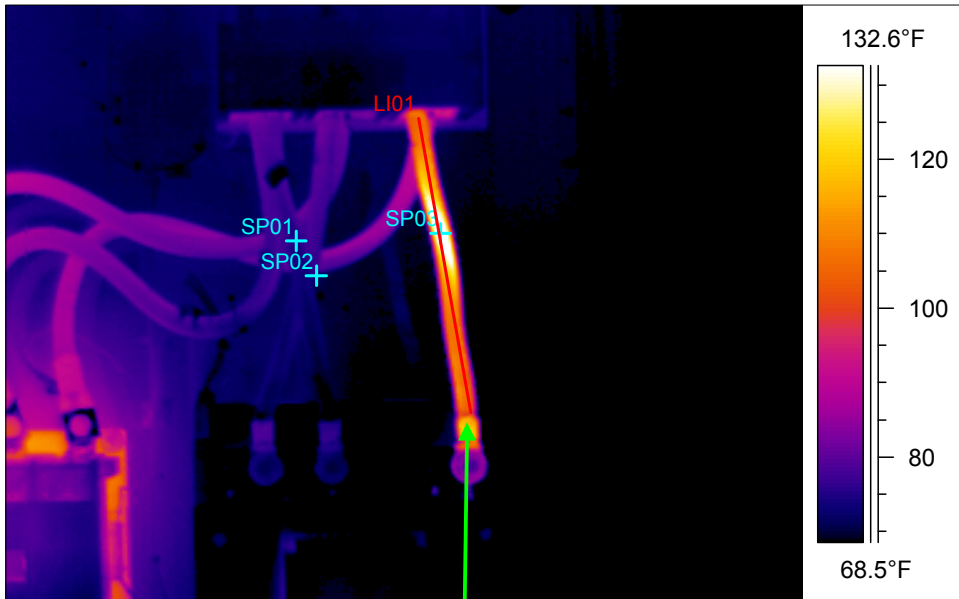
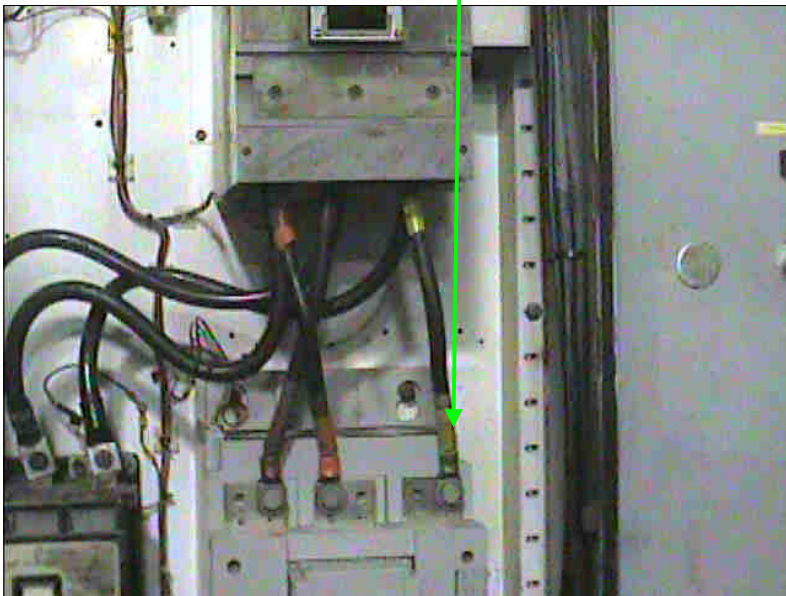
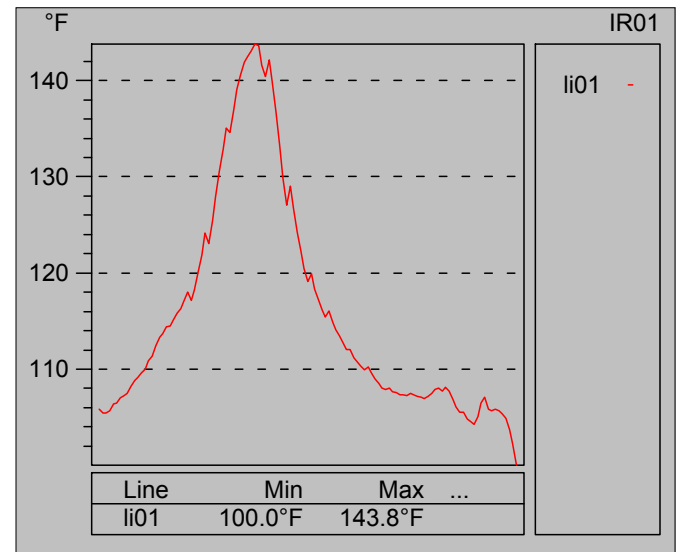
Component	Equipment/Bucket ID	Plant/Area	Date
Phase 3 Lead	C-3 MCC	Brandon, MS	12/10/19

Label	Value
IR : max	144.1°F
IR : min	57.1°F
SP01	74.6°F
SP02	73.6°F
SP03	144.1°F
LI01 : max	143.8°F
LI01 : min	100.0°F

Fault	Damaged wire/Loose connections
Defect Rating	CLASS III

IR image shows a substantial temp delta on the phase 3 lead going to the motor starter. Lead needs to be replaced as soon as possible. Ensure lugs and connections are clean and tight.

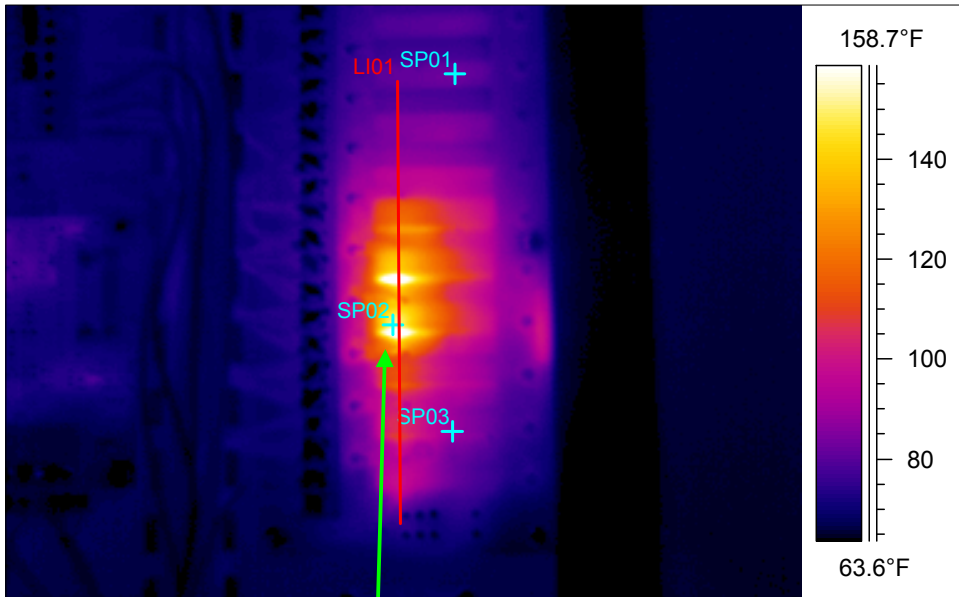
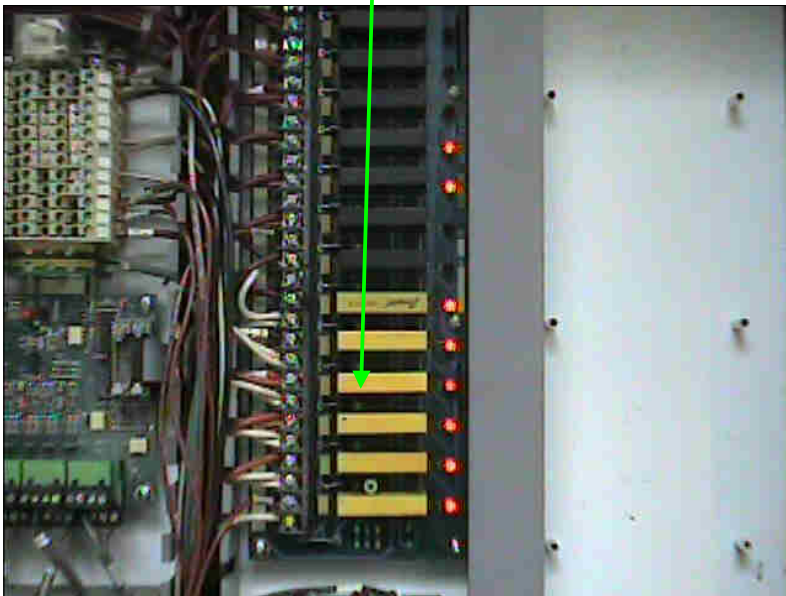
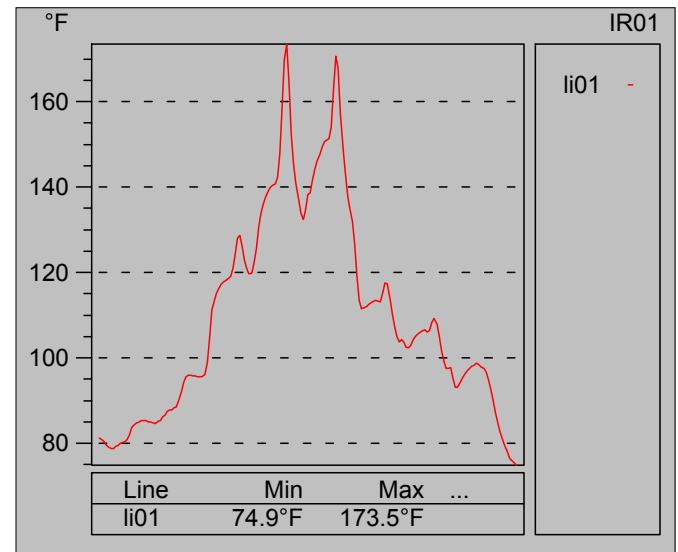
Component	Equipment/Bucket ID	Plant/Area	Date
Unknown components	C-2 Microprocessor Control Panel	Brandon, MS	12/10/19

Label	Value
IR : max	173.5°F
IR : min	57.0°F
SP01	83.1°F
SP02	151.3°F
SP03	89.6°F
LI01 : max	173.5°F
LI01 : min	74.9°F

Fault	Faulty component/connection
Defect Rating	CLASS II

IR image shows unknown components to either have a bad connections or they have internal faults. It appears that the two components with the issue are the 4th and 5th ones from the bottom. Check components for proper connection and replace if needed.
