Quarterly Infrared Thermography Report

Atlantic Dry Ice

June 2022

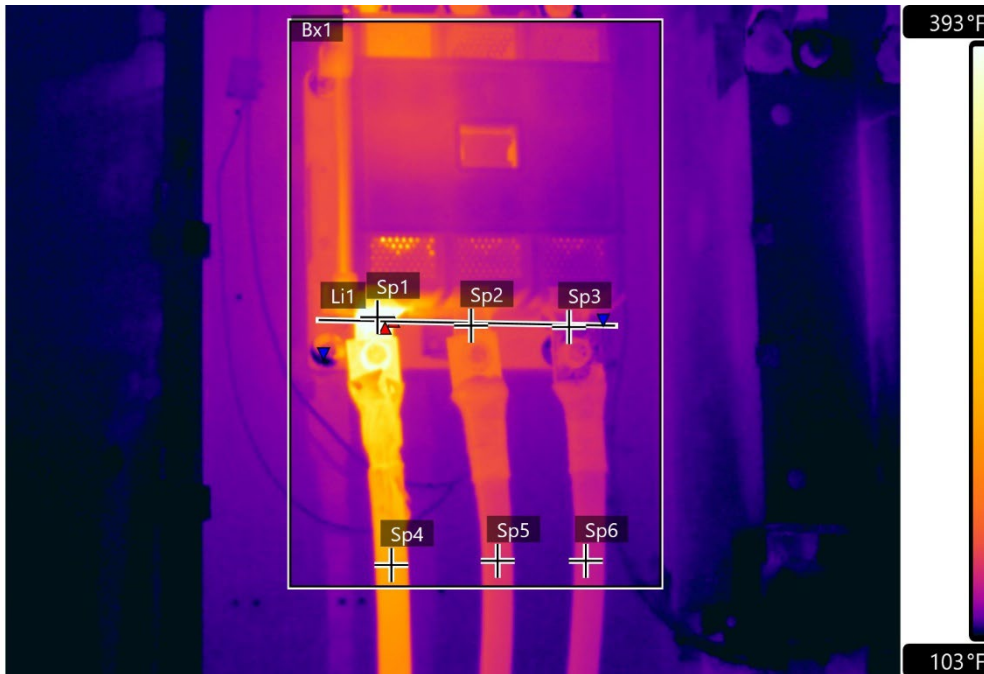
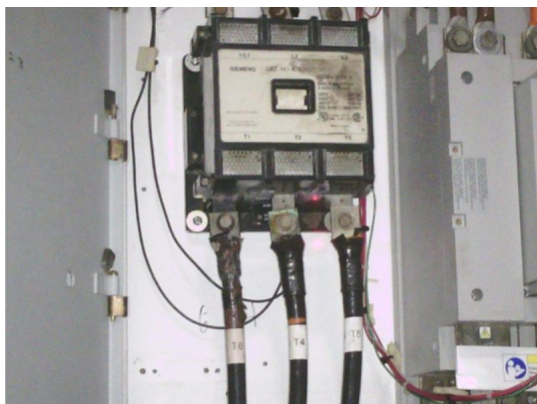
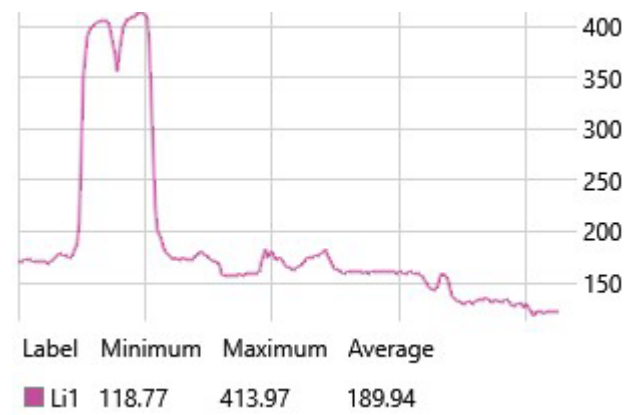
Component	A Phase connection
Equipment/Bucket ID	CM-3

Sp1	417.5 °F
Sp2	164.7 °F
Sp3	132.2 °F
Sp4	239.4 °F
Sp5	154.9 °F
Sp6	142.5 °F
Li1 Minimum	118.8 °F
Li1 Maximum	414.0 °F
Bx1 Minimum	102.6 °F
Bx1 Maximum	430.8 °F

Fault	Bad Connection
Defect Rating	CLASS III

Recommendations	<p>Extreme amount of heat can be seen in the IR image above. A phase connection is very hot and has damaged the lug and lead. Ensure contactor lug is not loose inside the contactor. Electrician was called for emergency repair on 6/29/22.</p>
-----------------	---

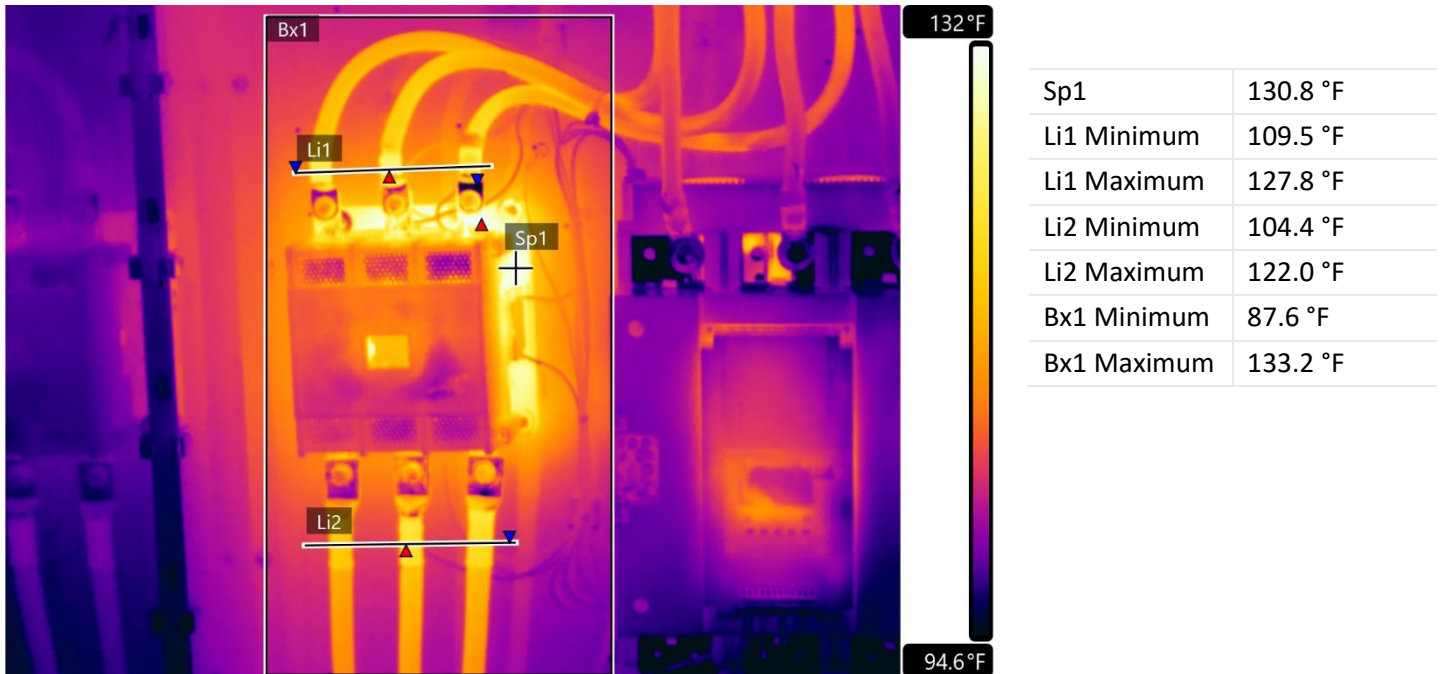
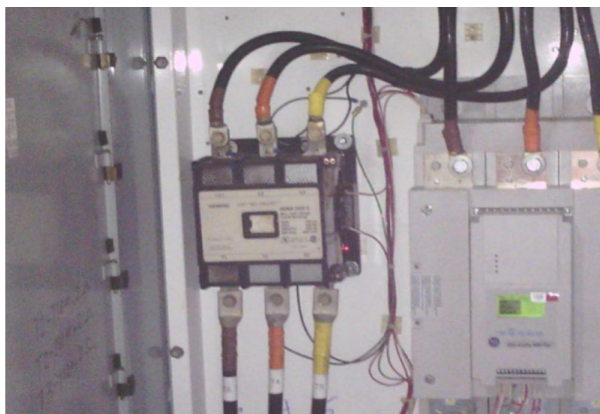
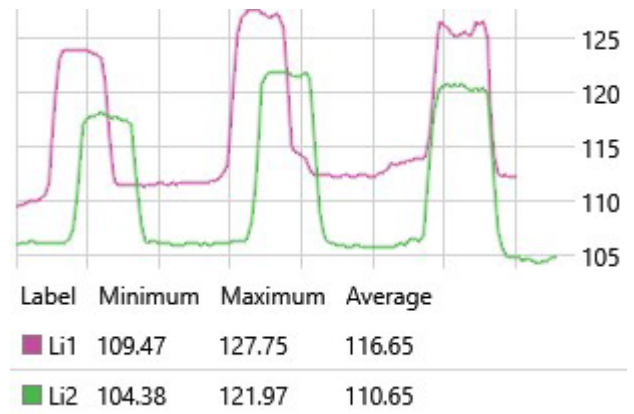
Component	N/A
Equipment/Bucket ID	CM-2

Fault	None
Defect Rating	None

Recommendations	IR image shows no issues to be present at this time.
-----------------	--

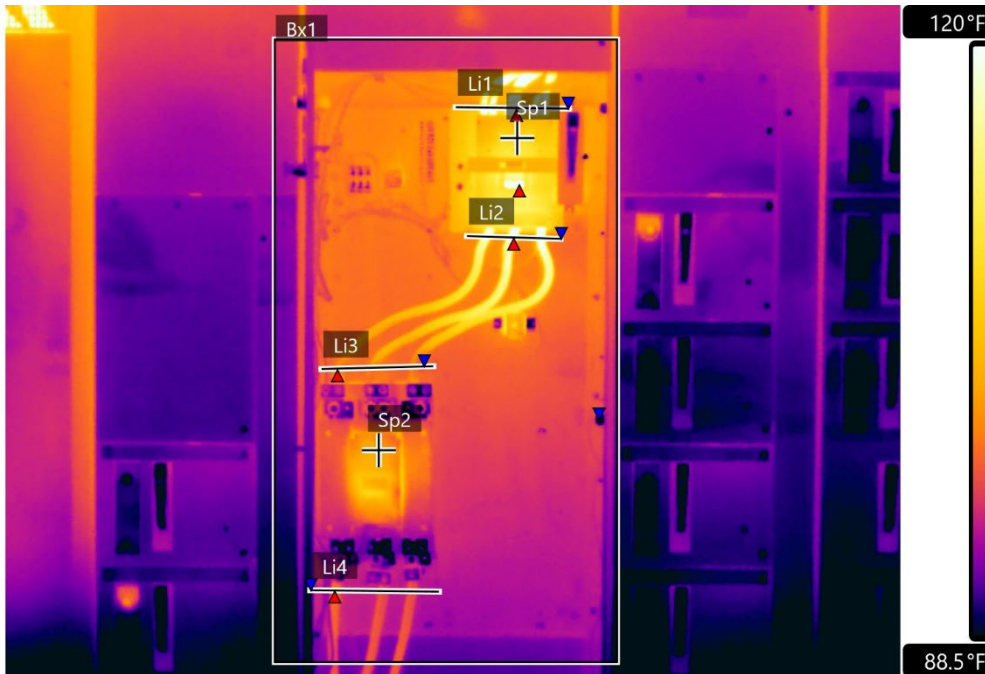
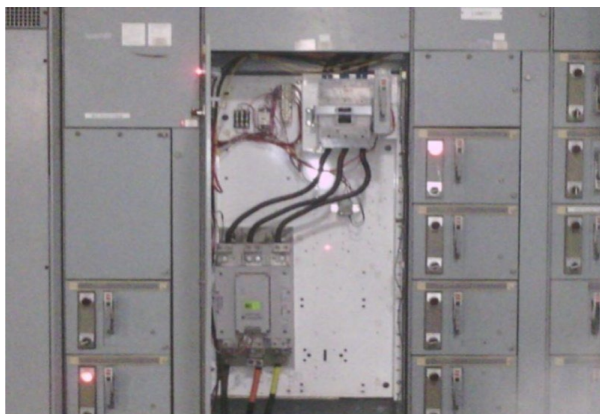
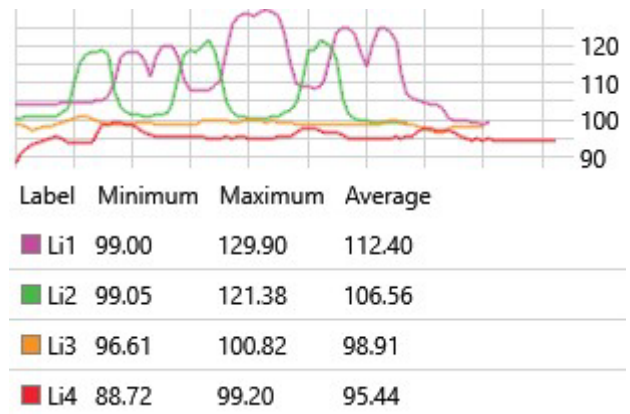
Component	N/A
Equipment/Bucket ID	CM-1

Sp1	107.1 °F
Sp2	102.2 °F
Li1 Minimum	99.0 °F
Li1 Maximum	129.9 °F
Li2 Minimum	99.1 °F
Li2 Maximum	121.4 °F
Li3 Minimum	96.6 °F
Li3 Maximum	100.8 °F
Li4 Minimum	88.7 °F
Li4 Maximum	99.2 °F
Bx1 Minimum	76.0 °F
Bx1 Maximum	134.0 °F

Fault	None
Defect Rating	None

Recommendations	IR image shows no issues to be present at this time.
-----------------	--
