ATLANTIC DRY ICE

Brandon, MS

AMMONIA COMPRESSOR MCC

Infrared Thermography Report

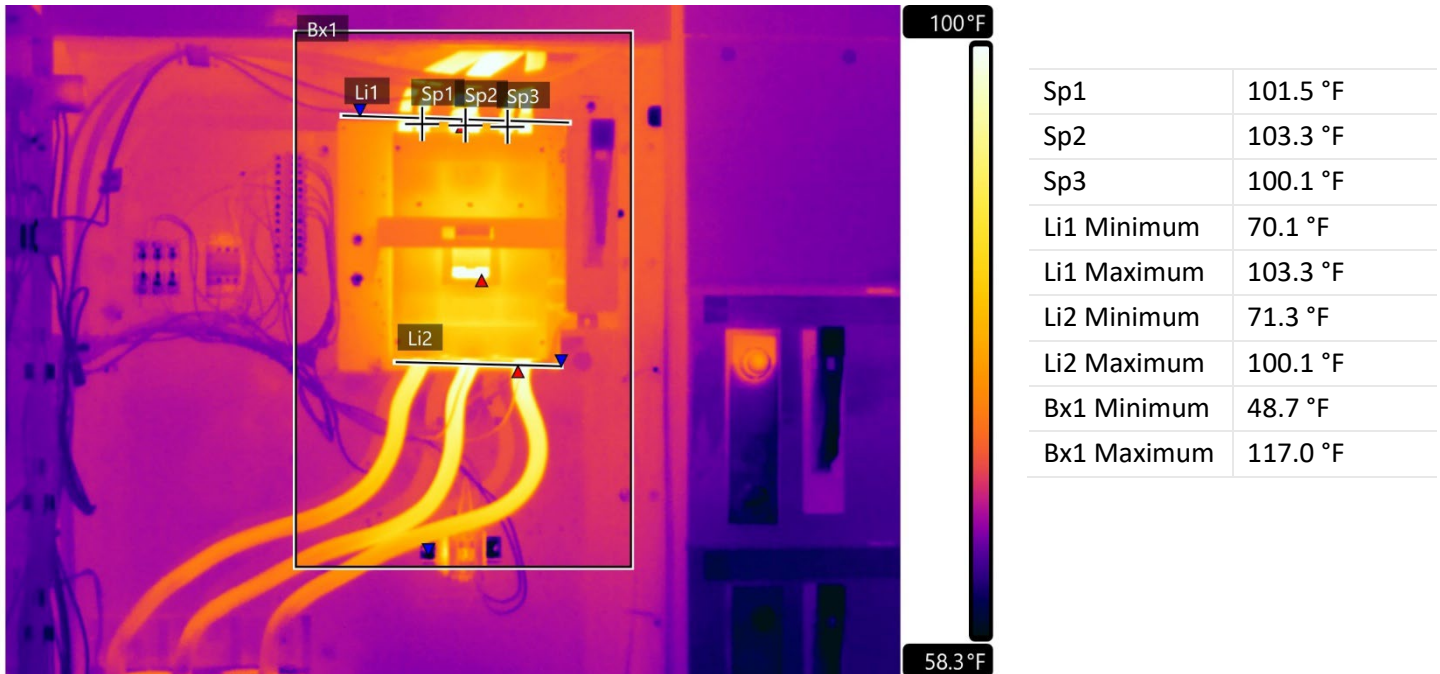
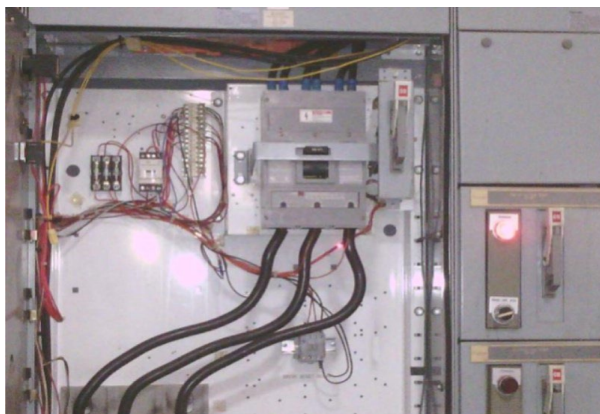
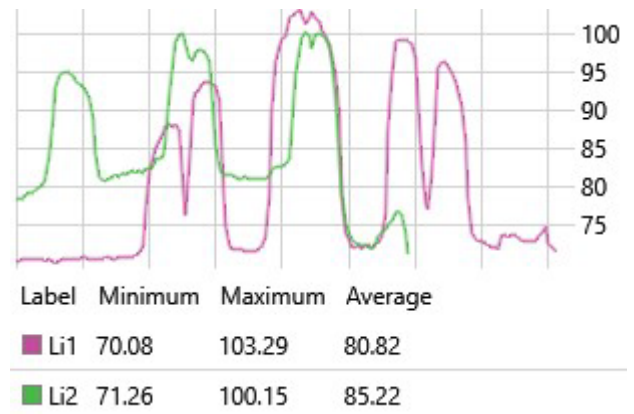
Component	CP-1
Equipment/Bucket ID	Breaker

Fault	NONE
Defect Rating	NONE

Recommendations	IR image shows no issues to mention.
-----------------	--------------------------------------

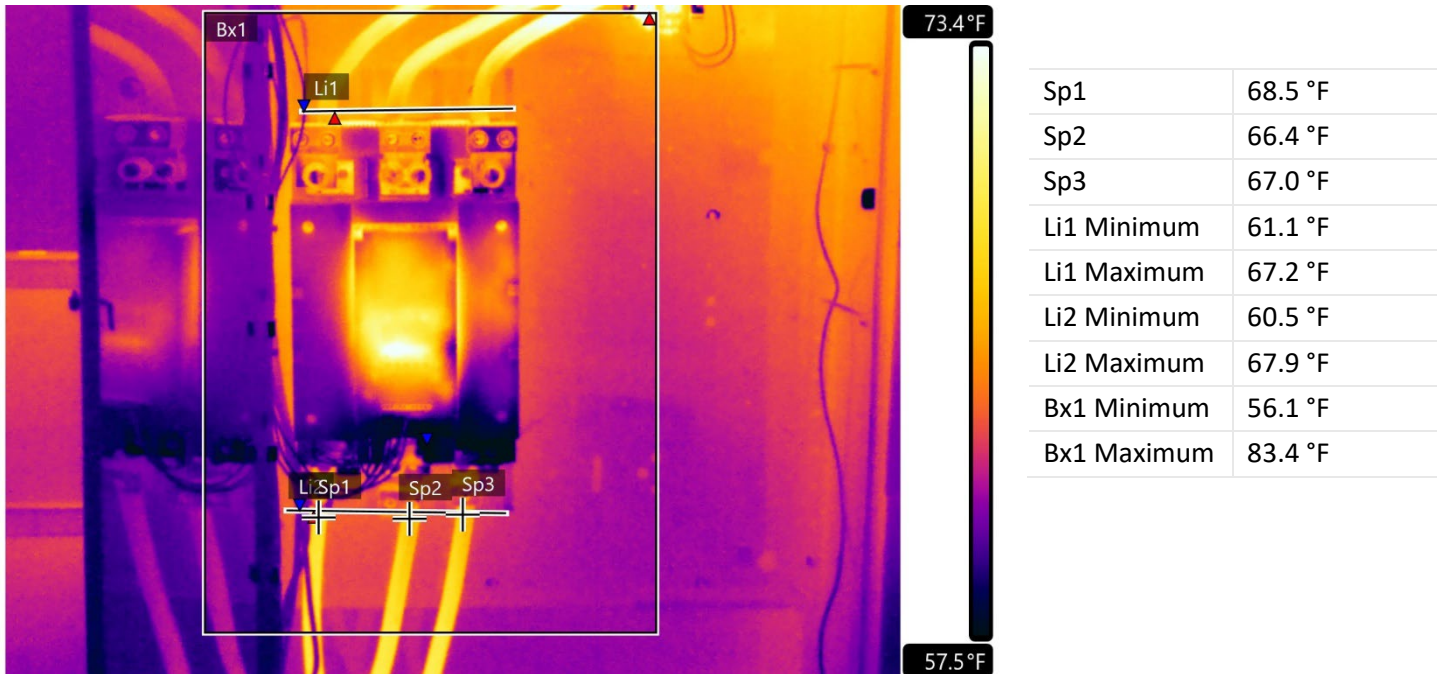
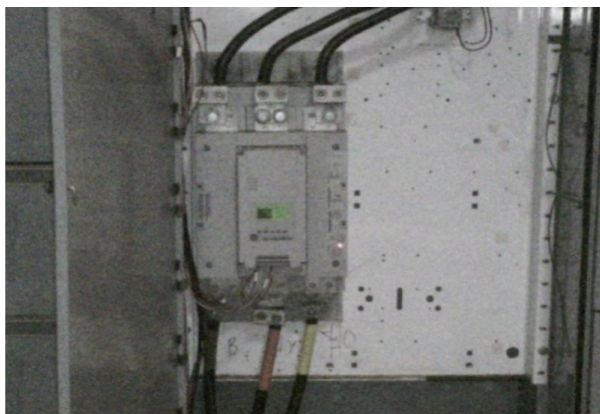
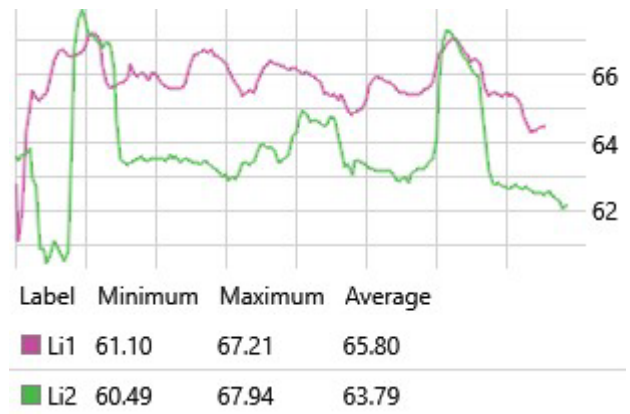
Component	CP-1
Equipment/Bucket ID	Starter

Fault	NONE
Defect Rating	NONE

Recommendations	IR Image shows no issues to mention.
-----------------	--------------------------------------

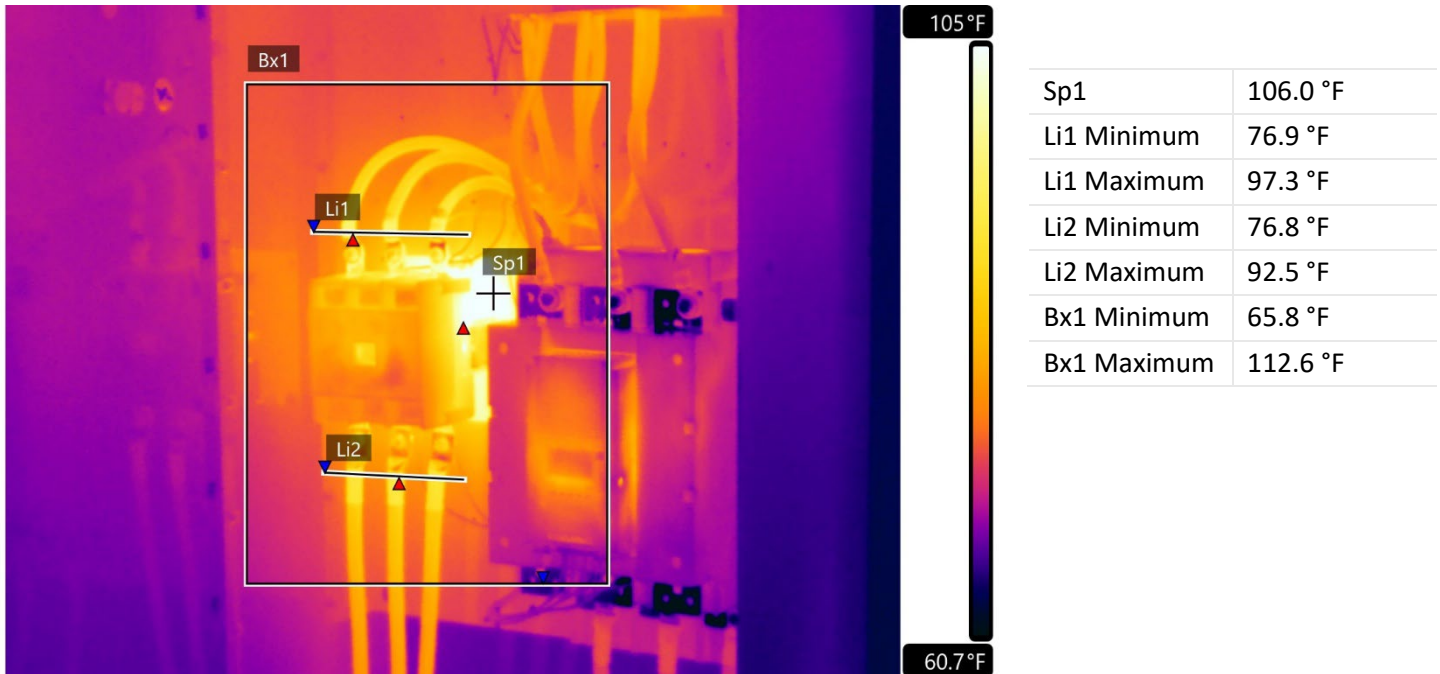
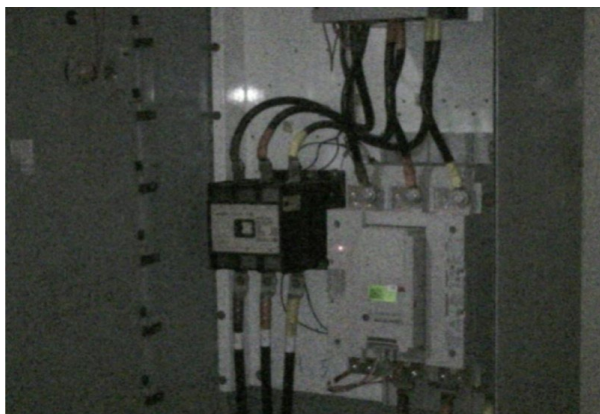
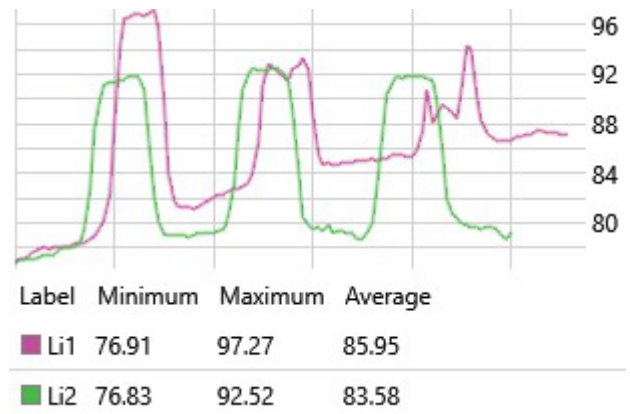
Component	CP-2
Equipment/Bucket ID	Starter

Fault	NONE
Defect Rating	NONE

Recommendations	IR Image shows no issues to mention.
-----------------	--------------------------------------

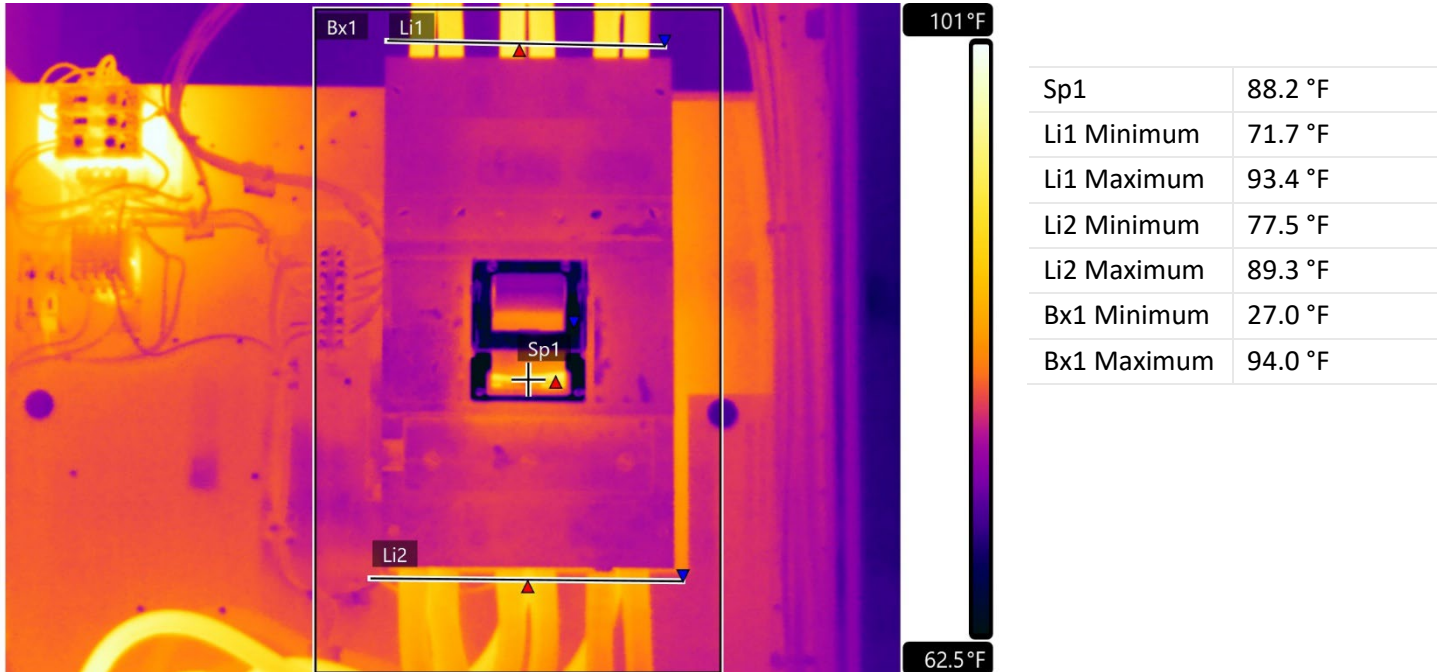
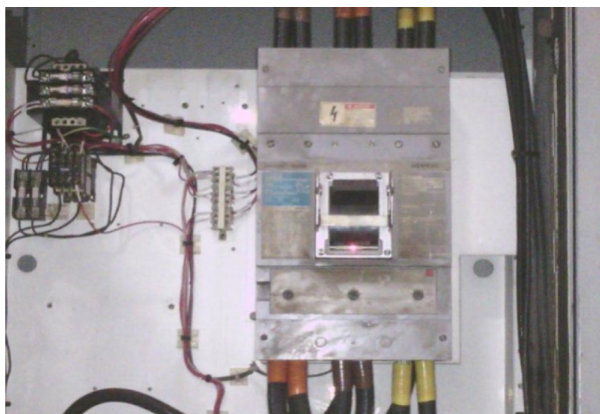
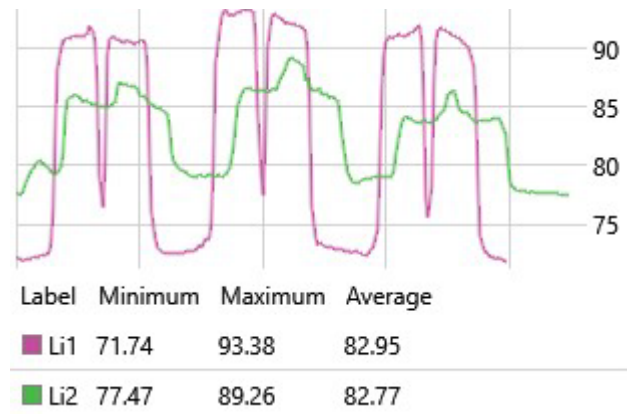
Component	CP-2
Equipment/Bucket ID	Breaker

Fault	NONE
Defect Rating	NONE

Recommendations	IR Image shows no issues to mention.
-----------------	--------------------------------------

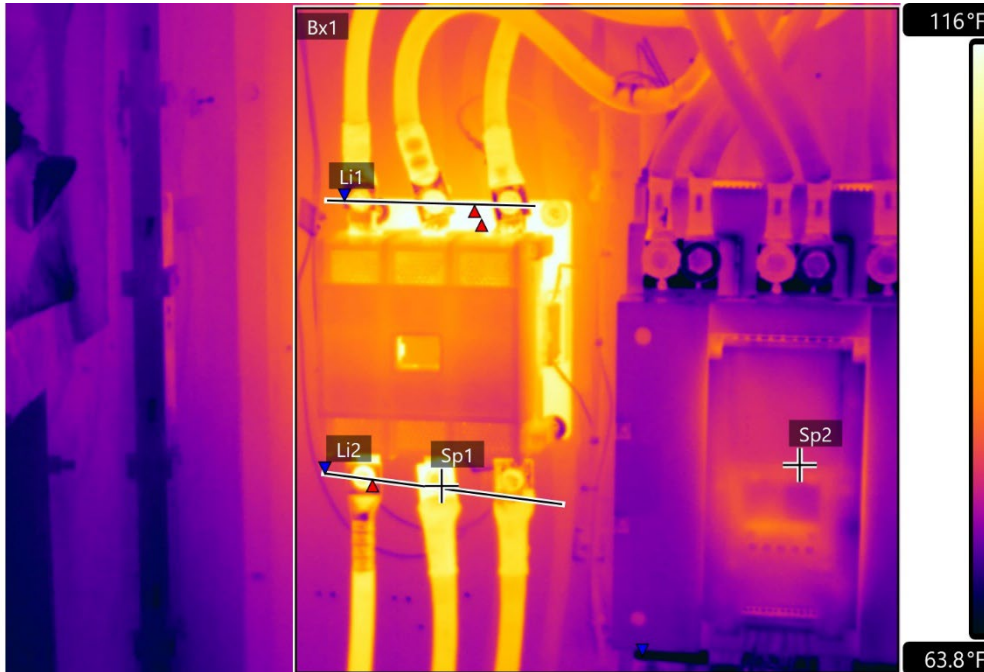
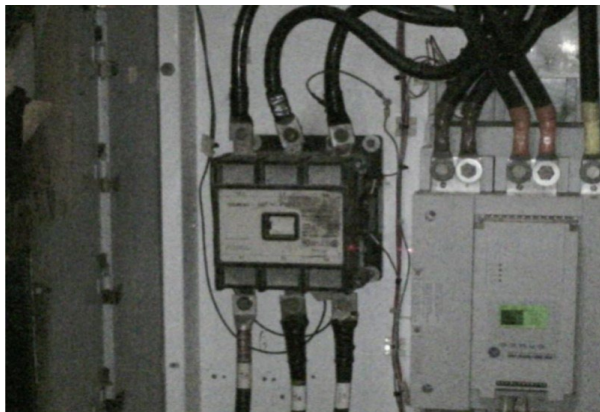
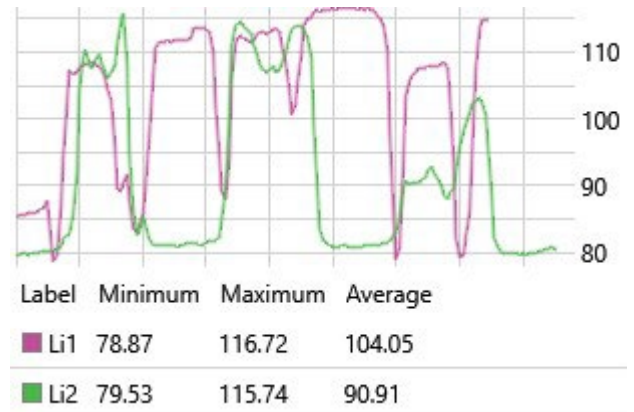
Component	C-3
Equipment/Bucket ID	Breaker/Starter

Sp1	107.9 °F
Sp2	79.6 °F
Li1 Minimum	78.9 °F
Li1 Maximum	116.7 °F
Li2 Minimum	79.5 °F
Li2 Maximum	115.7 °F
Bx1 Minimum	50.8 °F
Bx1 Maximum	118.4 °F

Fault	NONE
Defect Rating	NONE

Recommendations	IR image shows no issues to mention.
-----------------	--------------------------------------
