Infrared Thermography Report

ARCOSA 11-4-2021

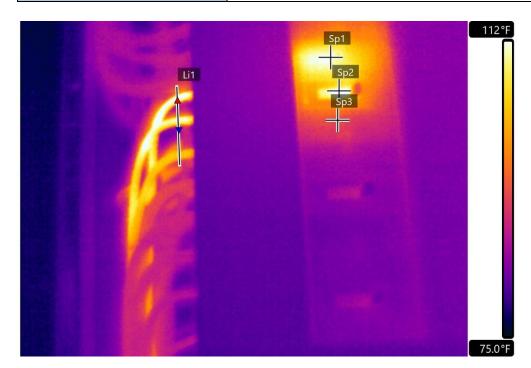
Component	Main Panel DP2	
Equipment/Bucket ID	t/Bucket ID Final Trim Breaker

Sp1	110.7 °F
Sp2	114.1 °F
Sp3	93.3 °F
Li1 Minimum	85.8 °F
Li1 Maximum	114.0 °F
Areas	-

Fault	Phase to phase temperature variation	
Defect Rating	Class I

Check all connections for proper torque, signs of oxidation or corrosion. Inspect breaker to buss bar connections also. Check for load imbalance.

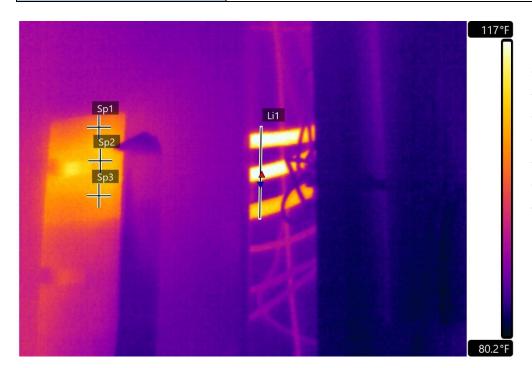
Component	Main Circuit Breaker	
Equipment/Bucket ID	Final Trim Electrical Panel Mains

Sp1	103.3 °F
Sp2	107.9 °F
Sp3	105.2 °F
Li1 Minimum	87.0 °F
Li1 Maximum	119.1 °F
Areas	-

Fault	Phase to phase temperature variation	
Defect Rating	Class I

Check all connections for proper torque, signs of oxidation or corrosion. Inspect breaker to buss bar connections also. Check for load imbalance.
