December 6, 2022

Infrared Thermography Report

Arcosa Marine Fiberglass Plant

Caruthersville, MO

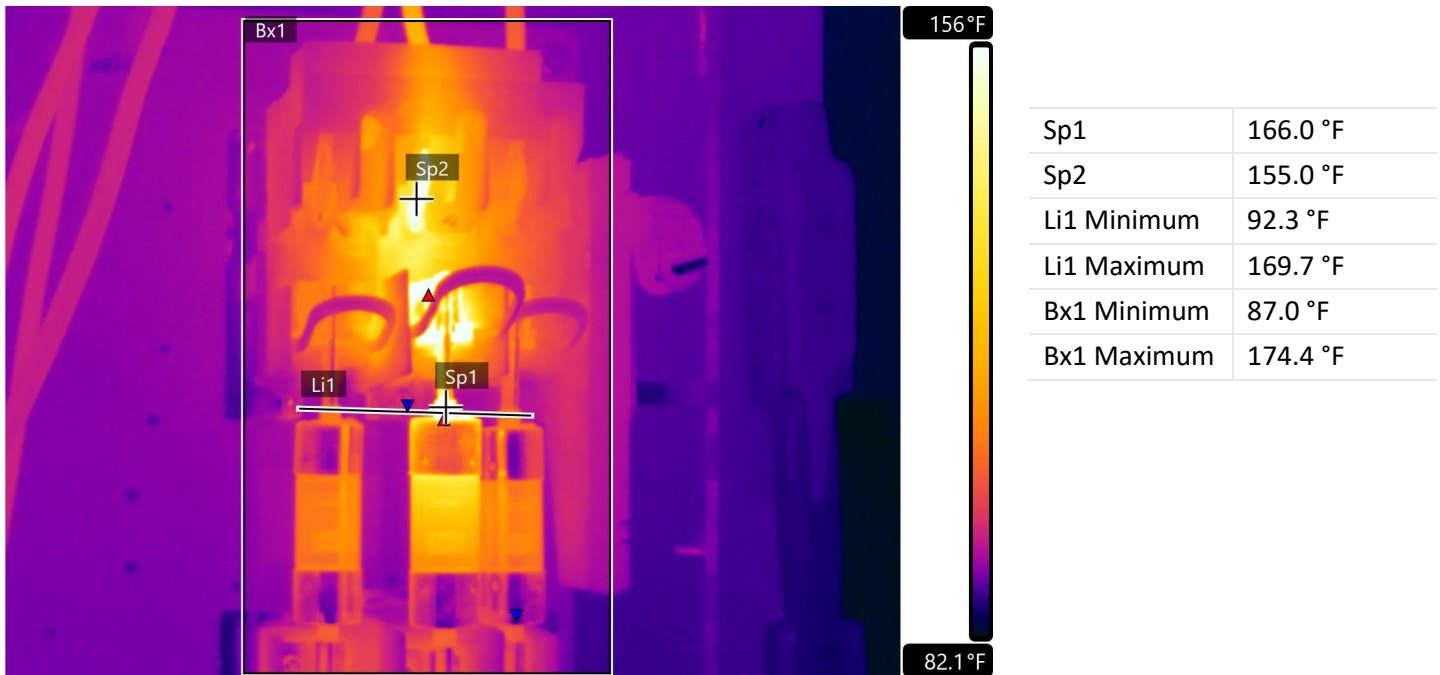
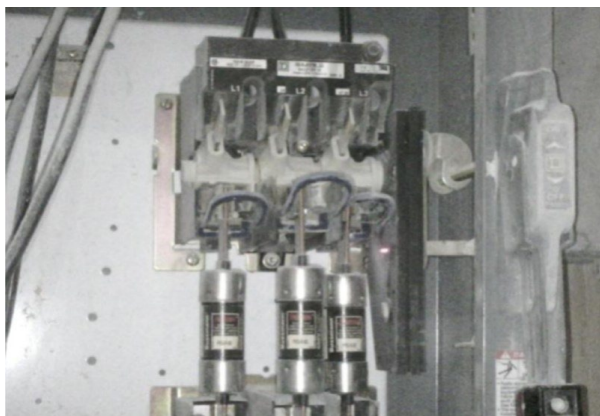
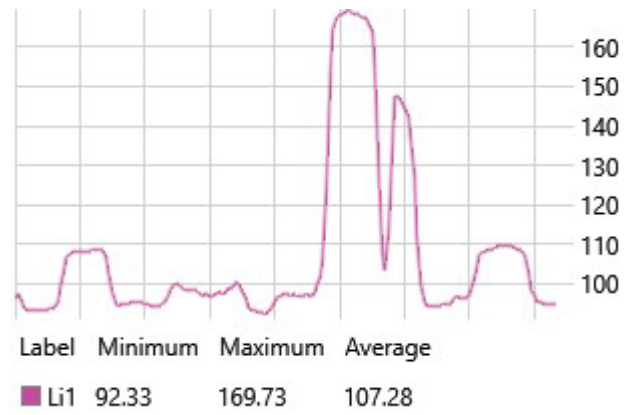
Component	B Phase Fuse Clip/Fuse
Equipment/Bucket ID	South Dust Collection System (Trim Area)

Fault	Loose fuse clip/Fuse connection
Defect Rating	CLASS I

Recommendations
B phase fuse/fuse clip appears to have an issue. Check fuse clip and fuse ensuring that there is a tight/clean connection.

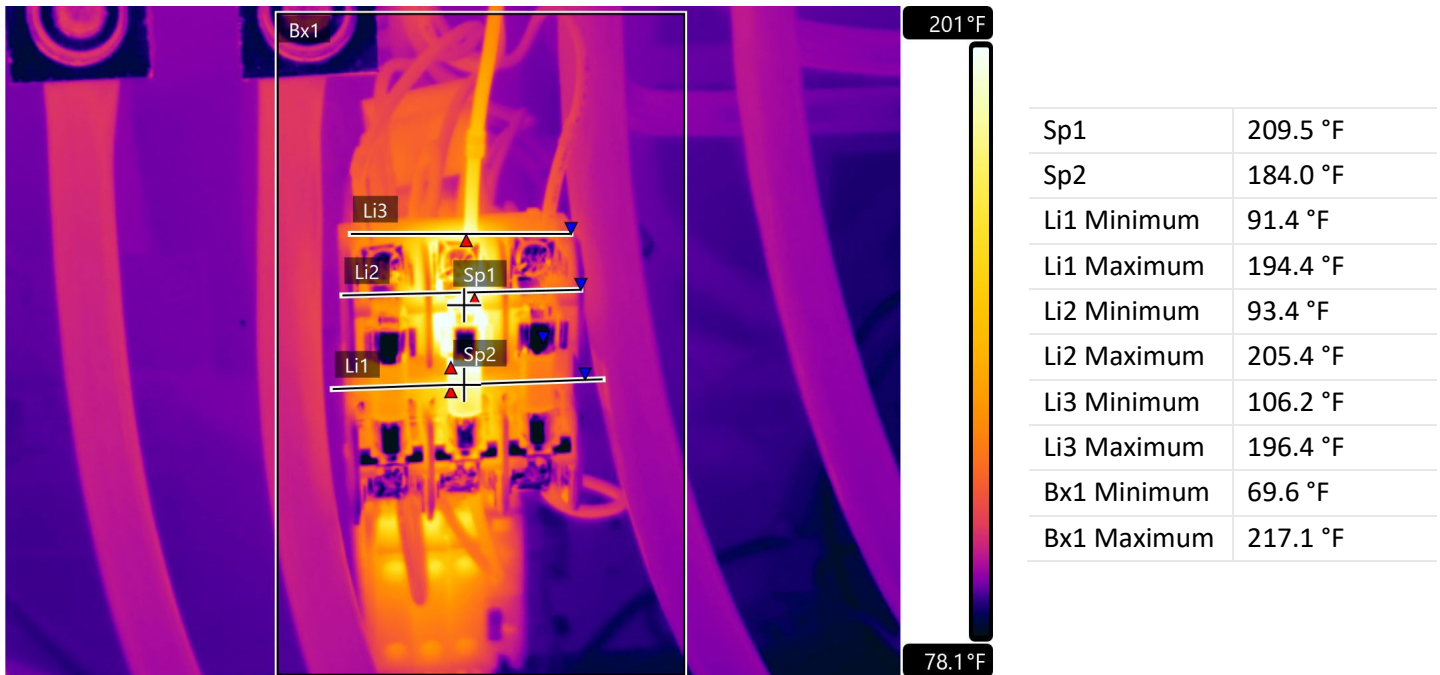
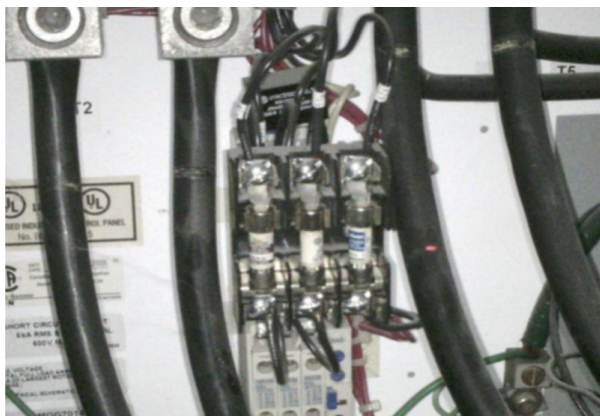
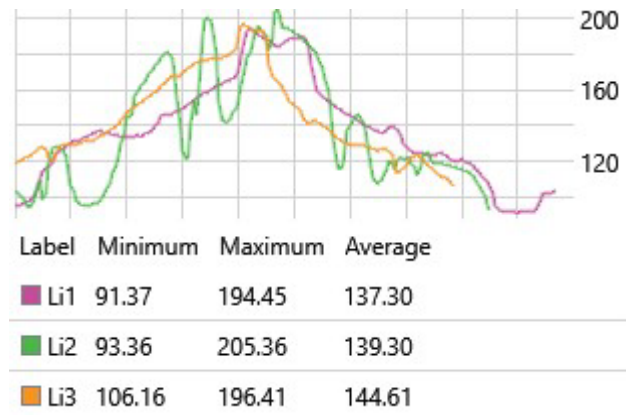
Component	B Phase Fuse connections
Equipment/Bucket ID	Gardner Denver Air Compressor Panel

Fault	Loose fuse connection B Phase
Defect Rating	CLASS II

Recommendations
B phase fuse and connection behind fuse appear to have high amount of heat. Check fuse and lead connection behind top of fuse soon. Ensure connections are clean and tight.
