January 13, 2022

Arkema  
Fite Rd.  
Memphis, TN

The following is a summary report for the Motion Amplification and Vibration Analysis on the SPT Pump 101 Pump 102, and specific locations on process piping. Several MA videos were taken with Pump 102 operating at 60 Hz, 45 Hz, 30 Hz. on the VFD. Vibration data was also taken on Pump 101, Pump 102, and six piping locations at 60 Hz, 45 Hz, 30 Hz. on the VFD. Please let us know if there are any questions or comments.

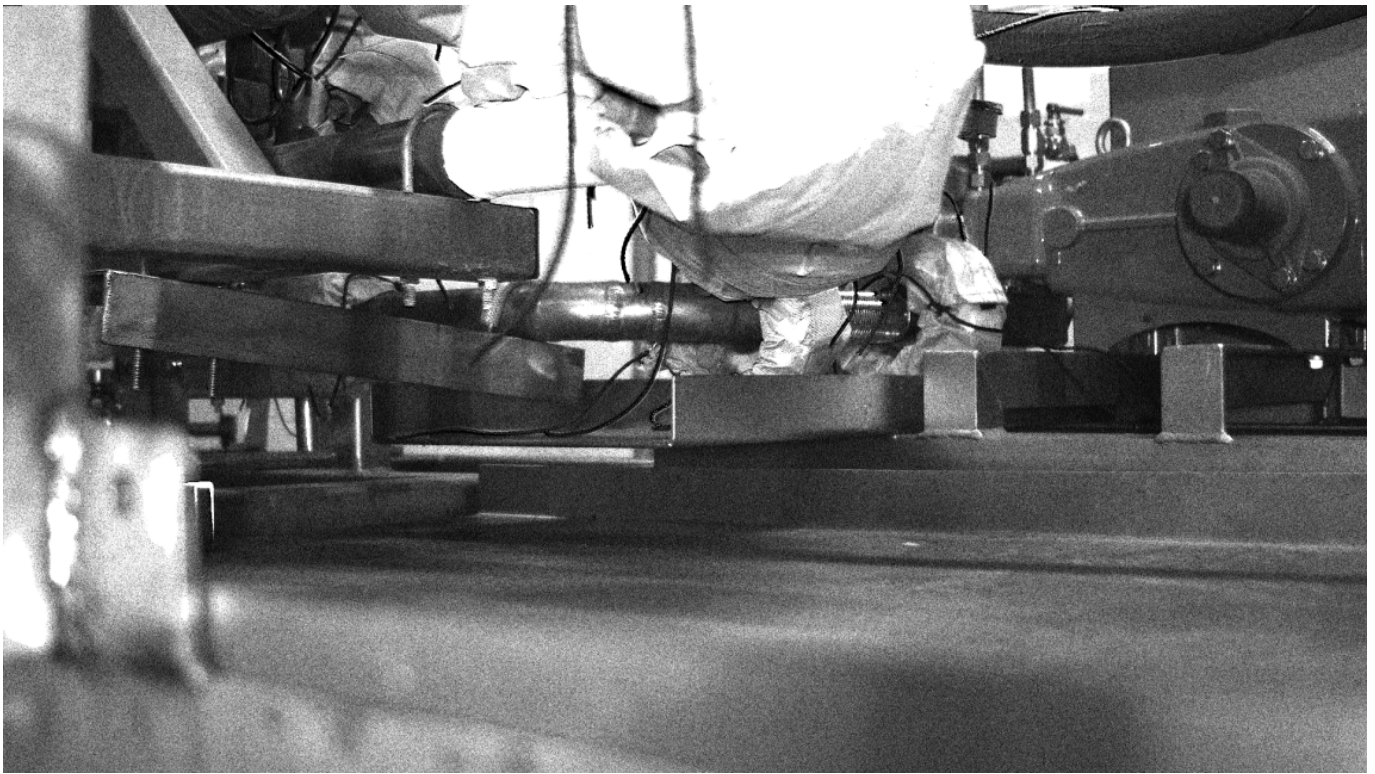
Vibration analysis and motion amplification was taken on Pump 102, process piping, and Pump 101 motor. During our testing, it was noticed that a specific area of piping had excessive motion. This motion appeared at 60 Hz and 45 Hz with an extreme amount of motion and vibration at 45 Hz. See motion amplification videos below. ***Click on picture to open video link. (Must have internet access to play videos as they are large data files.) Also you may have to change the resolution on the video setting after clicking on the play tab.***

**Figure 2:** Pump 102 Piping at 60 Hz. drive speed.

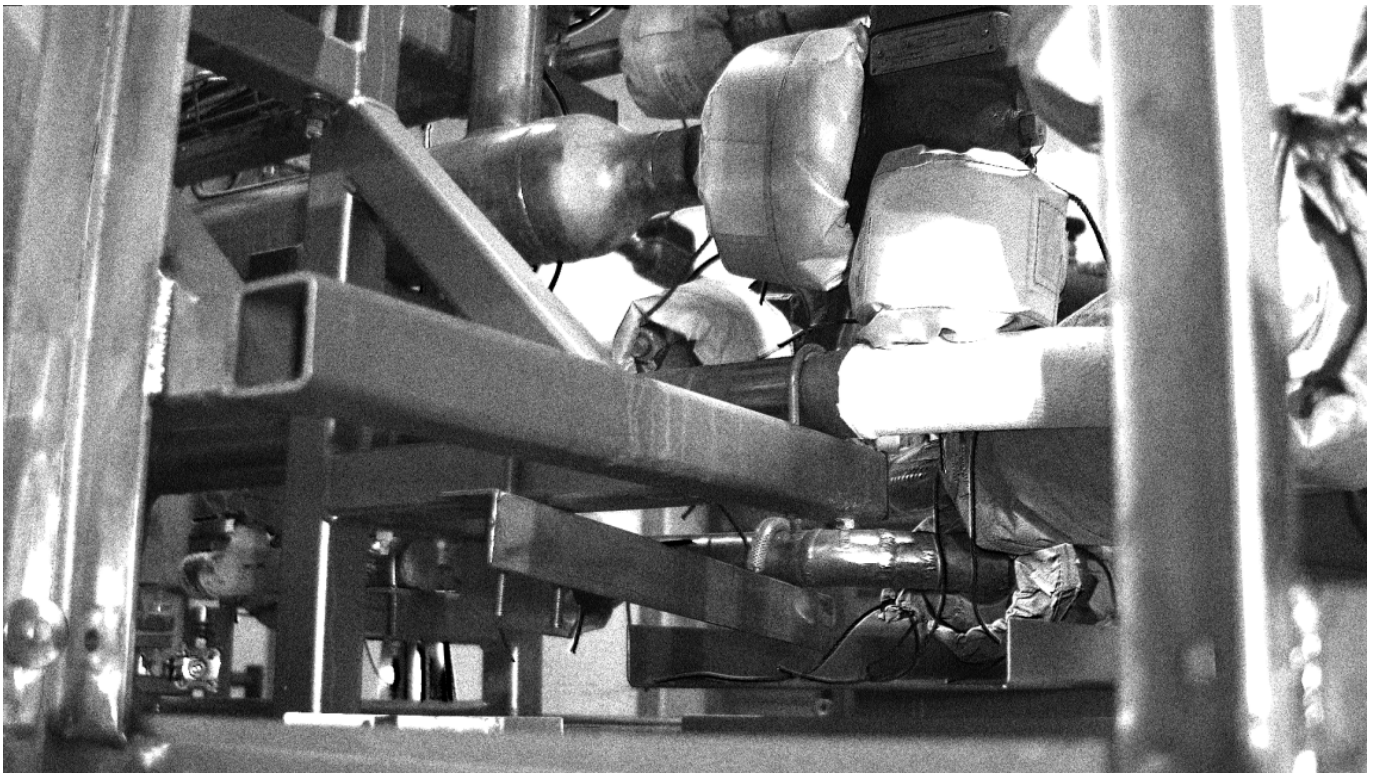
**Figure 3:** Pump 102 Piping at 45 Hz. drive speed.

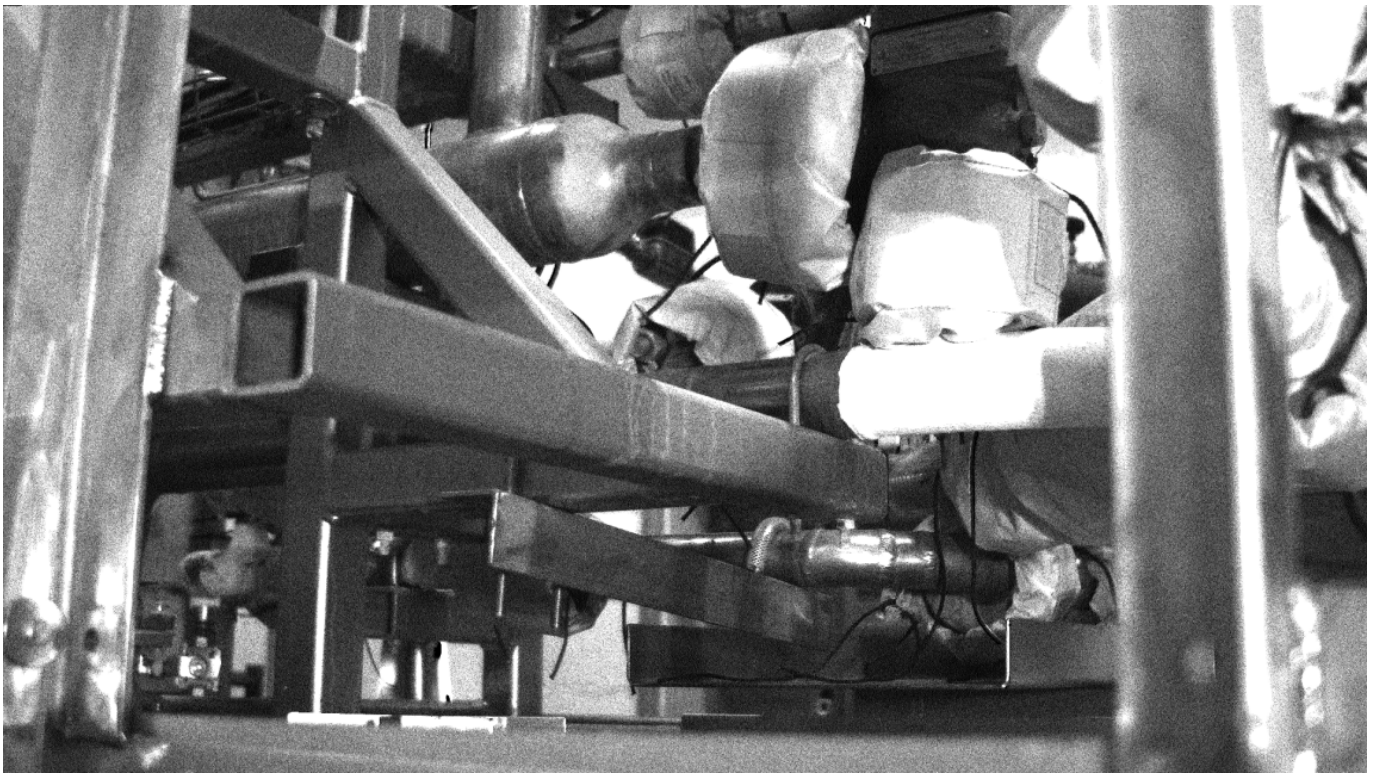
**Figure 4:** Pump 102 Piping at 30 Hz. drive speed.

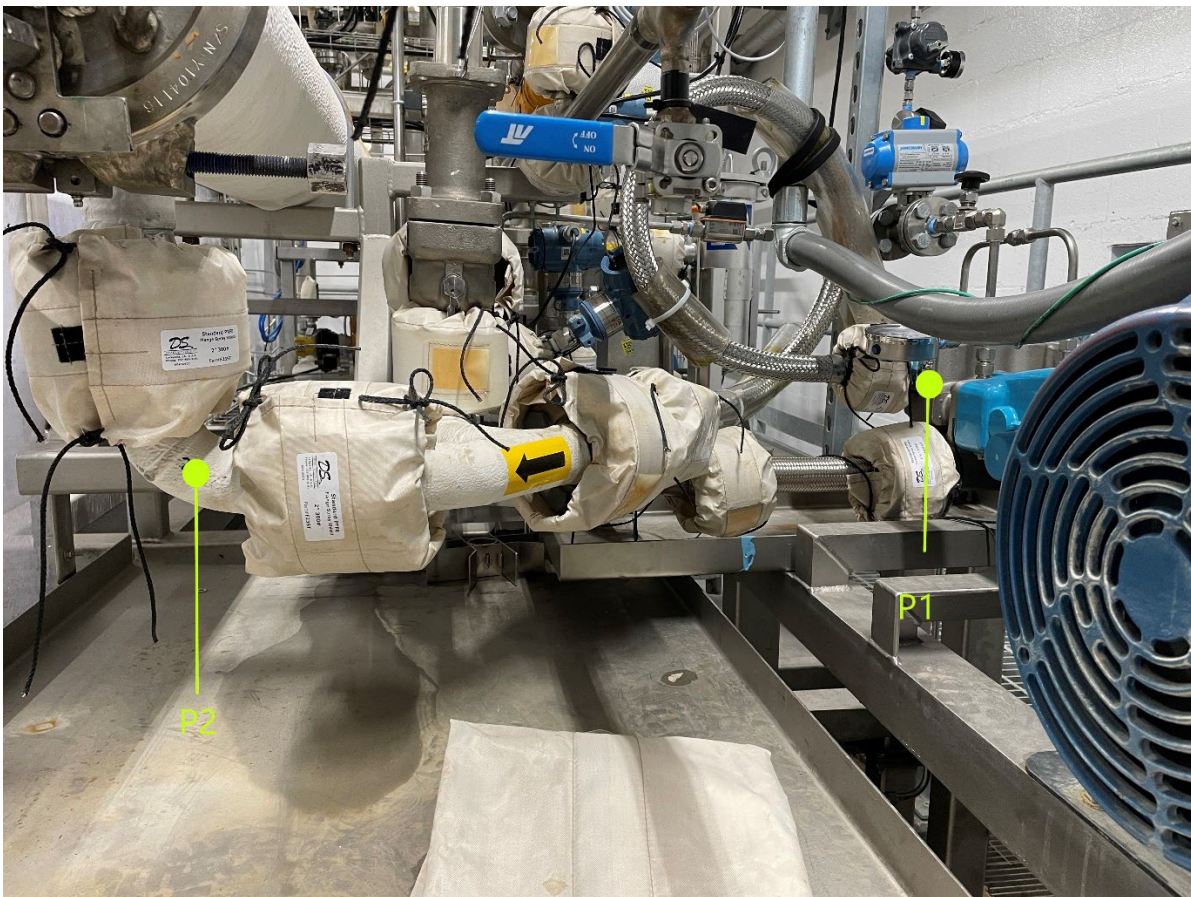
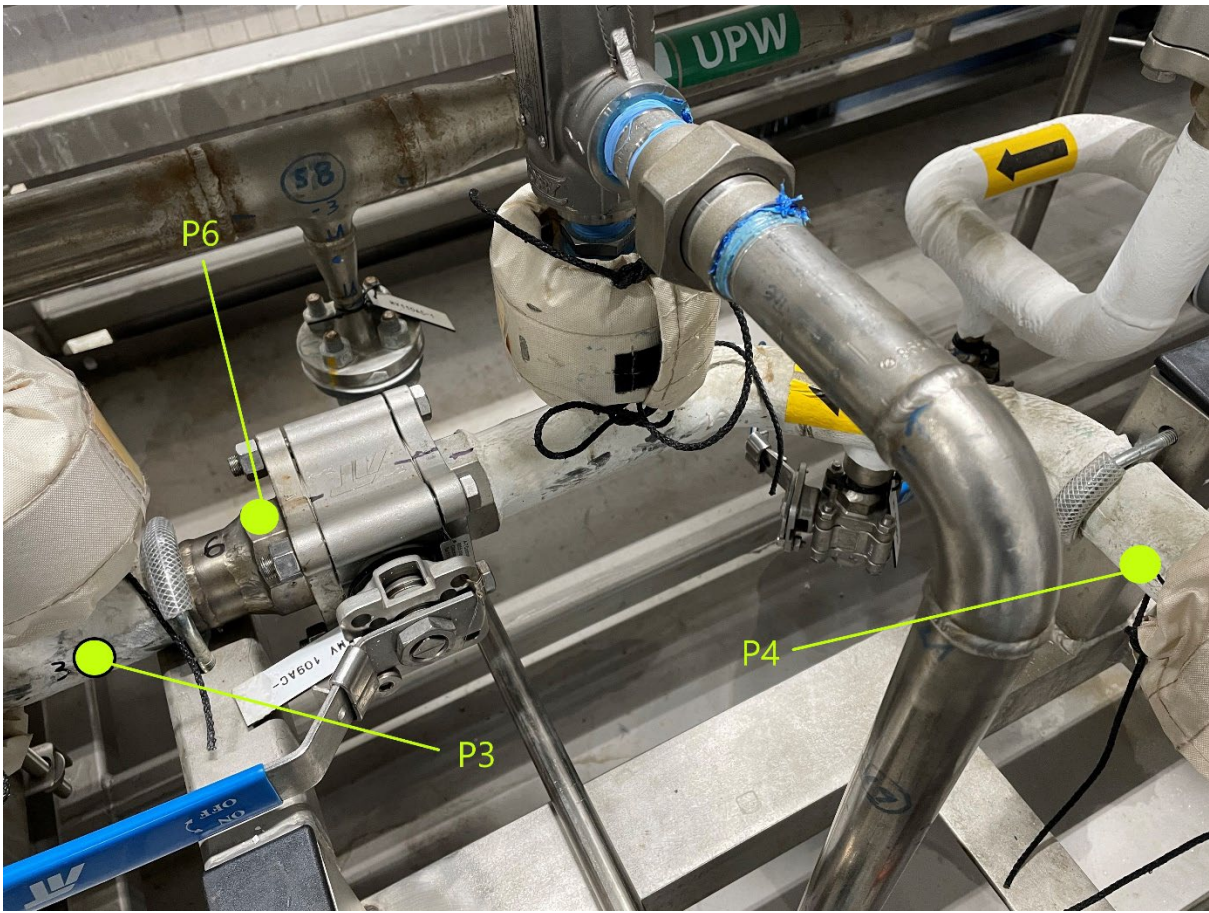
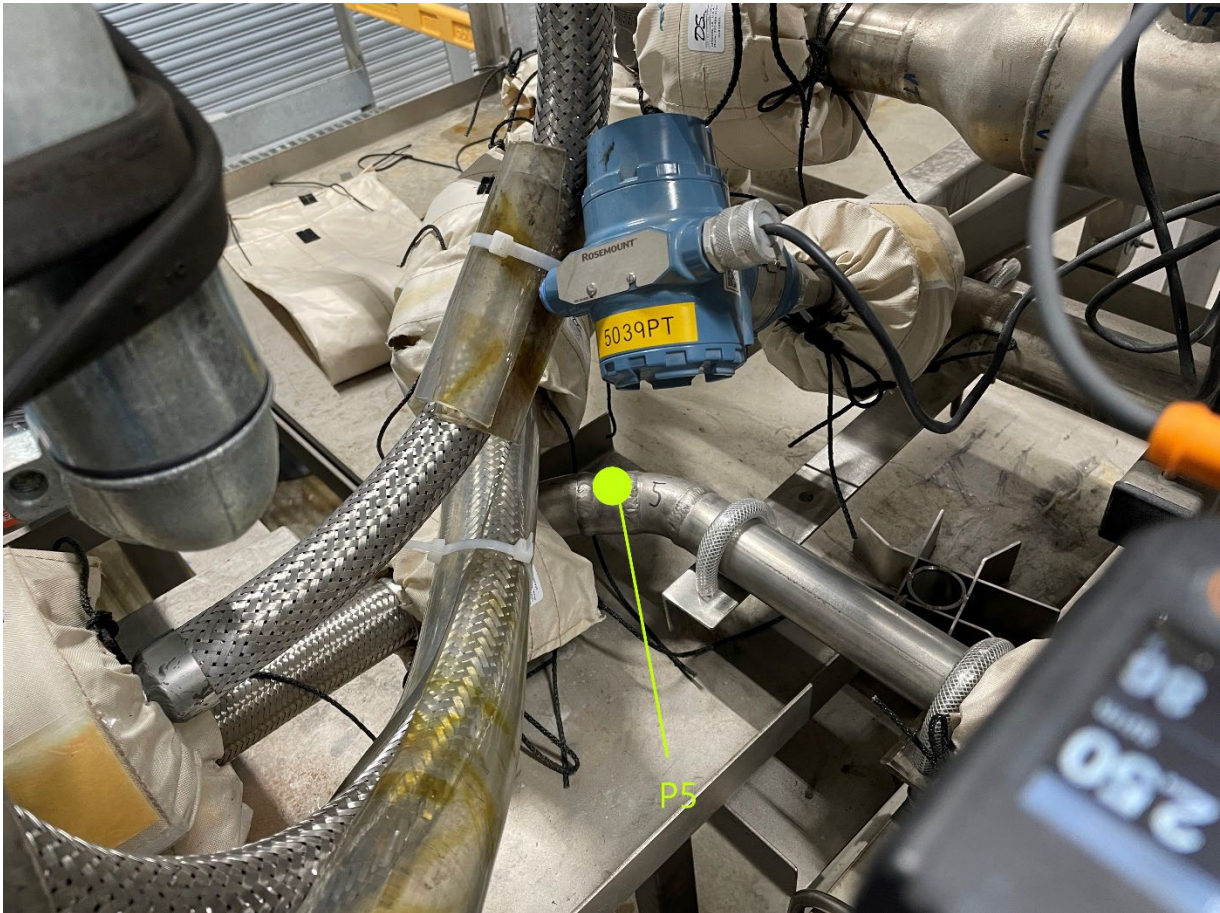
Most of this motion/vibration was at piping locations 3, 5, and 6. *See pictures below for piping locations.*

After analyzing video and vibration data, it was determined that the suction piping for pump 102 did not have sufficient support. MA video showed the bracket that the piping was U bolted to was very flexible and offering minimal support. Plans were made with Arkema Maintenance personnel and a clamping bracket was installed at the section of piping that was generating the most motion/vibration. After these actions were taken, vibration data was collected on the pumps and six piping locations. Vibration had minimal change on Pump 102 motor and pump and Pump 101. However, we did notice significant decrease in vibration at piping point 3, 5 and 6. See below trends of the Pump 102 and each piping point to support these findings.

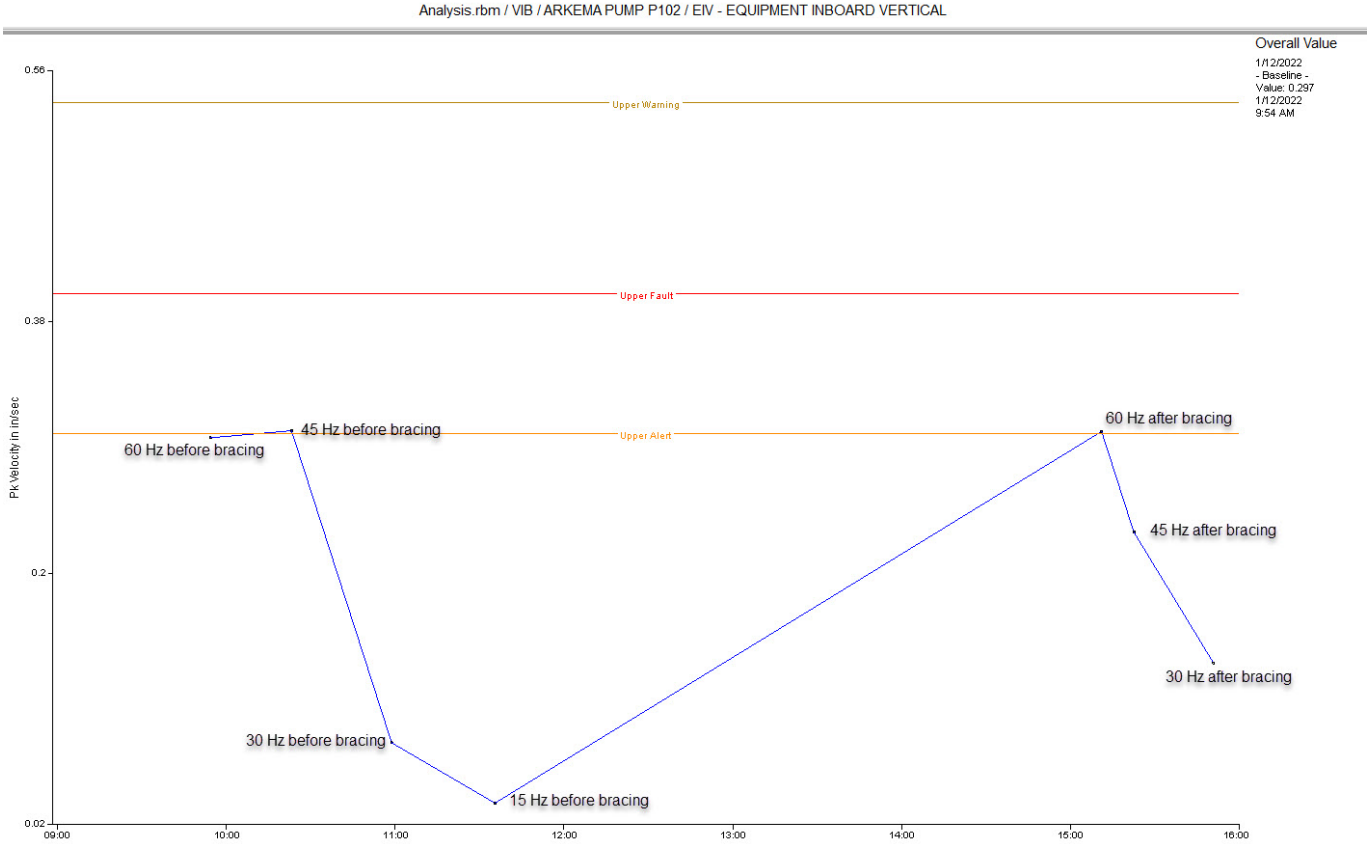
Data plot above is the pump inboard (DE) vertical.

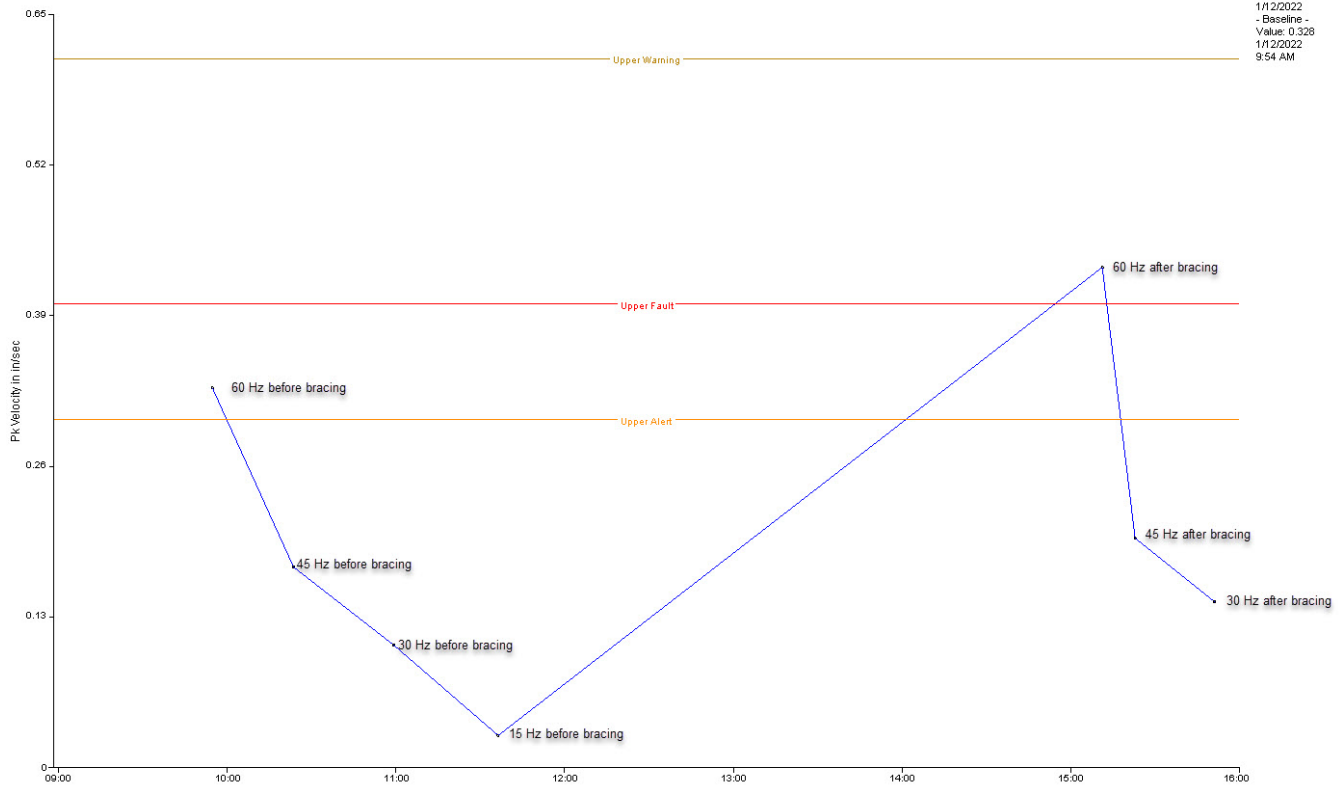
Data plot above is the pump outboard (ODE) horizontal.

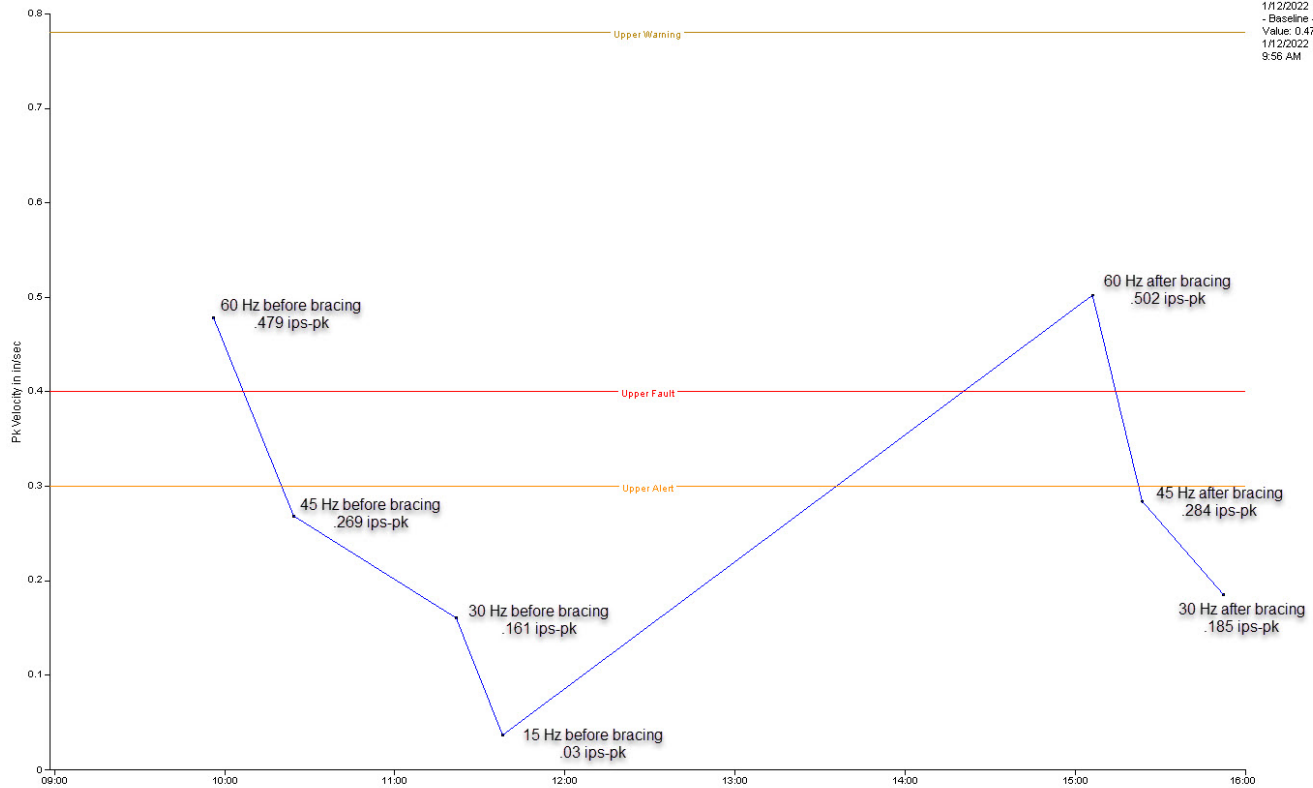
Data plot above is the pump piping (location #1). Not much change after adding bracing.

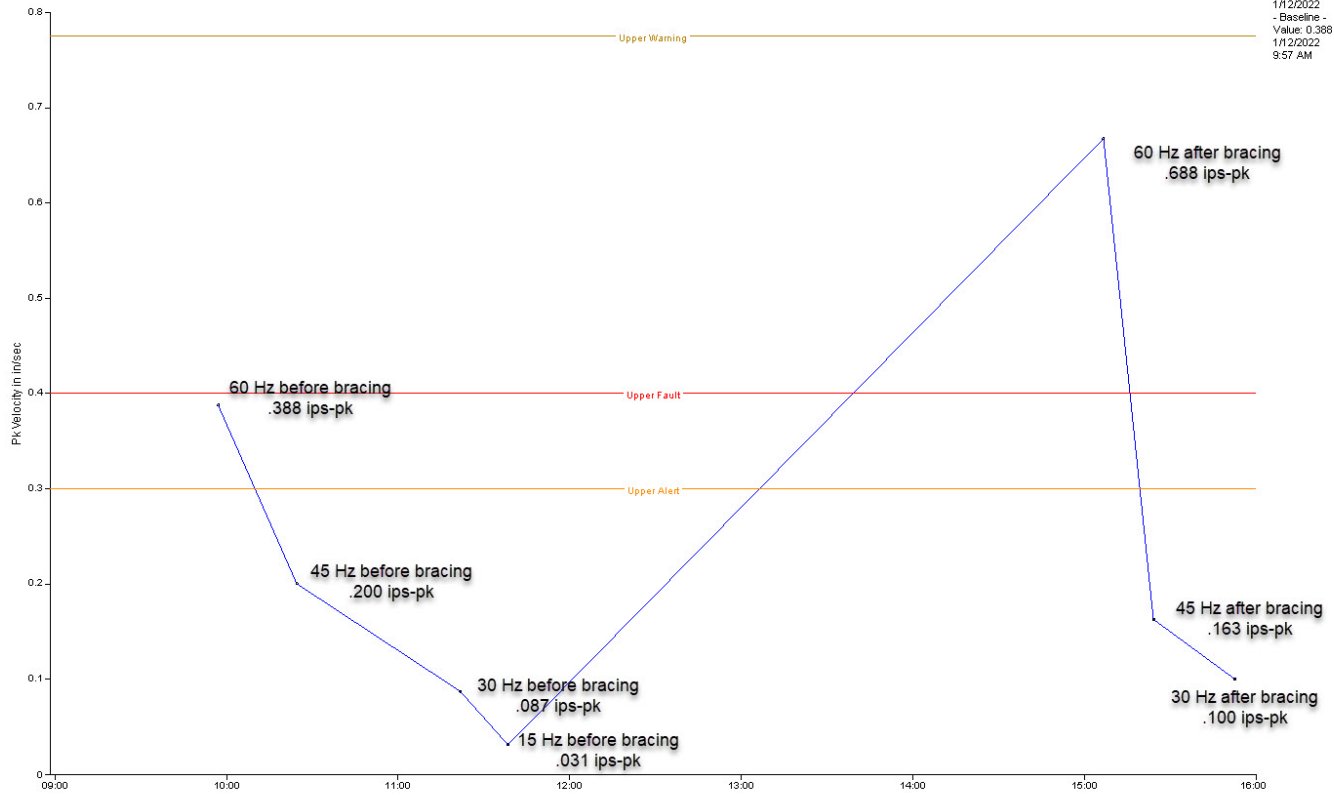
Data plot above is the piping location #2. There was an increase in vibration at this location (at 60 Hz.) after bracing was installed.

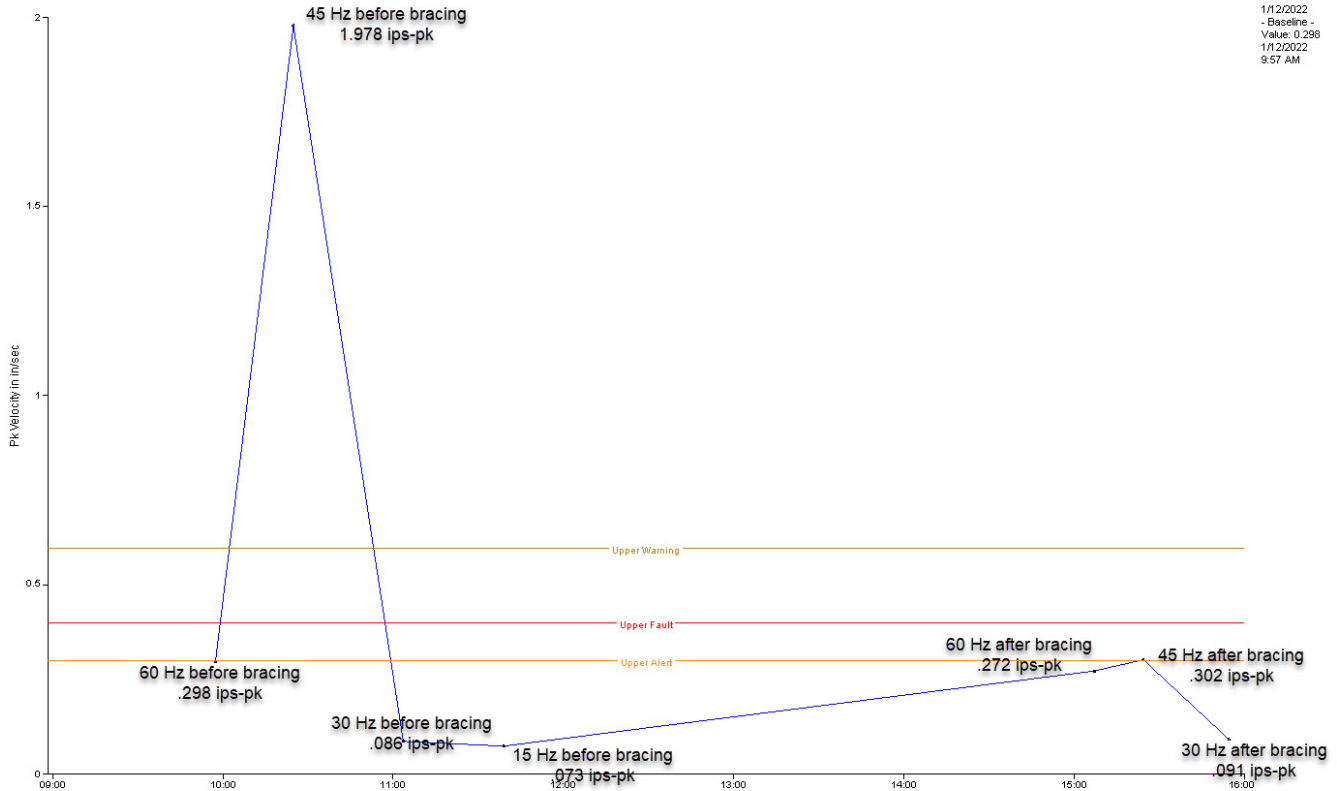
Piping location #3 trend plot shows a significant decrease in amplitude at 45 Hz. after adding the piping bracing. Vibration decreased from 1.978 ips-pk to .302 ips-pk.

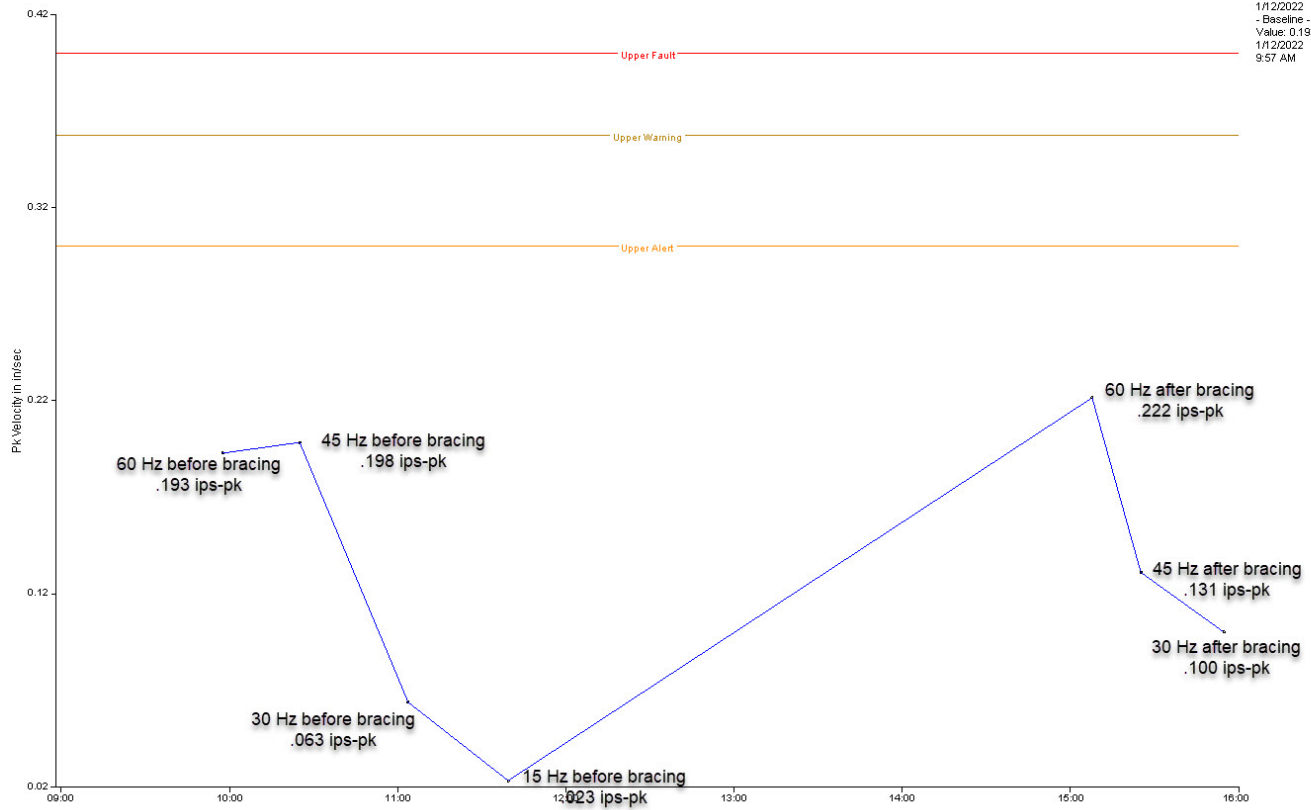
Piping location #4 shows minimal change in vibration.

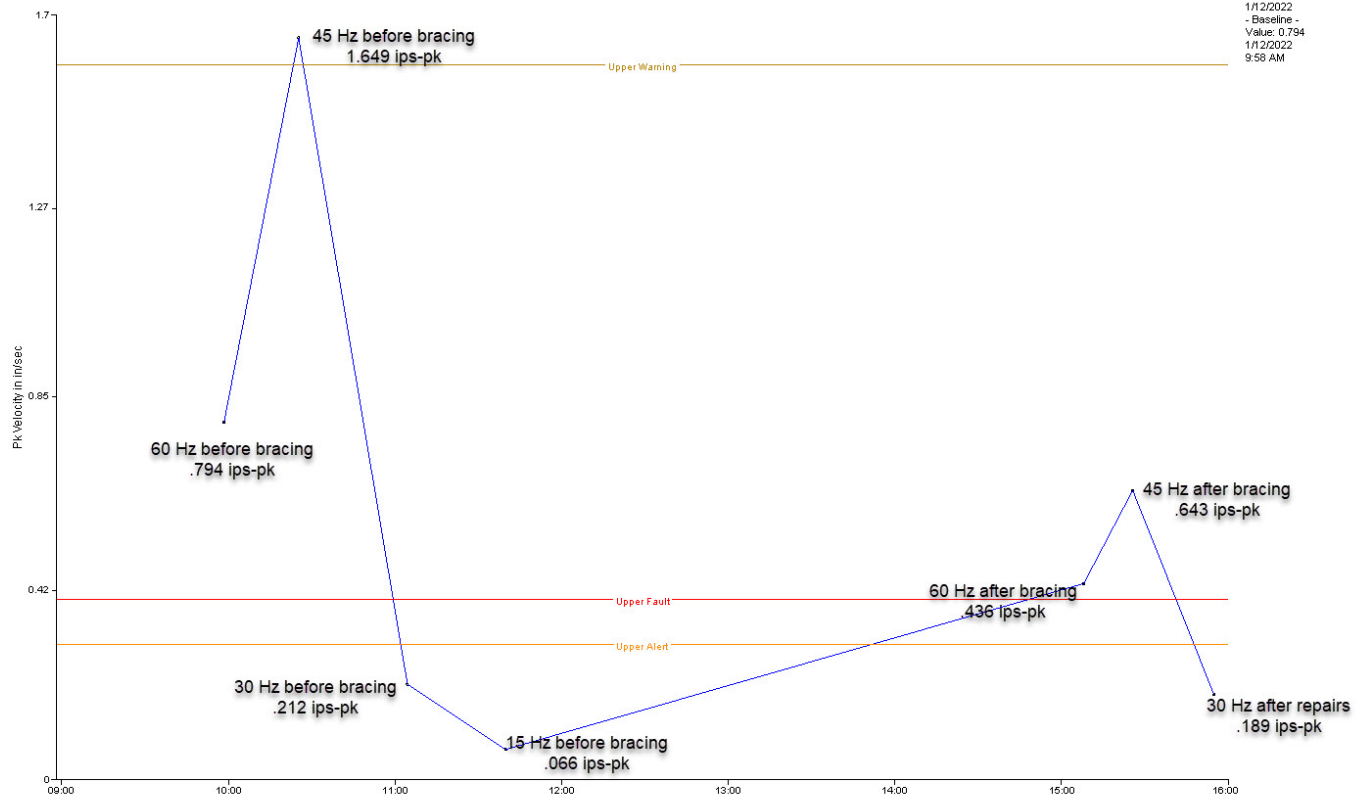
Location #5 trend shows a substantial decrease in vibration after bracing the piping. Overall vibration decreased from 1.649 ips-pk to .643 ips-pk

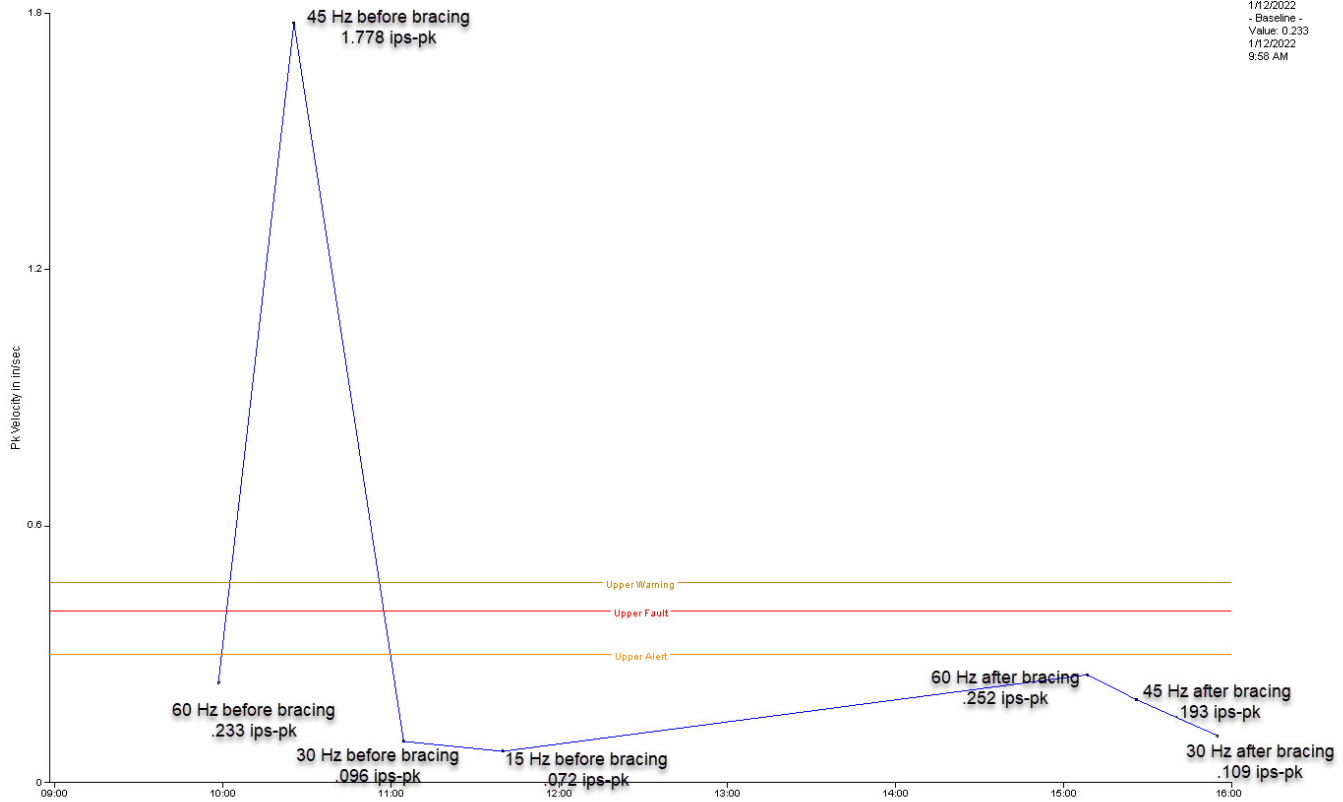
Piping location #6 trend shows another significant decrease in amplitude at 45 Hz.
