## Infrared Thermography Report

USG August 2020

All electrical panels were scanned using a   P60 infrared camera. The following report only contains defects that were found during the survey. Below is our classification system for each defect included in this report. If there are any questions or comments, please feel free to contact us at any time.

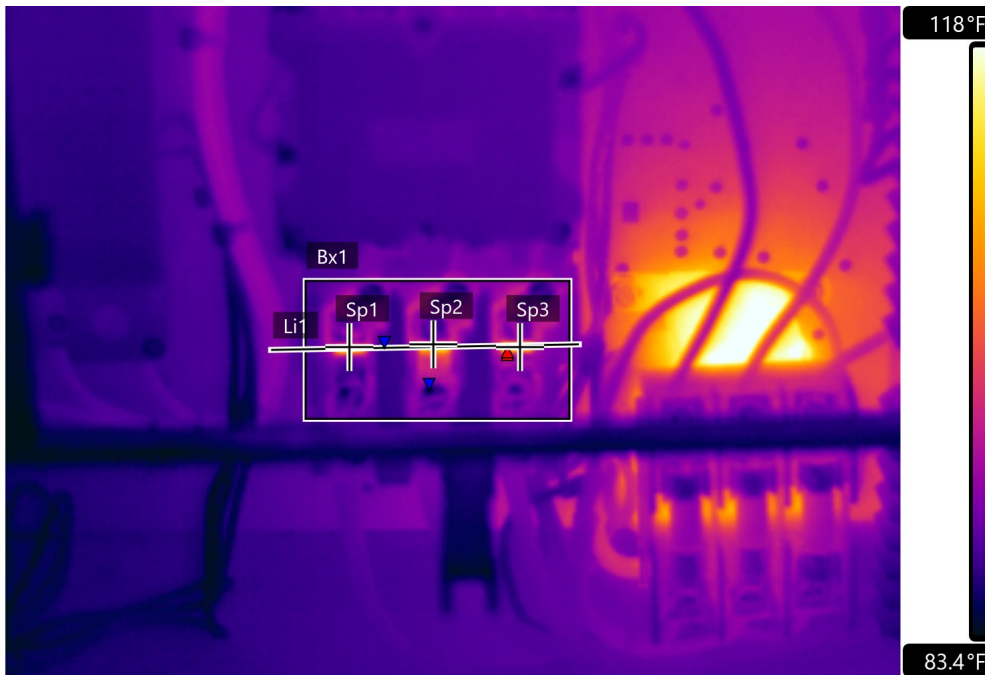
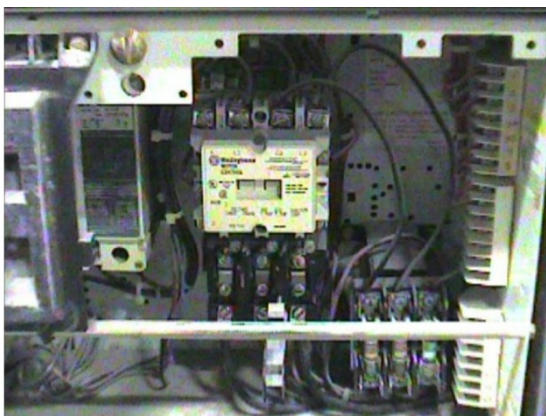
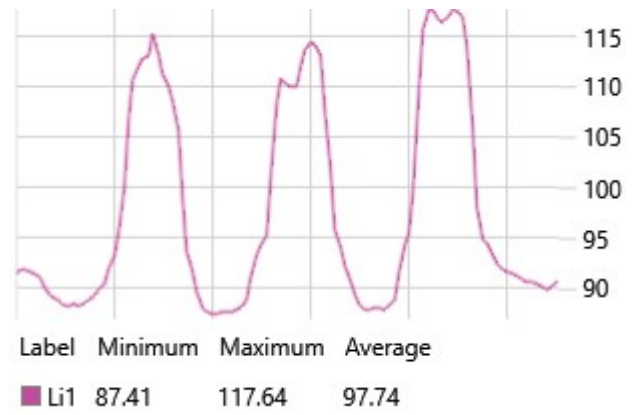
Component	Wet Zone Burner Room Exhaust Fan North
Equipment/Bucket ID	MCC-7D1/M5247

Sp1	115.1 °F
Sp2	110.0 °F
Sp3	116.3 °F
Li1 Minimum	87.4 °F
Li1 Maximum	117.6 °F
Bx1 Minimum	84.3 °F
Bx1 Maximum	117.8 °F

Fault	None
Defect Rating	None

Recommendations	This is a recheck after repairs. Issue has been resolved. No actions needed.
-----------------	--

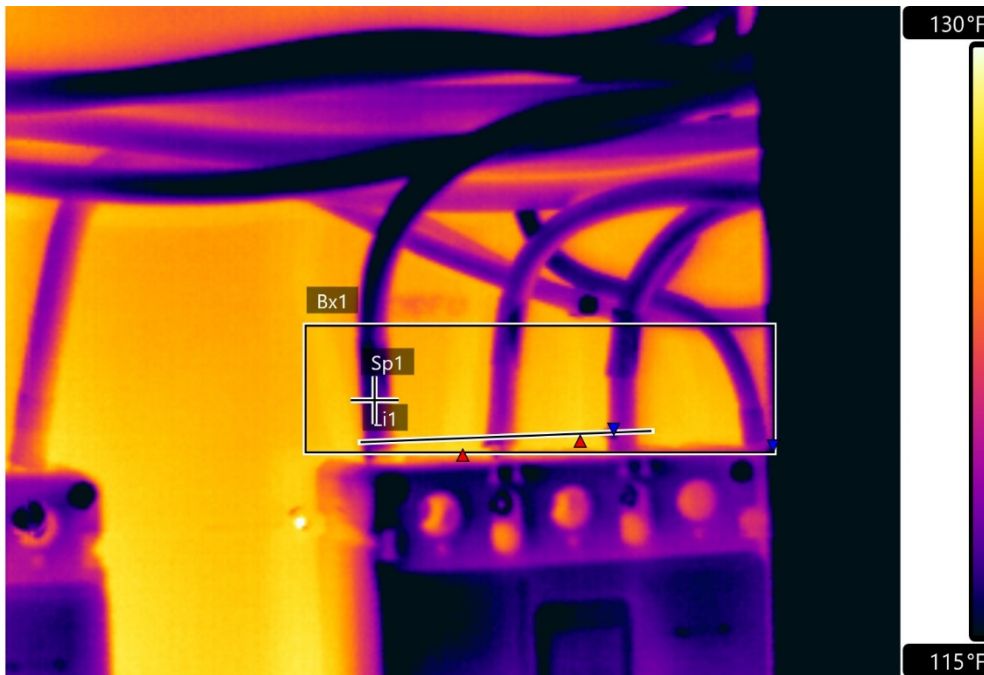
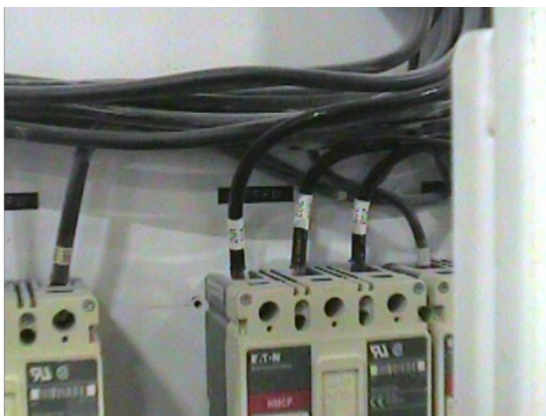
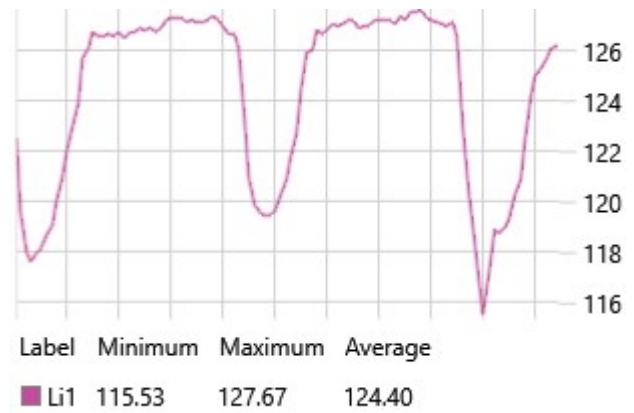
Component	109FUBreaker/201 Lead
Equipment/Bucket ID	#1 Wisconsin Oven

Sp1	116.4 °F
Li1 Minimum	115.5 °F
Li1 Maximum	127.7 °F
Bx1 Minimum	113.7 °F
Bx1 Maximum	127.7 °F

Fault	None
Defect Rating	None

Recommendations	This is a recheck after repairs. Issue has been resolved. No actions needed.
-----------------	--
