Infrared Thermography Report

IFF-Solae

Memphis, TN

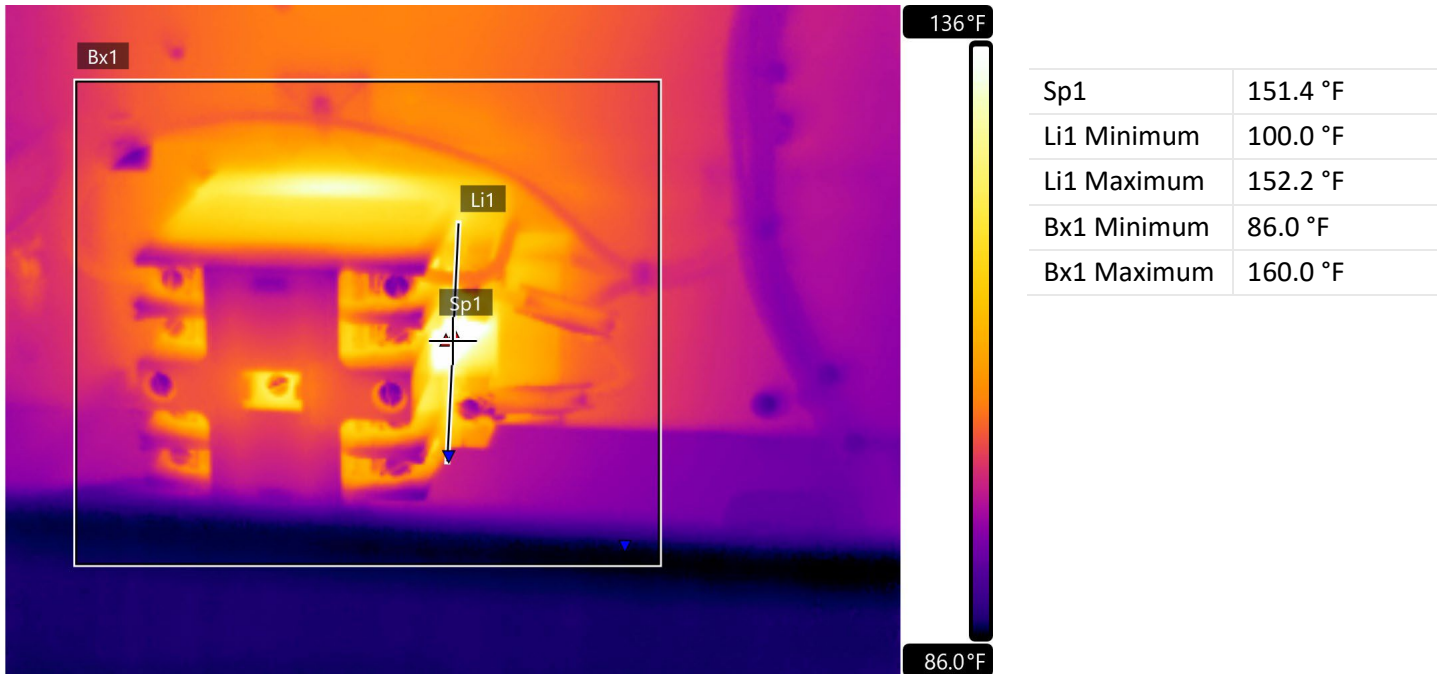
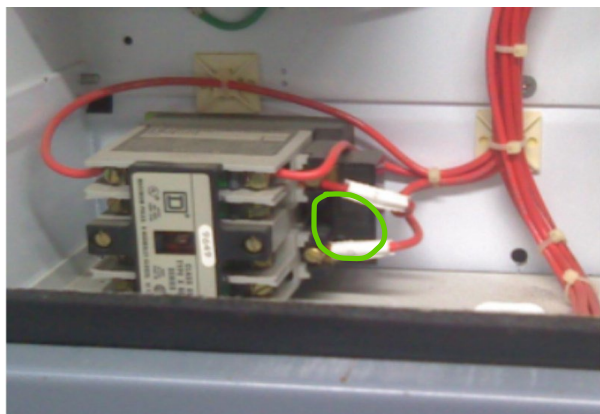
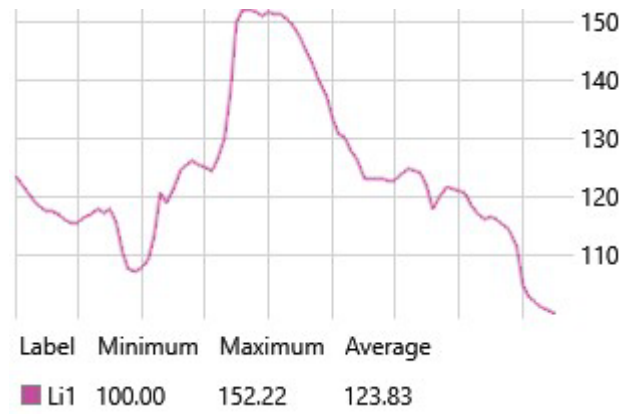
Component	Breaker
Equipment/Bucket ID	223FH PV-3471 Vacuum Pump

Fault	Possible loose connection or breaker issue
Defect Rating	CLASS I

Recommendations	Hard to see what it hot here. Check connection towards back of breaker. Heat may from breaker itself.
-----------------	---

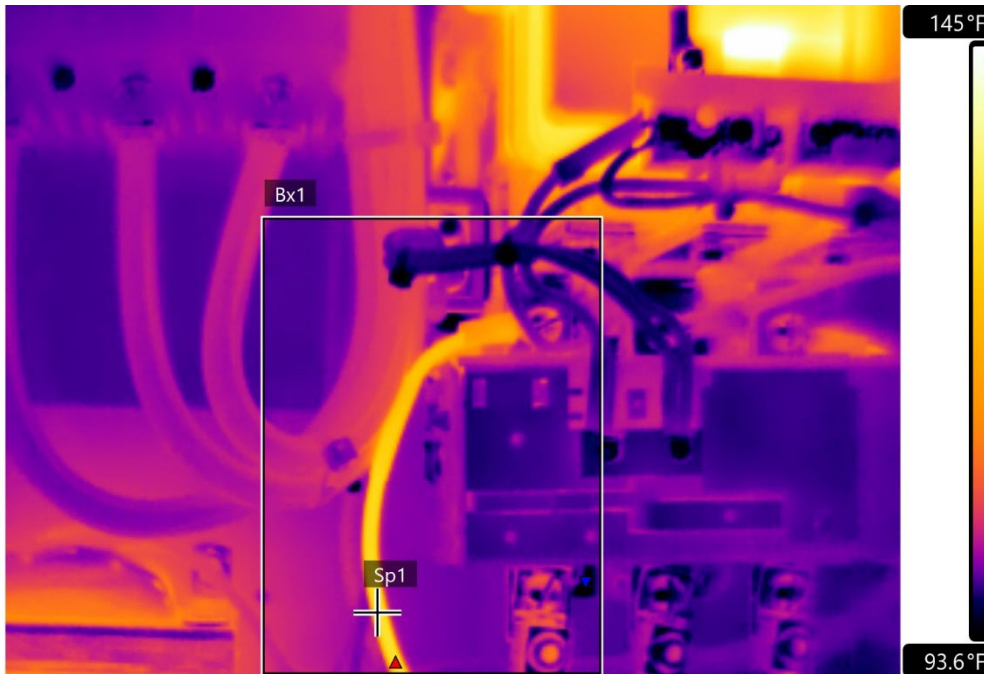
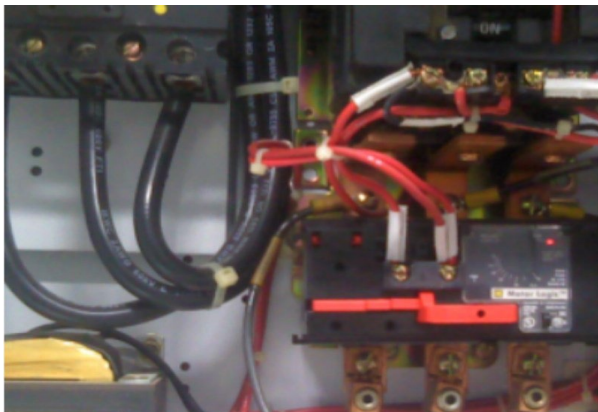
Component	Lead wire
Equipment/Bucket ID	243BF BL-8084 Baghouse Blower #5

Sp1	131.1 °F
Lines	-
Bx1 Minimum	91.7 °F
Bx1 Maximum	131.5 °F

Fault	Loaded circuit
Defect Rating	CLASS I

Recommendations
Looks like lead has heavy load. Check current on lead and ensure wire is sized correctly for load.

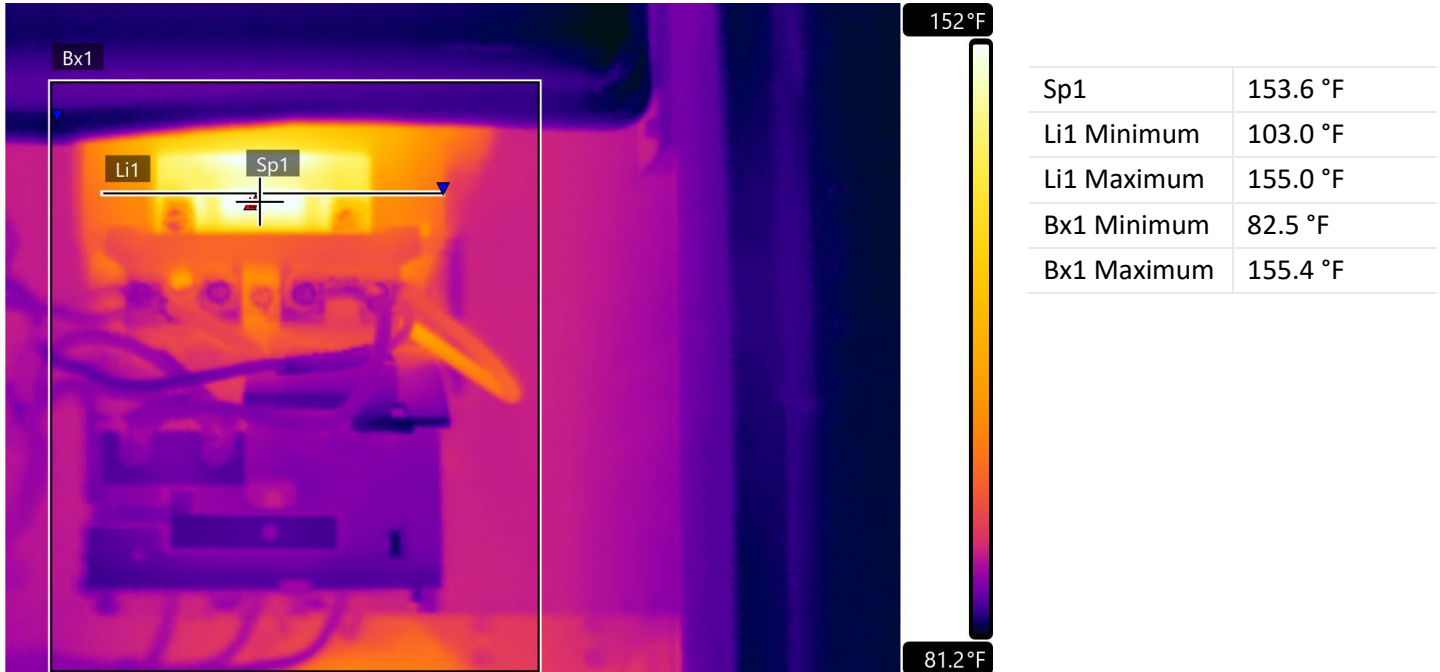
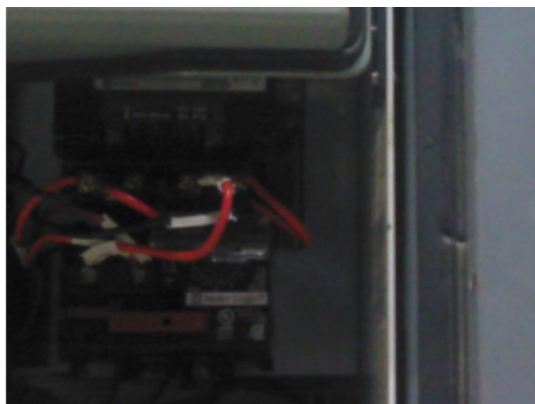
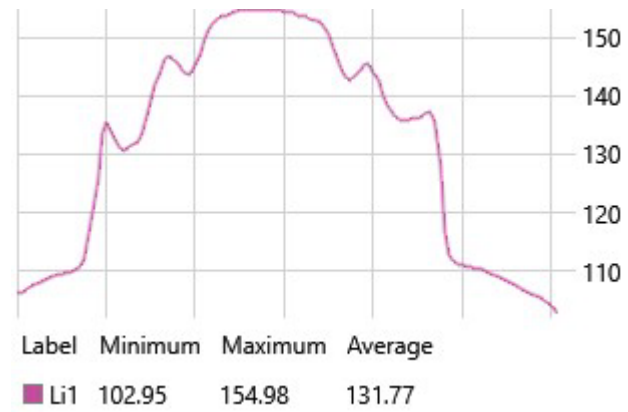
Component	Contactor
Equipment/Bucket ID	252FX RV-8038 CMC Cyclone #3 Fines Handling Rotary Valve

Fault	Possible load/connection issue
Defect Rating	CLASS I

Recommendations	Top side has highest temp. Could be a weak or loaded component. Inspect load and replace as needed.
-----------------	---

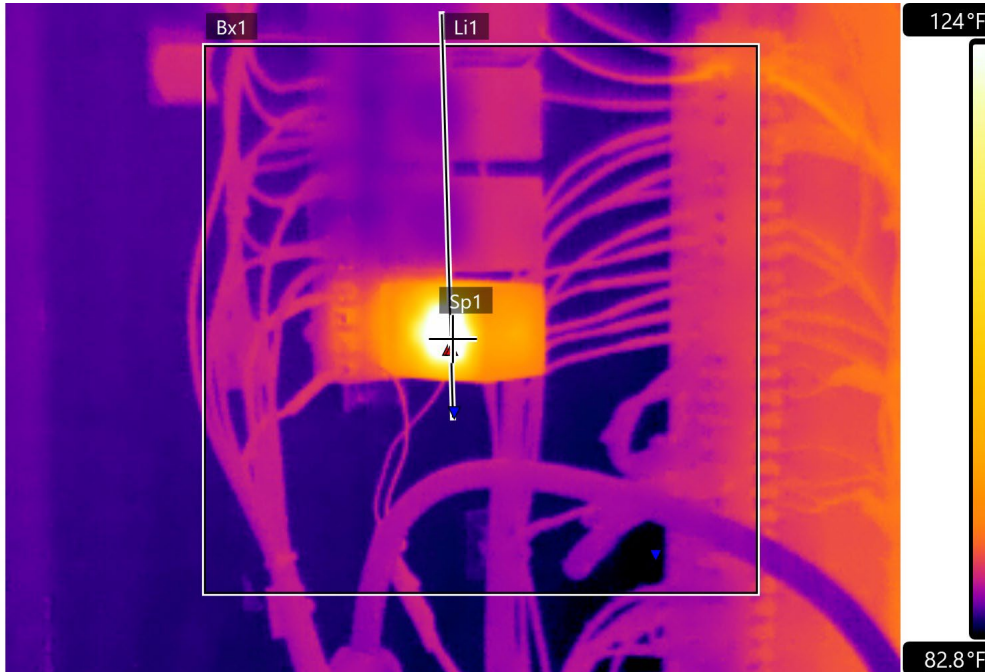
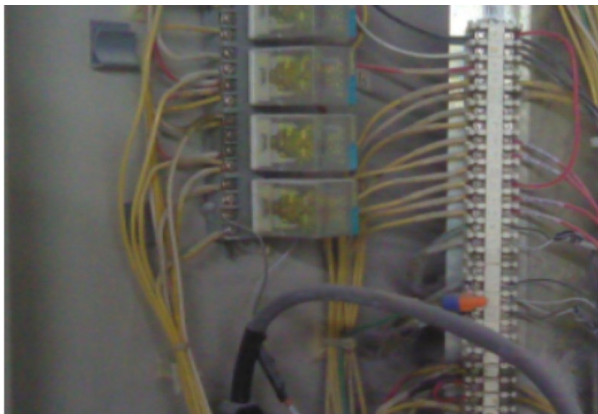
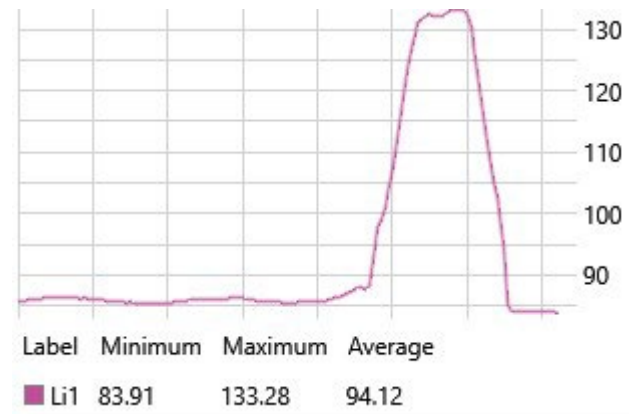
Component	
Equipment/Bucket ID	#3 214 FN MS2P SSMG #3

Sp1	133.0 °F
Li1 Minimum	83.9 °F
Li1 Maximum	133.3 °F
Bx1 Minimum	82.4 °F
Bx1 Maximum	133.3 °F

Fault	Faulty/Heavy loaded circuit
Defect Rating	CLASS II

Recommendations	Either has heavy load or internal issue. Replace as needed.
-----------------	---

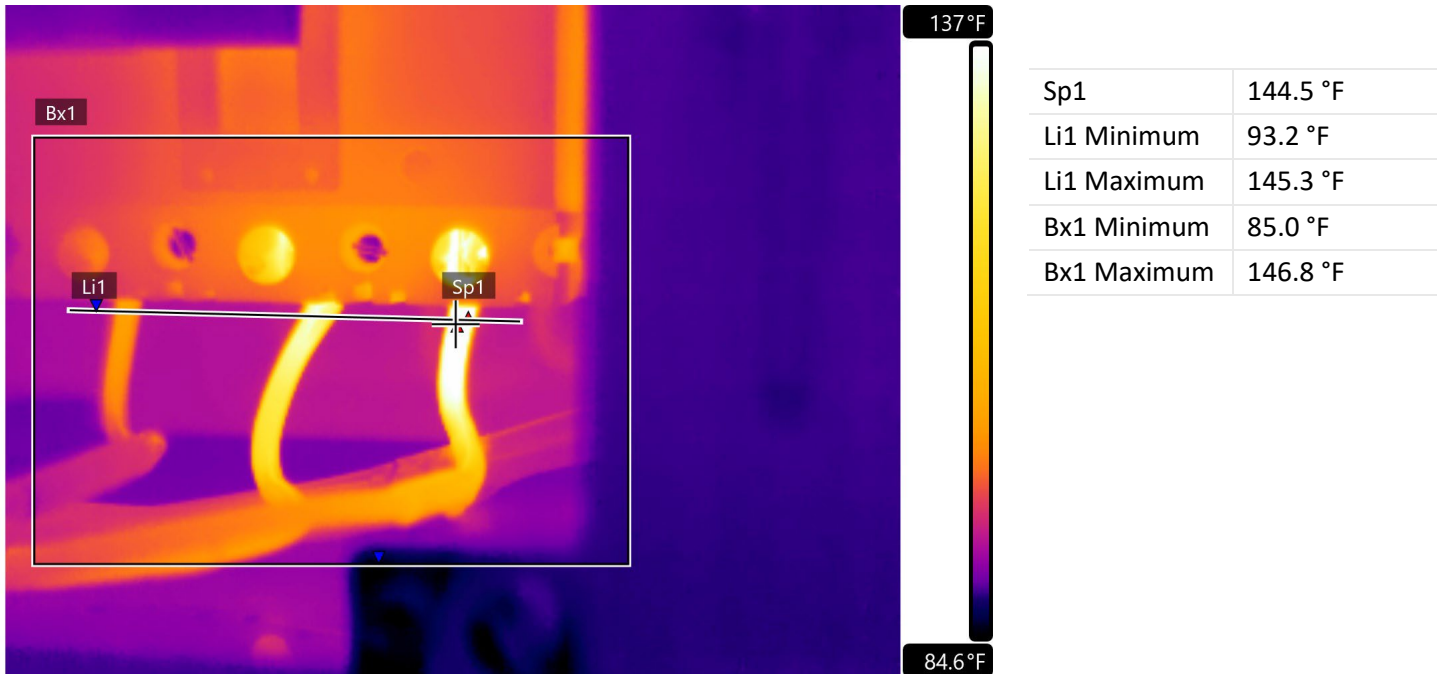
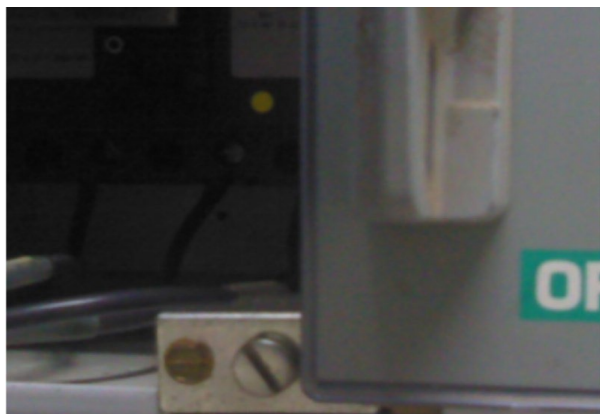
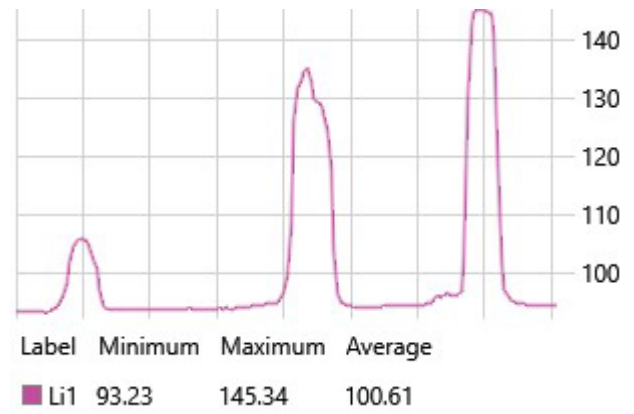
Component	Lead Connection
Equipment/Bucket ID	151BXL Air Handling Unit 1/O Room

Fault	Loose/faulty connection
Defect Rating	CLASS I

Recommendations	Likely a loose or faulty connection. Ensure a tight and clean connection.
-----------------	---

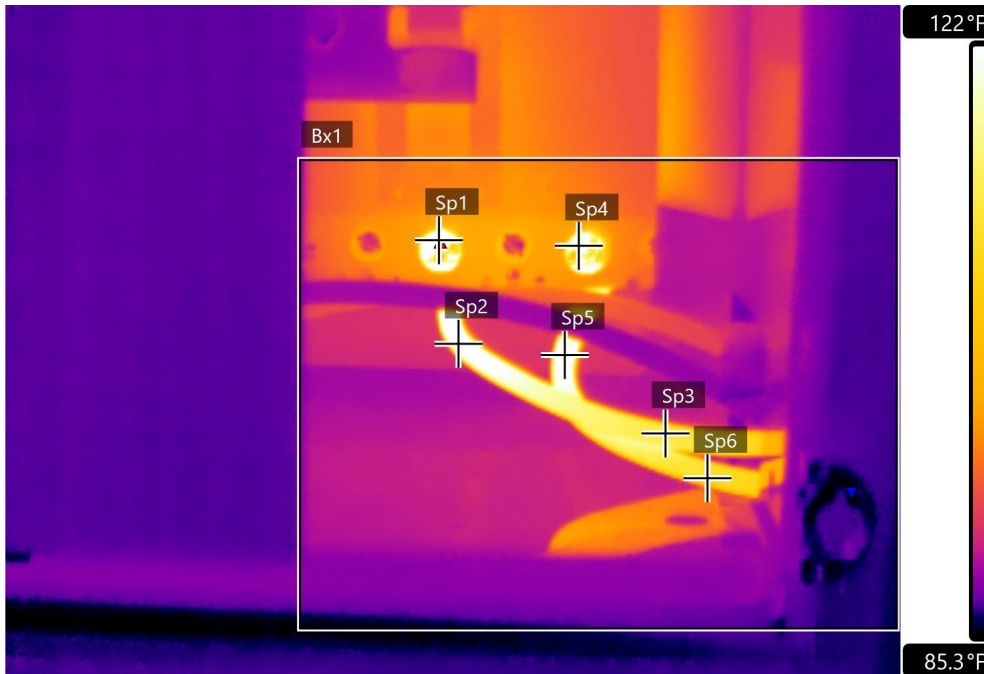
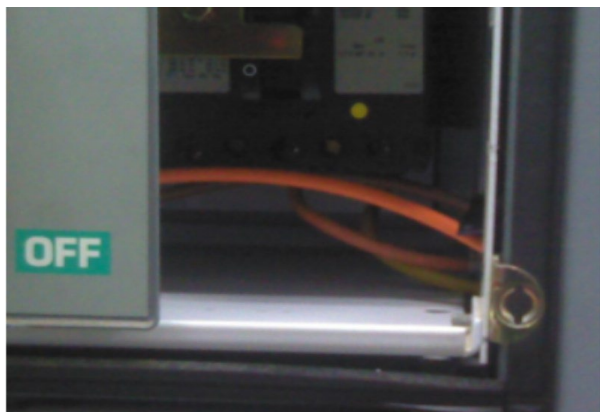
Component	Lead connections			
Equipment/Bucket ID	MS2P Roof MCC Room	T-AP103	171BTR	10KVA Transformer

Sp1	135.3 °F
Sp2	124.5 °F
Sp3	112.4 °F
Sp4	130.3 °F
Sp5	123.8 °F
Sp6	109.6 °F
Lines	-
Bx1 Minimum	85.0 °F
Bx1 Maximum	136.2 °F

Fault	Connection issue
Defect Rating	CLASS I

Recommendations
Likely a connection issue. Check load also.

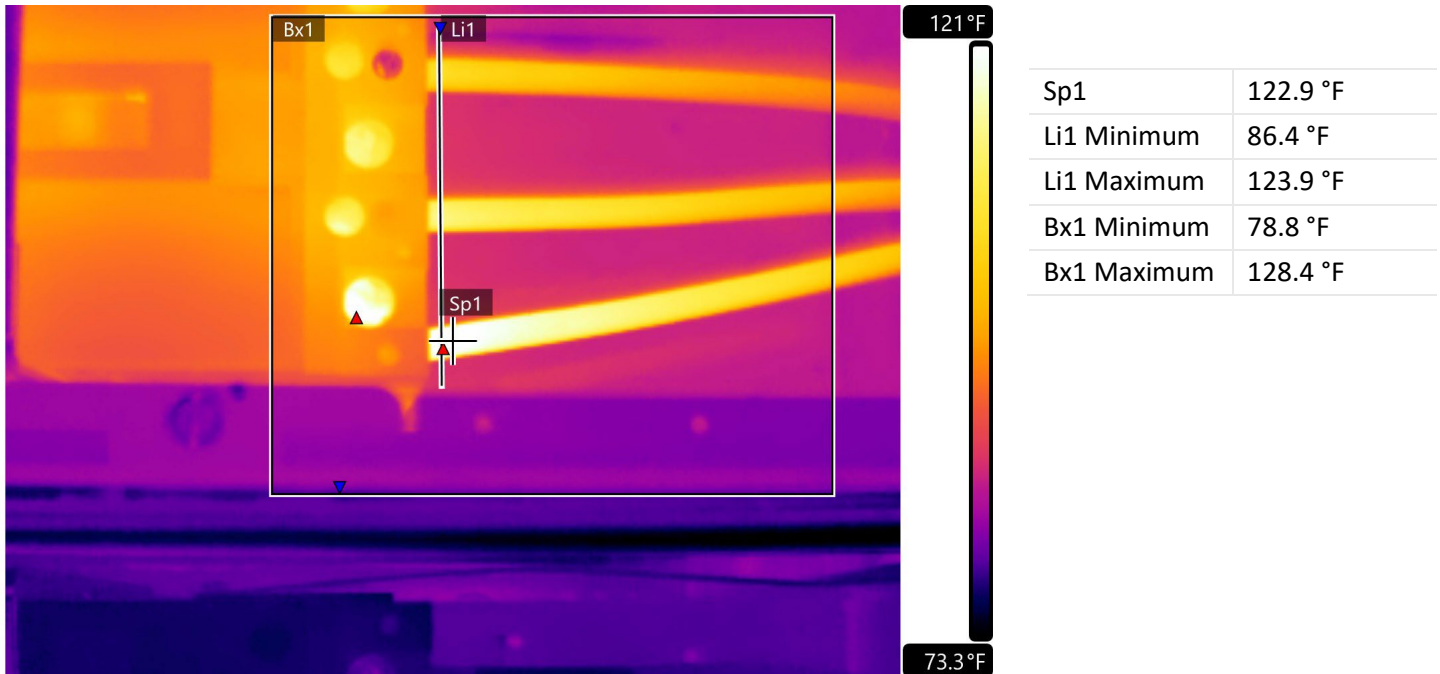
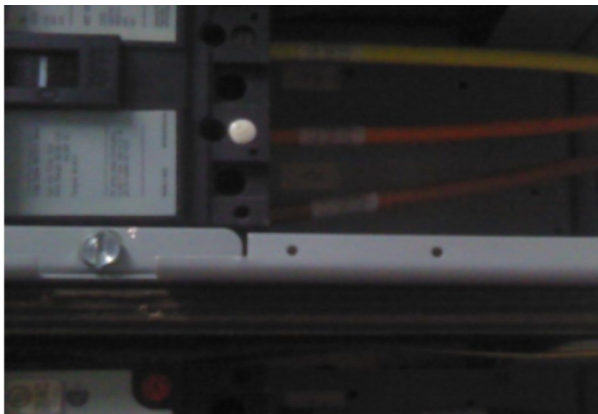
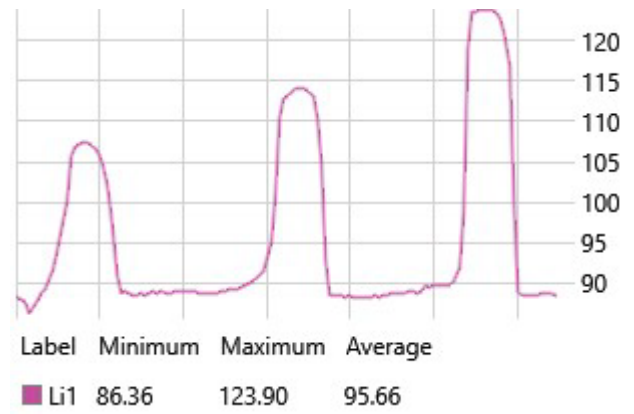
Component	Connection
Equipment/Bucket ID	MCC 300 AHU 351 F(E)

Fault	Connection issue
Defect Rating	CLASS I

Recommendations
Likely a loose or faulty connection. Ensure a tight and clean connection.

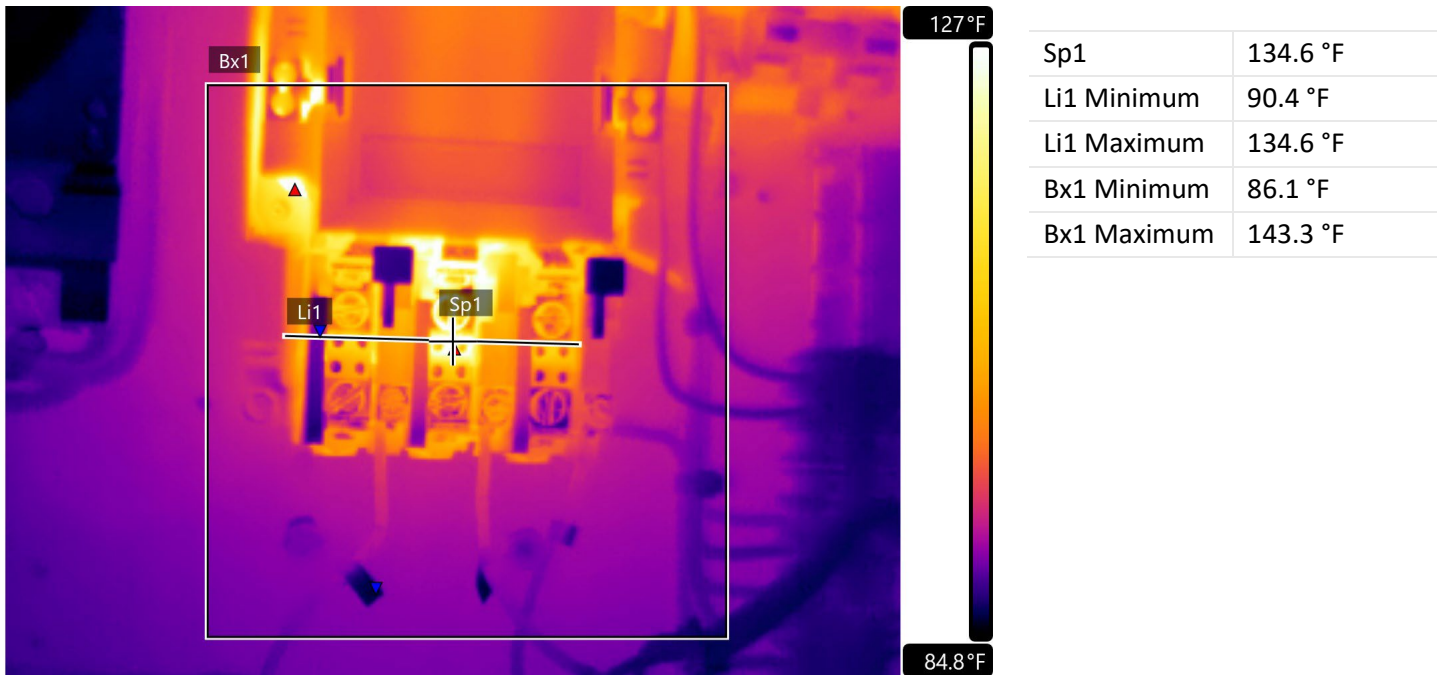
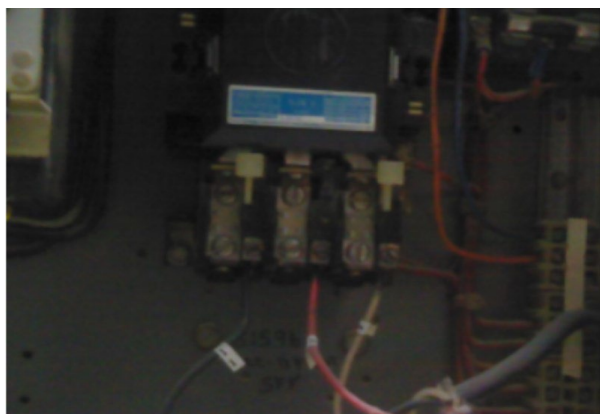
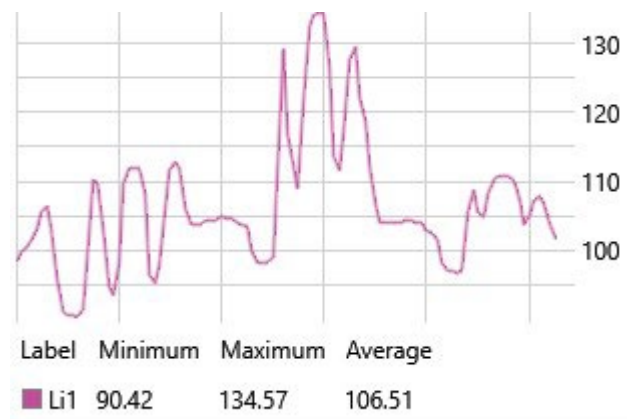
Component	Thermal Heater
Equipment/Bucket ID	P3 Spray Dryer 55 Bogey Condensate Pump

Fault	Thermal Heater Issue
Defect Rating	CLASS I

Recommendations
Thermal heater has possible issue. Replace as needed.

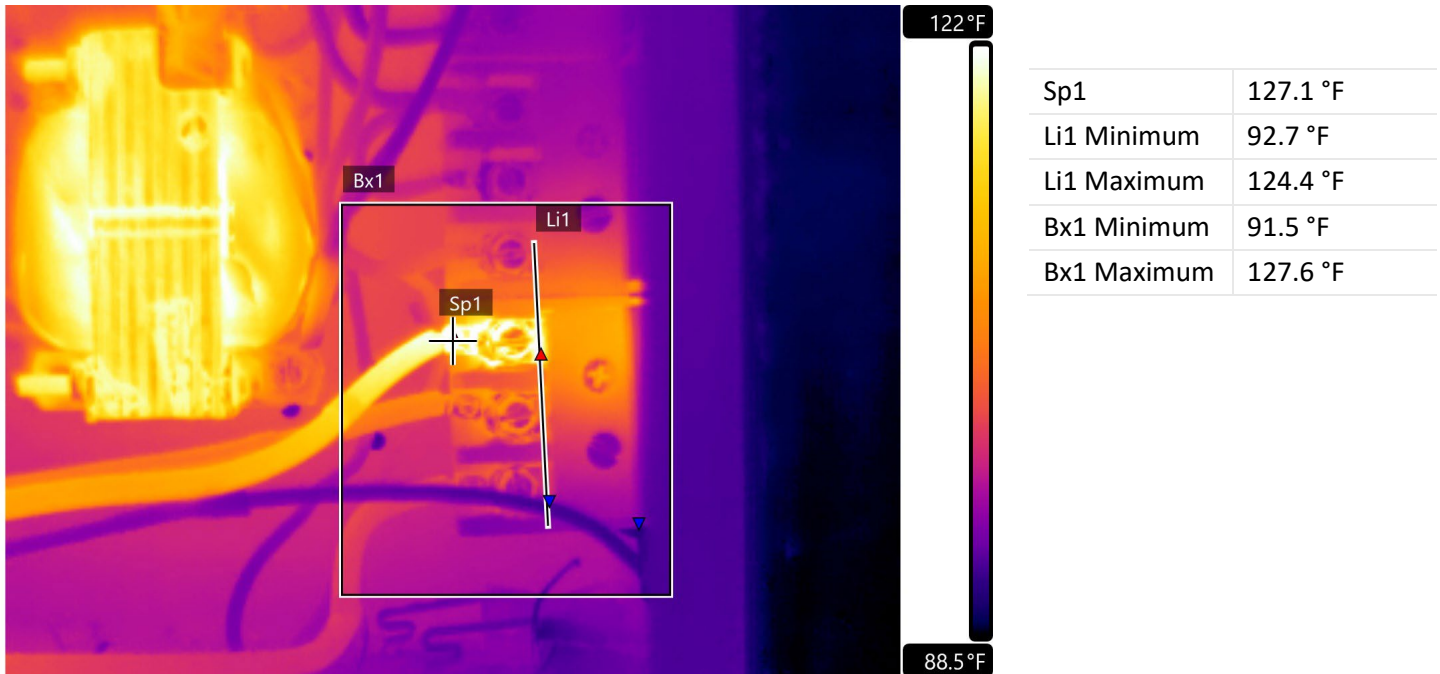
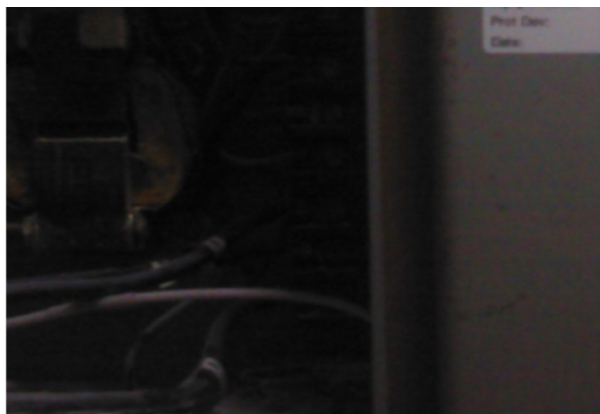
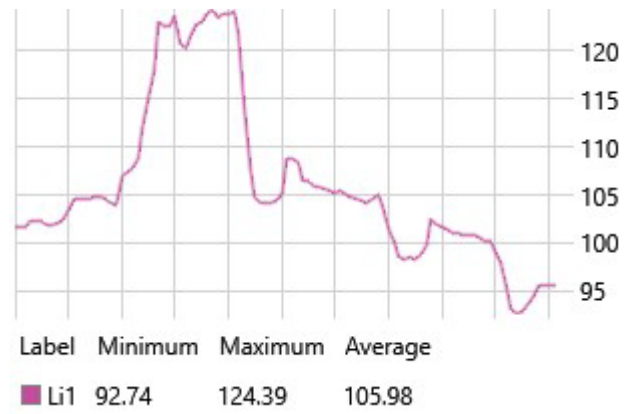
Component	Connection
Equipment/Bucket ID	286 HYD. Agitator #2

Fault	Connection issue
Defect Rating	CLASS I

Recommendations
Likely a loose or faulty connection. Ensure a tight and clean connection.

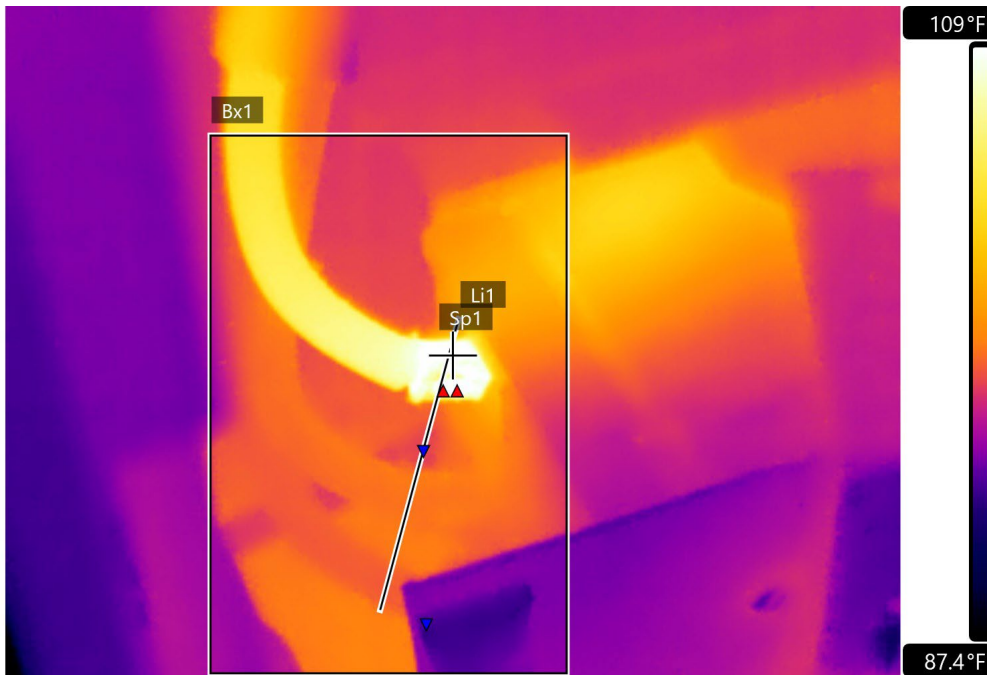
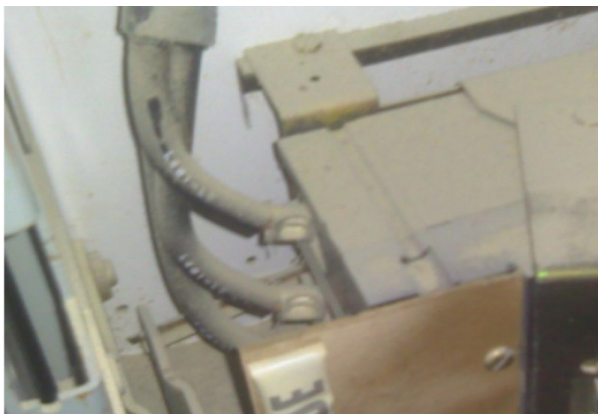
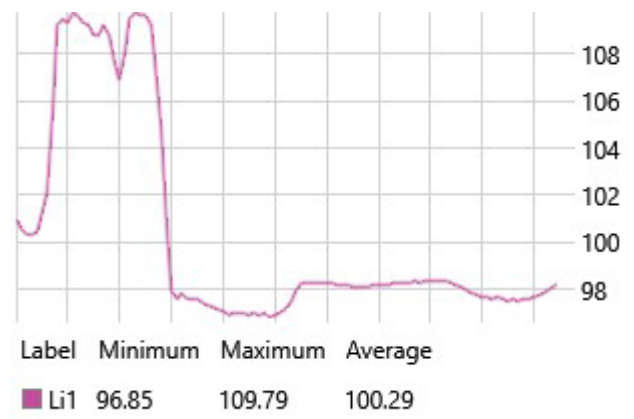
Component	Connection
Equipment/Bucket ID	21

Sp1	108.9 °F
Li1 Minimum	96.9 °F
Li1 Maximum	109.8 °F
Bx1 Minimum	92.6 °F
Bx1 Maximum	110.1 °F

Fault	Connection issue
Defect Rating	CLASS I

Recommendations
Likely a loose or faulty connection. Ensure a tight and clean connection.

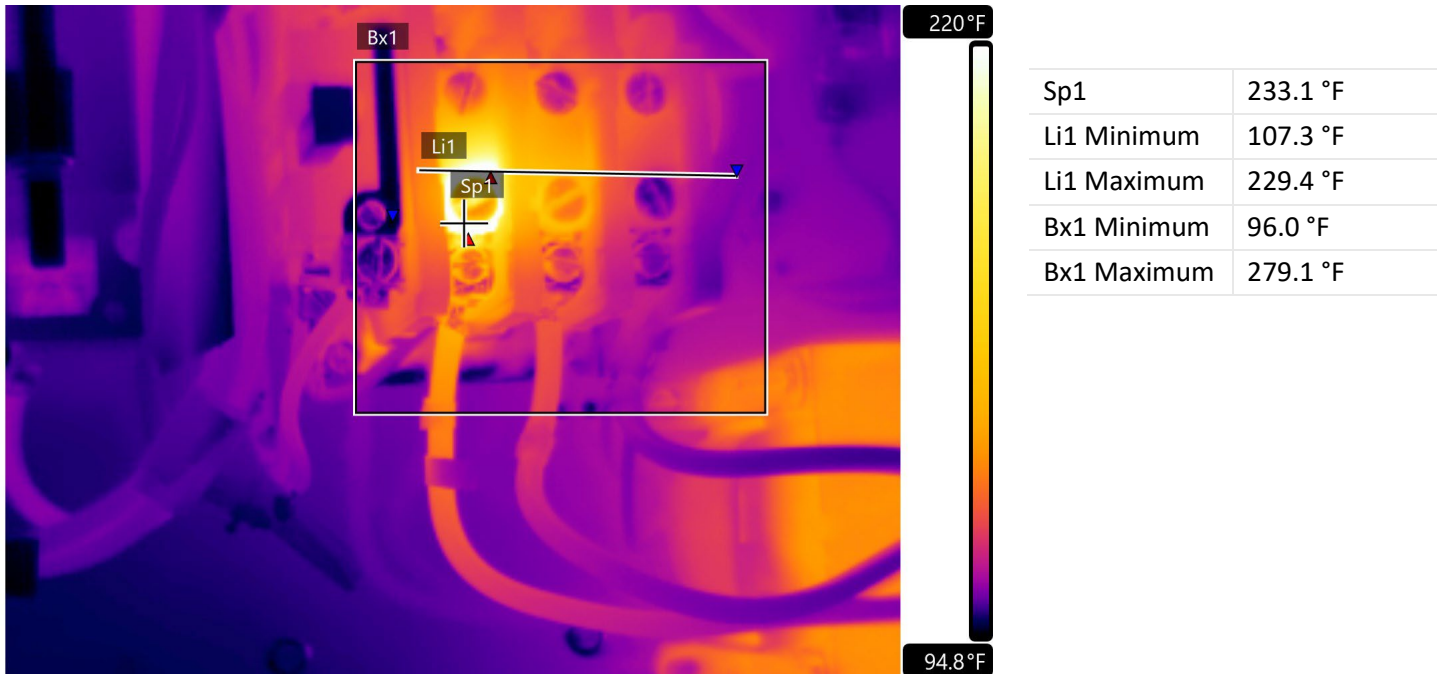
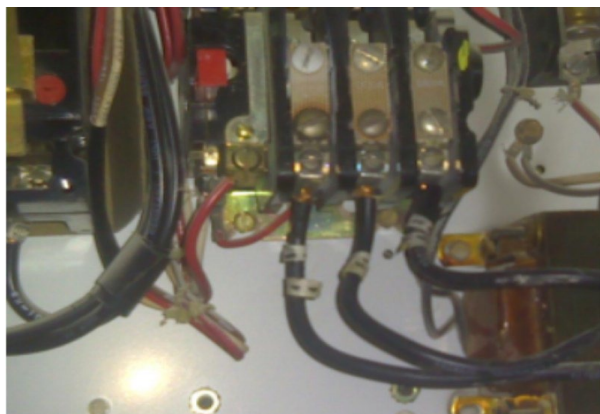
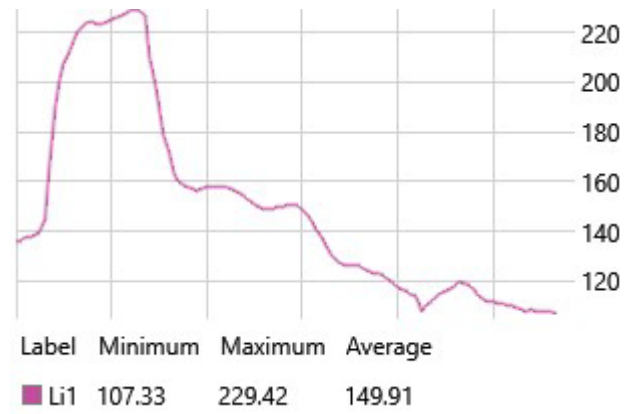
Component	Thermal heater connection
Equipment/Bucket ID	22 6119

Fault	Loose/faulty thermal heater
Defect Rating	CLASS I

Recommendations	Thermal heater has possible issue. Replace as needed.
-----------------	---
