The following is a summary of findings from the vibration analysis on the Dust Collector blower that was performed on 2/2/21. Please let us know if there are any questions or comments.

cotton oil.rbm / SCTN / SPARE

DUST COLLECTOR BLOWER

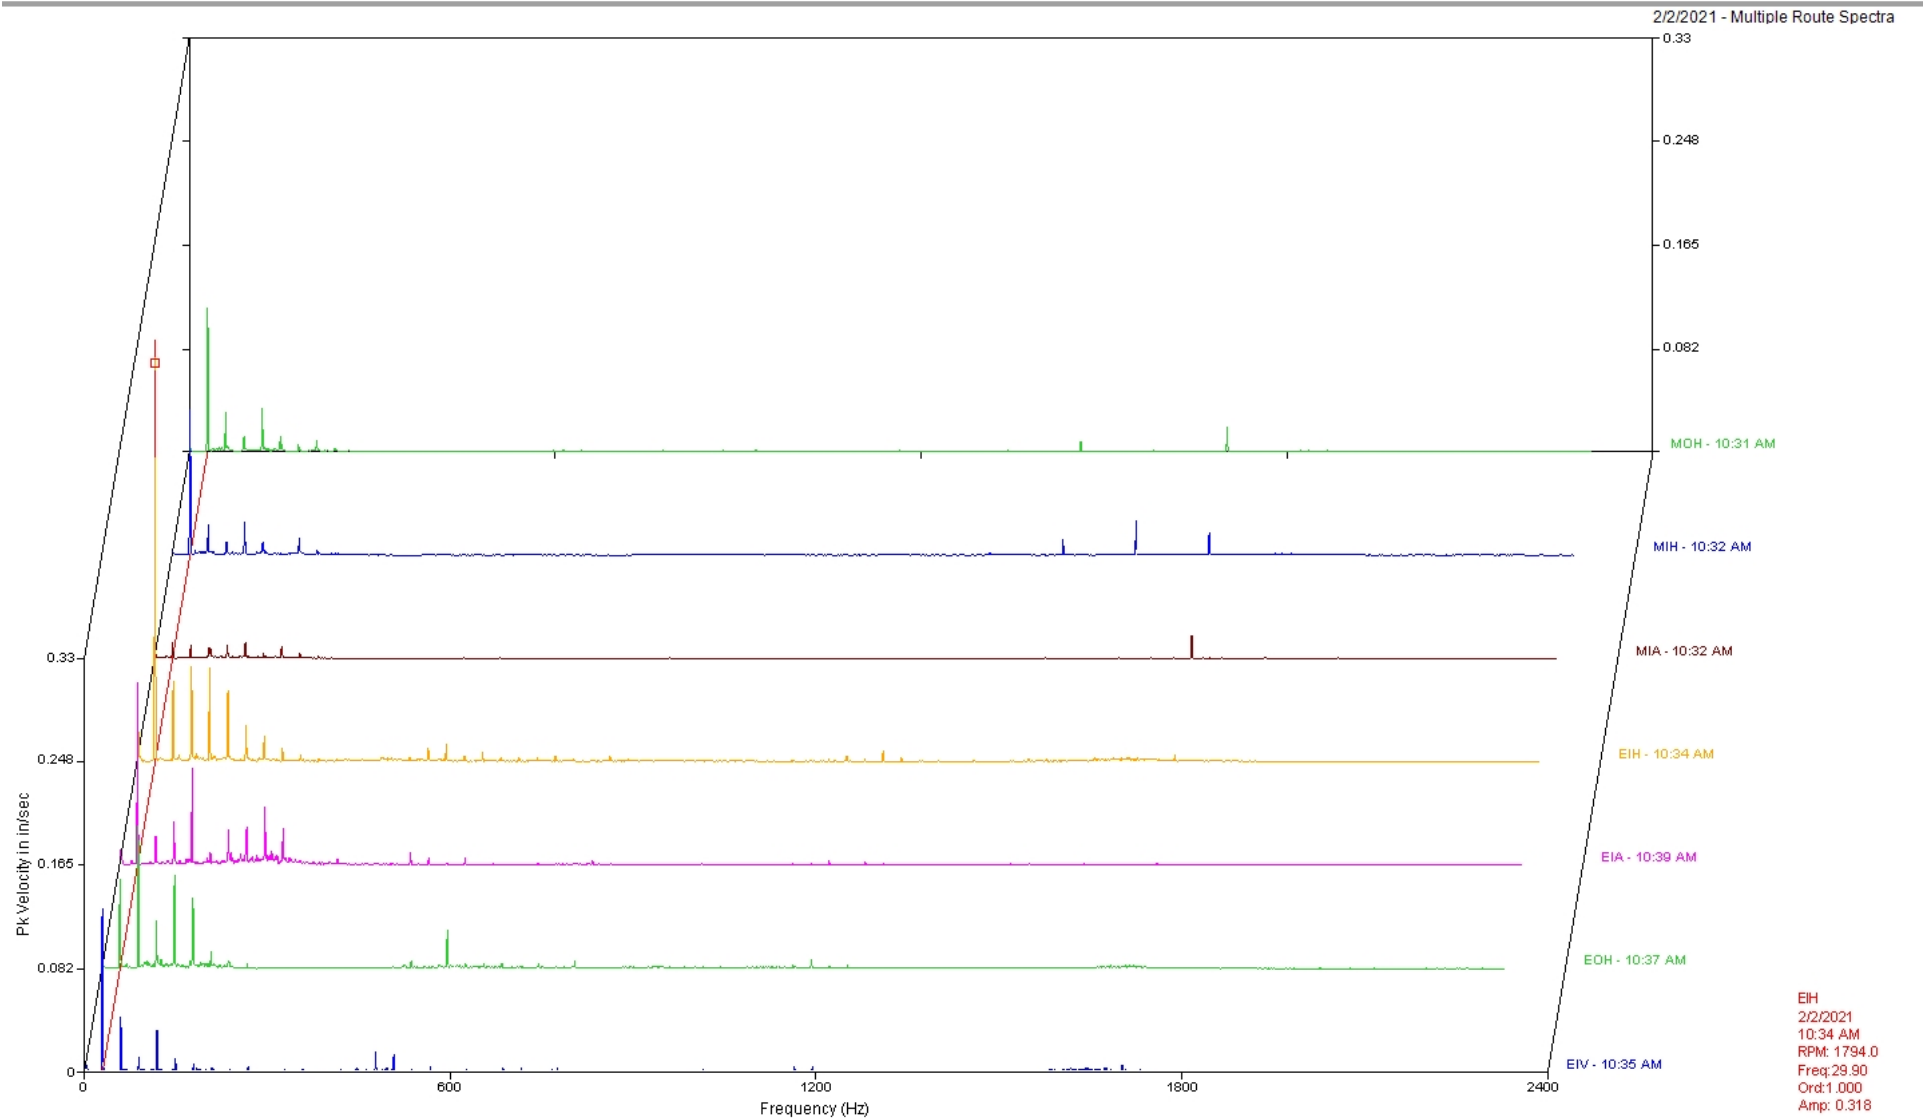
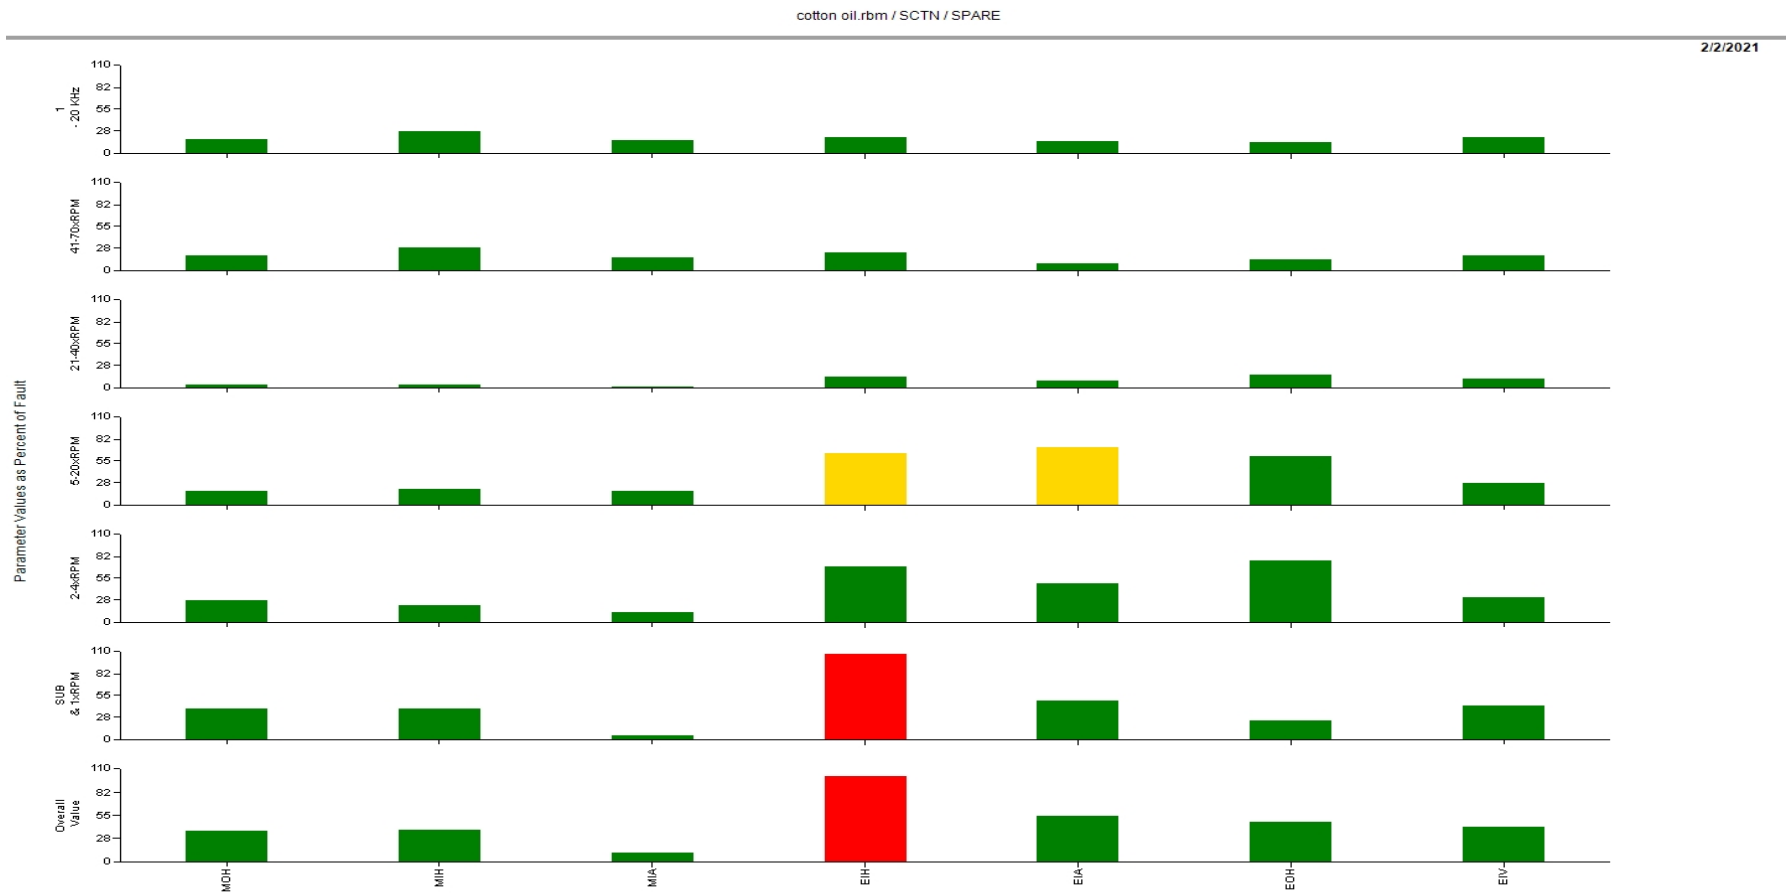
Vibration data of the blower indicates some imbalance with a high 1 x rpm vibration being present especially at the drive end of the blower. Highest amplitude is at the blower inboard horizontal. There are also several harmonics of rpm in this spectral data which indicates some mechanical looseness. Both bearings are showing signs of looseness with the DE bearing having the higher amplitude harmonics. Our recommendation is to clean the area around the bearings, remove the top half of the bearing housings (one at a time), and check bearing clearances. Refer to manufacturer's specification for the recommended clearances. If looseness harmonics are still present in the data after adjusting internal bearing clearances, then it may be the fact that the looseness is in the bearing housing fit. A lift check of the blower shaft will be needed to determine if fit looseness is present. It is also recommended to inspect the coupling for excessive wear and inspect/clean the fan wheel. If high 1 x rpm vibration persists after cleaning the wheel, then a field balance is recommended. In order to achieve a good balance of the unit, the bearing clearances will have to be within tolerance. This issue is rated as a **CLASS II** defect
