# QualiTest IR Radiometric Survey Report

Chemours  
HCN

| Job Number | 141407 |
| Survey Date | 12/17-18/19 |

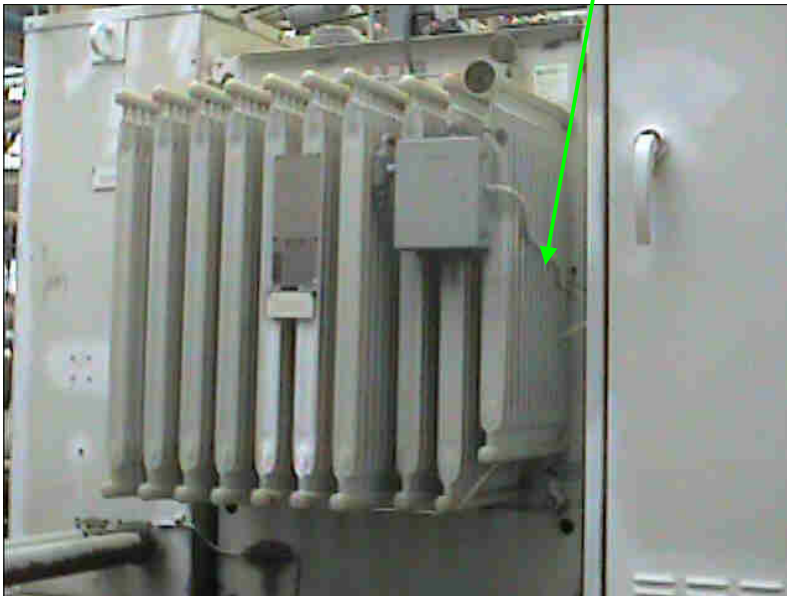
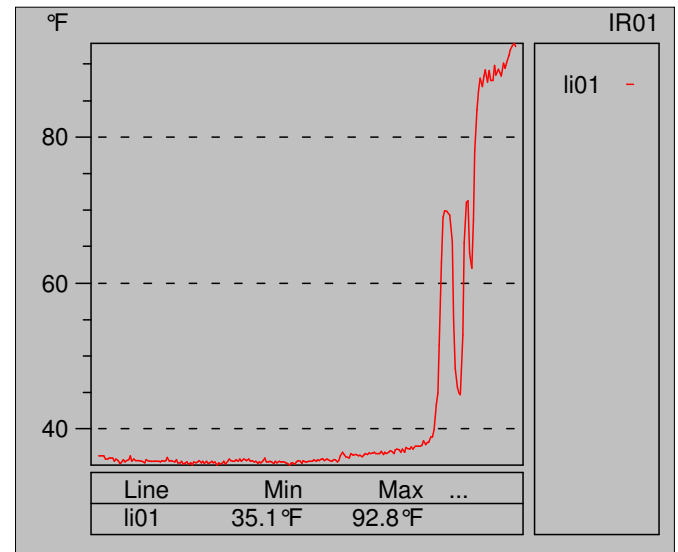
| Component | Equipment/Bucket ID | Plant/Area | Date |
|---|---|---|---|
| North Radiator | SUB 260 | HCN | 12-26-19 |

| <b>Fault</b> | Cooling Fault |
| <b>Defect Rating</b> | Class 2 |

Suspect low fluid level. Check coolant; add or replace as necessary. Possible blockage in cooling fins.

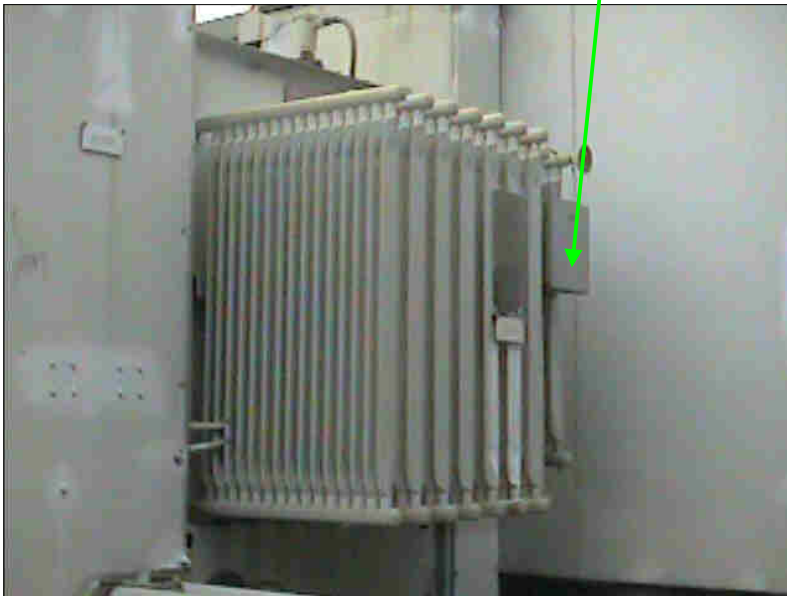
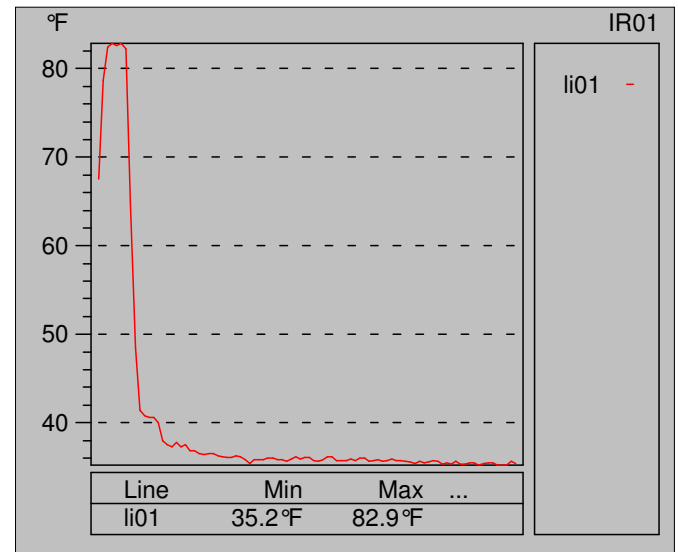
| Component | Equipment/Bucket ID | Plant/Area | Date |
|---|---|---|---|
| North Radiator (E view) | SUB 260 | HCN | 12-26-19 |

| <b>Fault</b> | Cooling Fault |
| <b>Defect Rating</b> | Class 2 |

Suspect low coolant level. Check coolant; add or replace as necessary. Possible blockage in coolant fins.

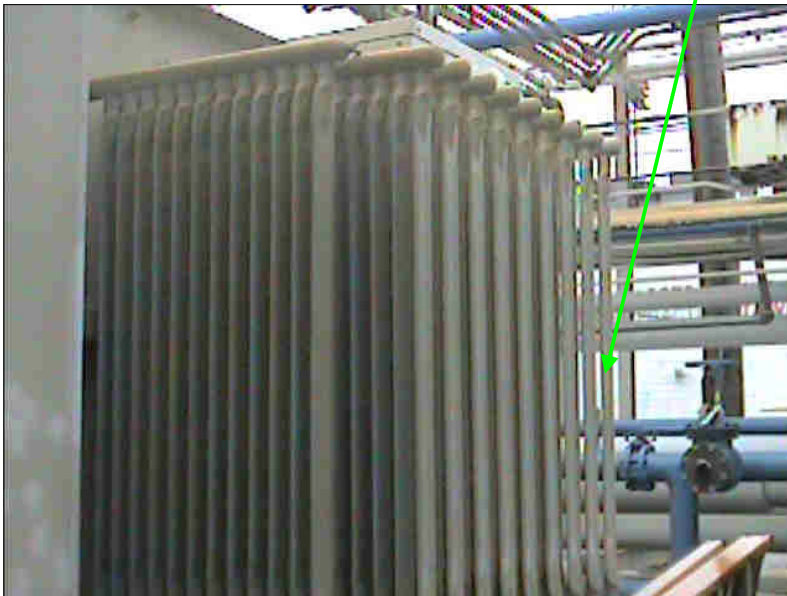
| Component | Equipment/Bucket ID | Plant/Area | Date |
|---|---|---|---|
| South Radaitor (West) | SUB 260 | HCN | 12-26-19 |

| <b>Fault</b> | Cooling Issue |
| <b>Defect Rating</b> | Class 2 |

Possible blocked fins and low coolant. At the next opportunity check coolant level and inspect fins for defects. This West view shows more operating fins than the East view.

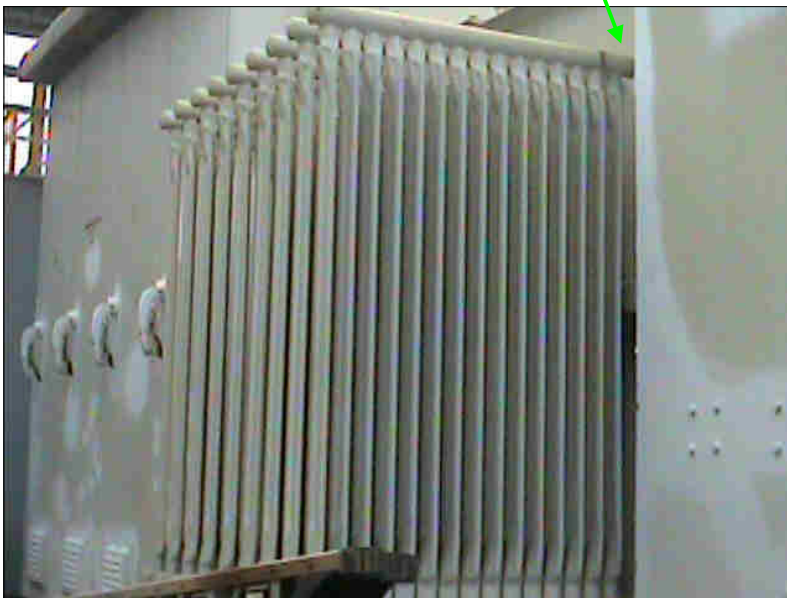
| Component | Equipment/Bucket ID | Plant/Area | Date |
|---|---|---|---|
| South Radiator (East) | Sub 260 | HCN | 12-26-19 |

| <b>Fault</b> | Cooling Issue |
| <b>Defect Rating</b> | Class 2 |

Possible blocked fins and low coolant level. At the next opportunity check coolant level and inspect fins for defects. This East view show less properly functioning fins than the West view.

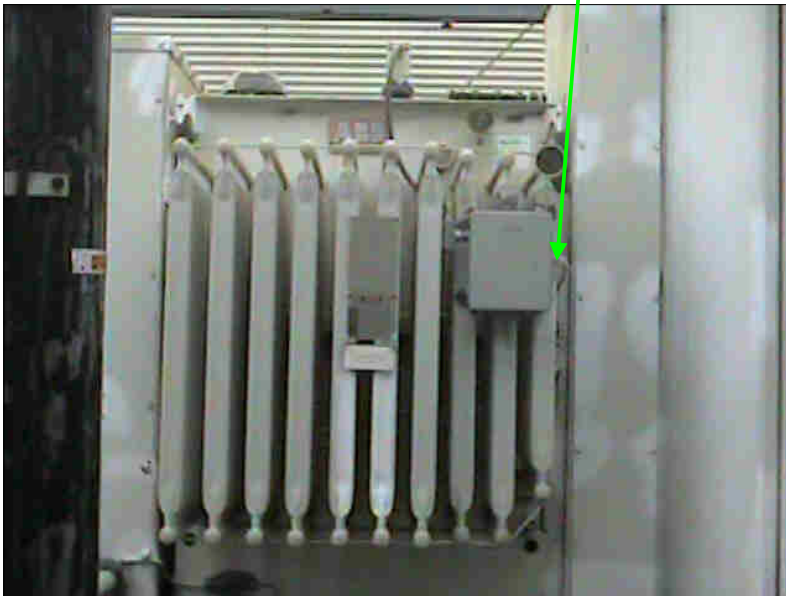
| Component | Equipment/Bucket ID | Plant/Area | Date |
|---|---|---|---|
| South Radiator NBody | SUB 260 | HCN | 12-26-19 |

| <b>Fault</b> | Cooling Issue |
| <b>Defect Rating</b> | Class 2 |

Possible blocked fins and low coolant levels. At the next opportunity check coolant level and inspect fins for possible defects. This North body view shows the possibility of low levels.

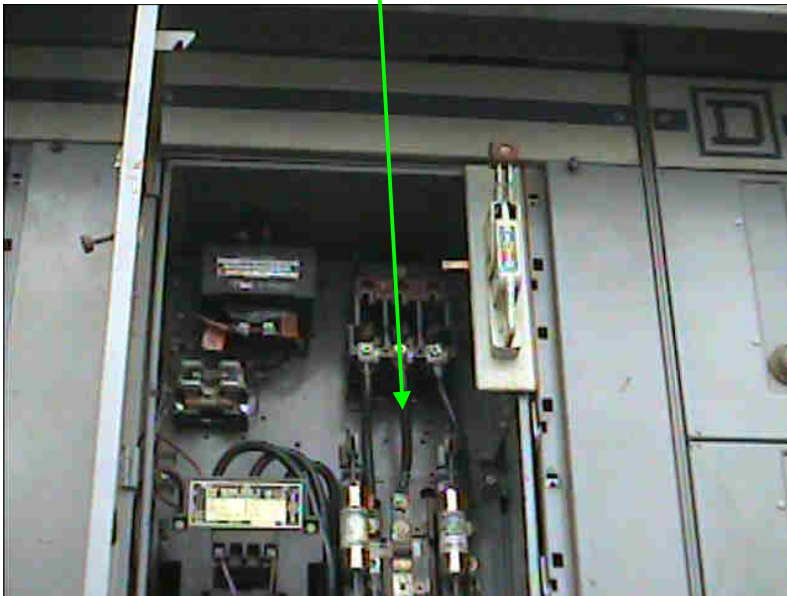
| Component | Equipment/Bucket ID | Plant/Area | Date |
|---|---|---|---|
| Comb. Air Blower | MCC 10 | HCN | 12-26-19 |

| <b>Fault</b> | Poor Contact at Switch |
| <b>Defect Rating</b> | Class 2 |

C phase shows what appears to be poor contact at the switch. Recommend inspection, repair and replace at the next opportunity.

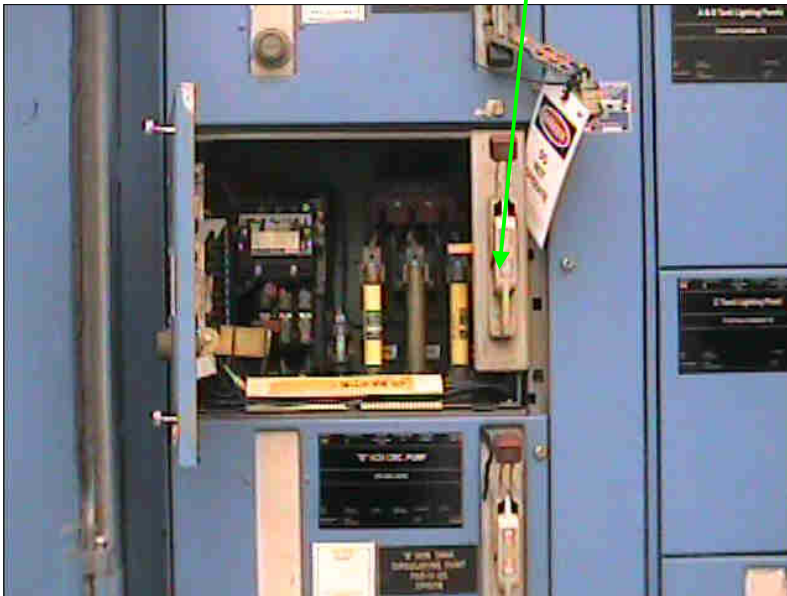
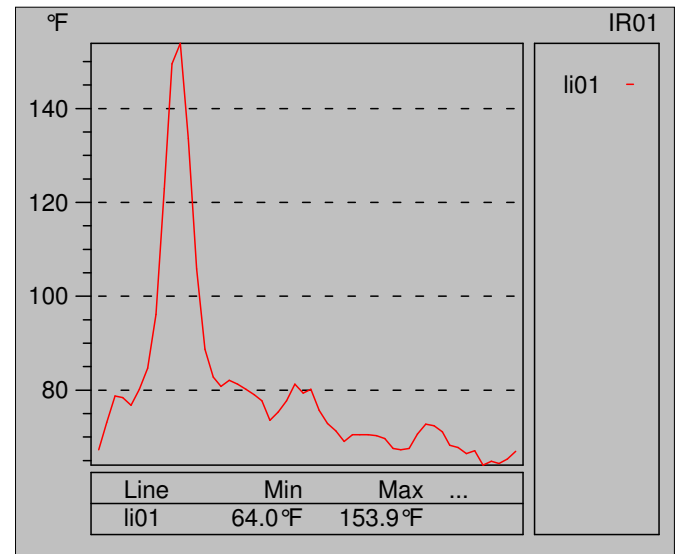
| Component | Equipment/Bucket ID | Plant/Area | Date |
|---|---|---|---|
| Methanol Pump | MCC B | HCN STO, TK. | 12-26-19 |

| <b>Fault</b> | Switch Contact |
| <b>Defect Rating</b> | Class 2 |

A phase appears to have poor contact at the switch. Recommend inspecting and repair/replace at the next opportunity.

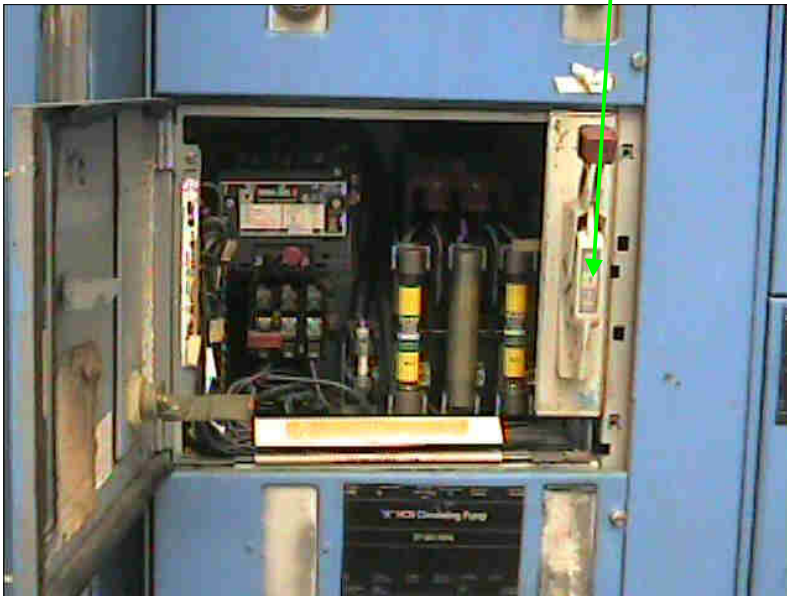
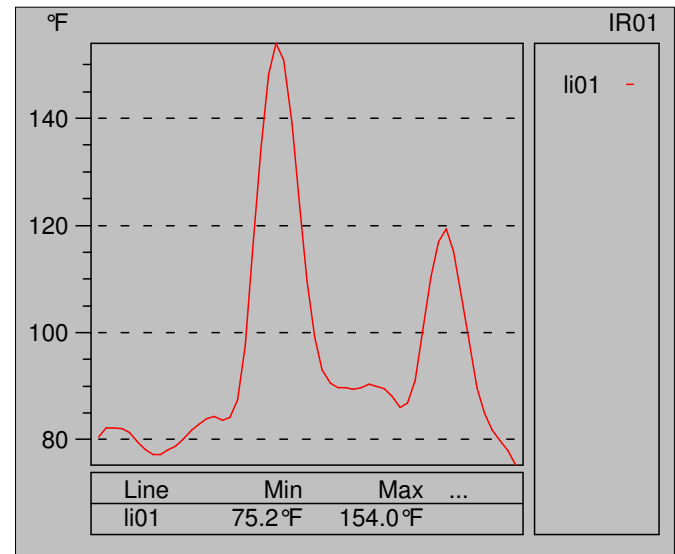
| Component | Equipment/Bucket ID | Plant/Area | Date |
|---|---|---|---|
| TK TRANS. PUMP | MCC B | HCN STO. TK. | 12-26-19 |

| <b>Fault</b> | Switch Contact Area |
| <b>Defect Rating</b> | Class 2 |

Phase B is showing poor contact at the top of the switch. Recommend repairing/replacing at the next opportunity.

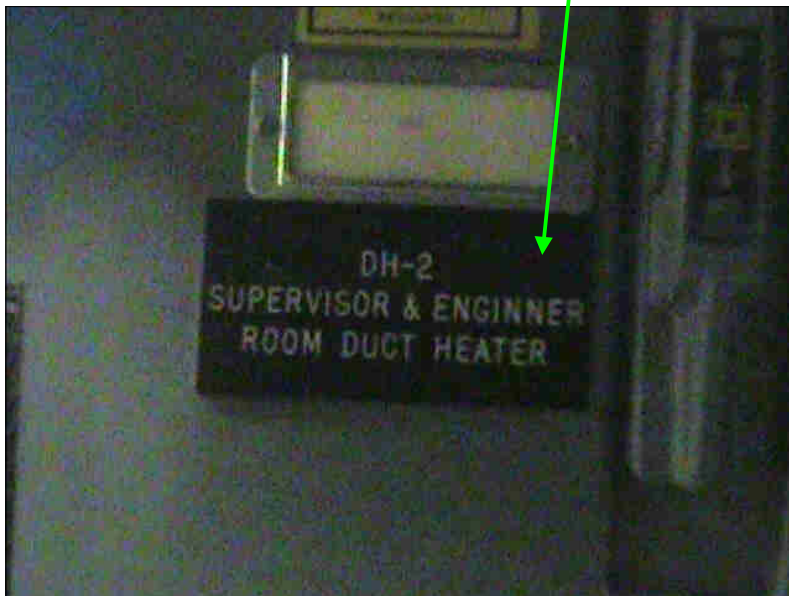
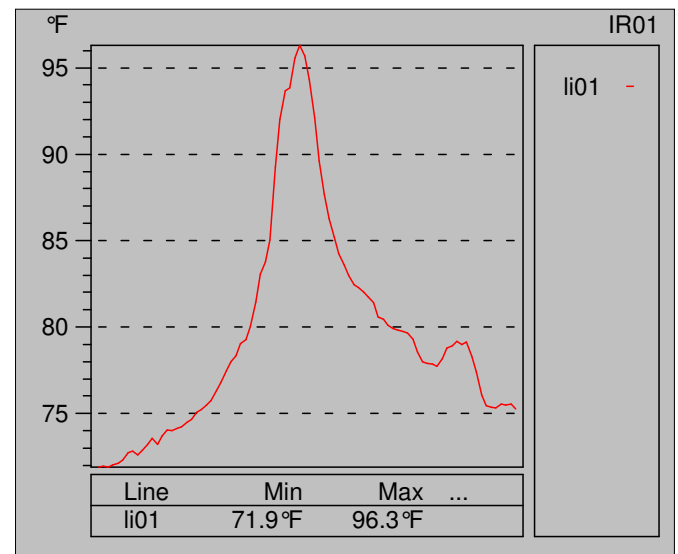
| Component | Equipment/Bucket ID | Plant/Area | Date |
|---|---|---|---|
| Switch | DH-2 | HCN BLD. 800 | 12-26-19 |

| <b>Fault</b> | Poor Conection |
| <b>Defect Rating</b> | Class 1 |

B phase is showing a possible poor connection causing increased tempature. Recommend inspecting and repairing in the near future.

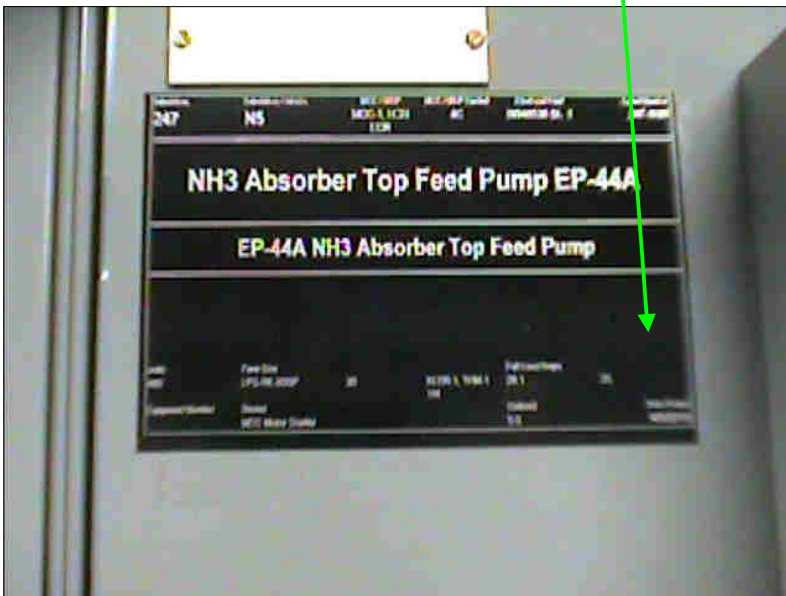
| Component | Equipment/Bucket ID | Plant/Area | Date |
|---|---|---|---|
| Top Feed Pmp.EP44A | MCC1 NH3 | HCN ECR | 12-26-19 |

| <b>Fault</b> | Poor connection at fuse clips |
| <b>Defect Rating</b> | Class 1 |

Showing an increased temperature at top of both fuse clips. Recommend inspection. Clean, repair and replace at the next opportunity.

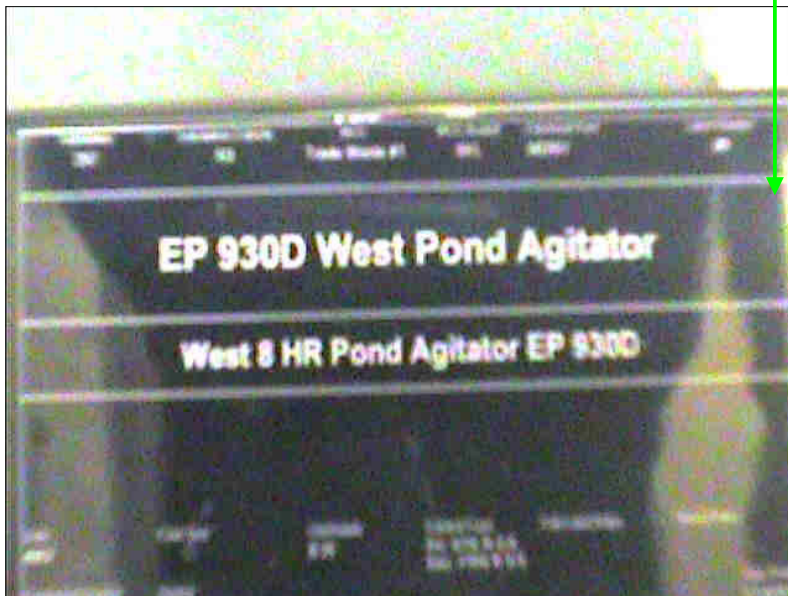
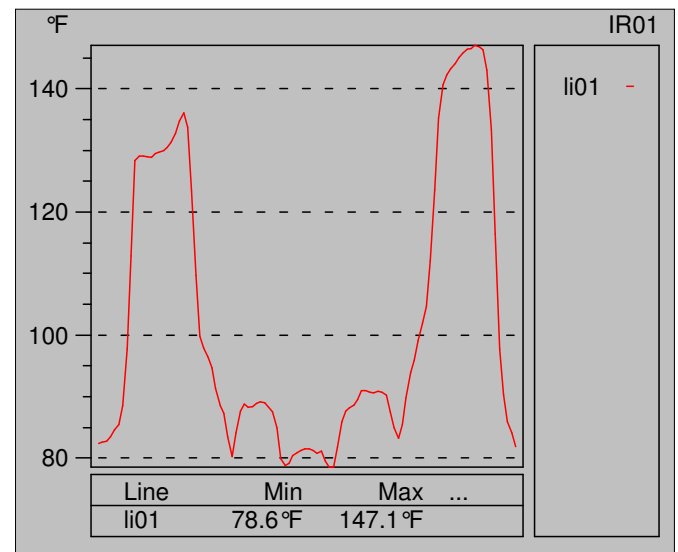
| Component | Equipment/Bucket ID | Plant/Area | Date |
|---|---|---|---|
| EP 930D | MCC 1 | HCN Trade Waste | 12-26-19 |

| <b>Fault</b> | Poor connection at fuse clips |
| <b>Defect Rating</b> | Class 1 |

Possible poor connection at fuse clips. Recommend inspection, cleaning, and possibly replacing in the near future.

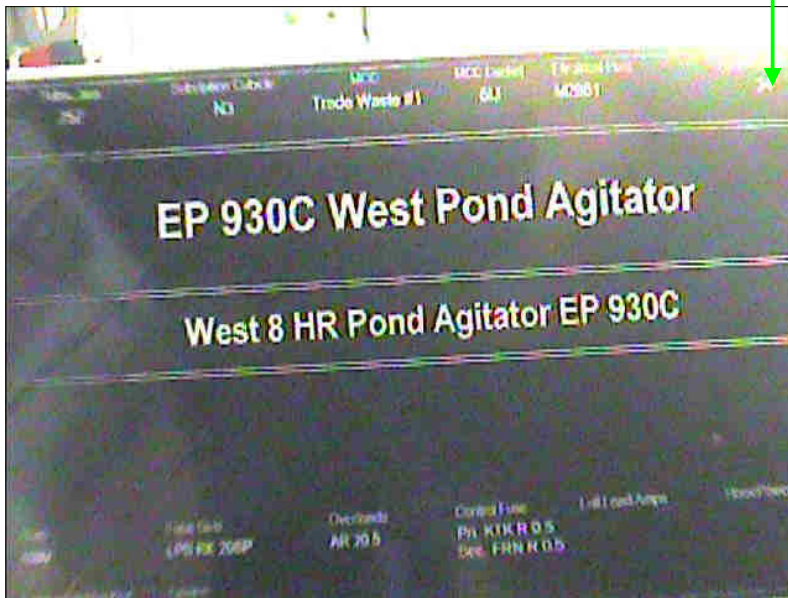
| Component | Equipment/Bucket ID | Plant/Area | Date |
|---|---|---|---|
| EP 930C | MCC1 | HCN Trade Waste | 12-26-19 |

| <b>Fault</b> | Connection at fuse clips |
| <b>Defect Rating</b> | Class 2 |

Possible poor connection at fuse clips. Recommend inspection. Clean, repair and replace at the next opportunity.

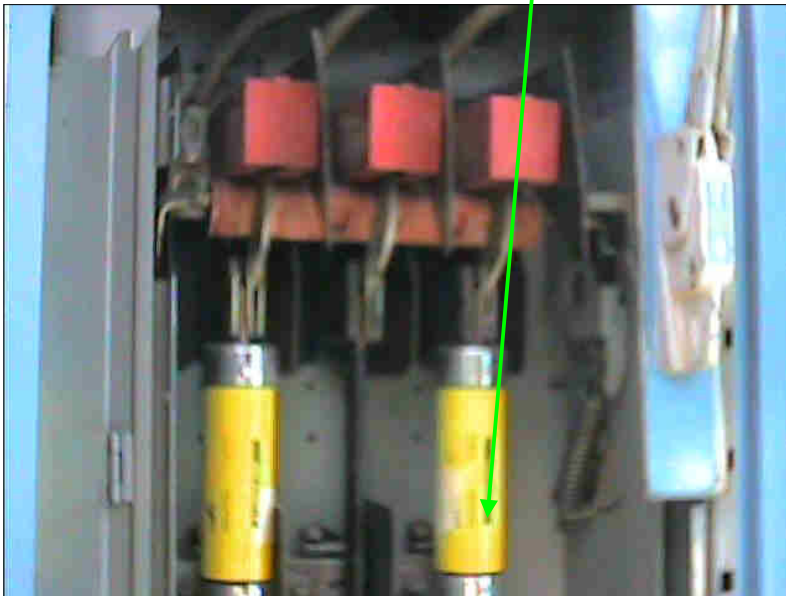
| Component | Equipment/Bucket ID | Plant/Area | Date |
|---|---|---|---|
| #1 Lift pump | MCC1 ECF | HCN | 12-26-19 |

| <b>Fault</b> | Bad Connection |
| <b>Defect Rating</b> | Class 2 |

Poor contact at switch in B phase. Recommend cleaning and inspecting. Repairing/replacing at the next opportunity. Make sure all connections are tight after maintenance.

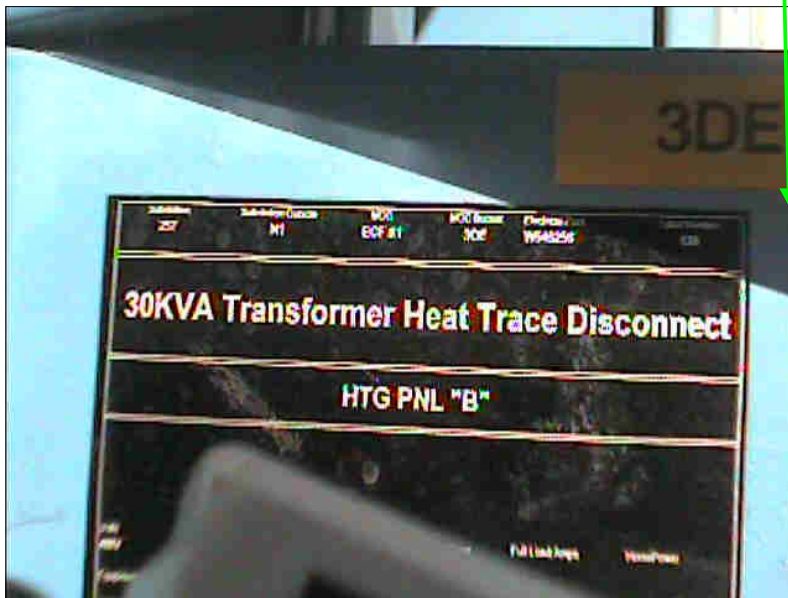
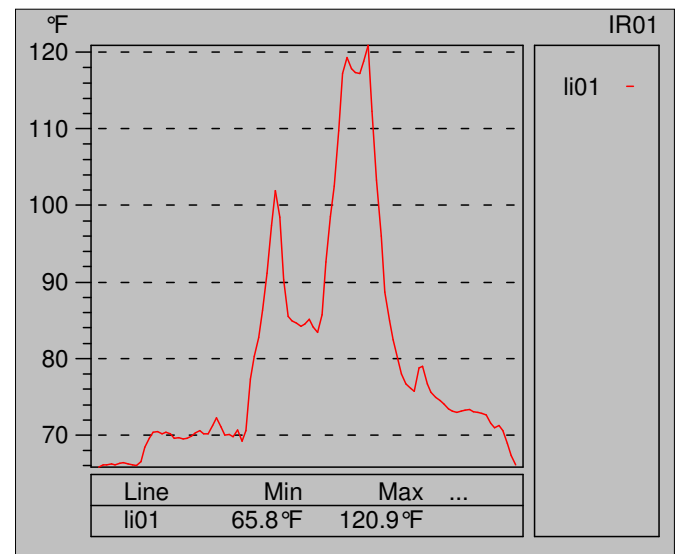
| Component | Equipment/Bucket ID | Plant/Area | Date |
|---|---|---|---|
| Heat Trace Disc. | MCC 1 ECF | HCN | 12-26-19 |

| <b>Fault</b> | Bad Connection |
| <b>Defect Rating</b> | Class 1 |

Poor contact at switch in B phase. Recommend inspecting and cleaning, repairing/replacing in the near future.

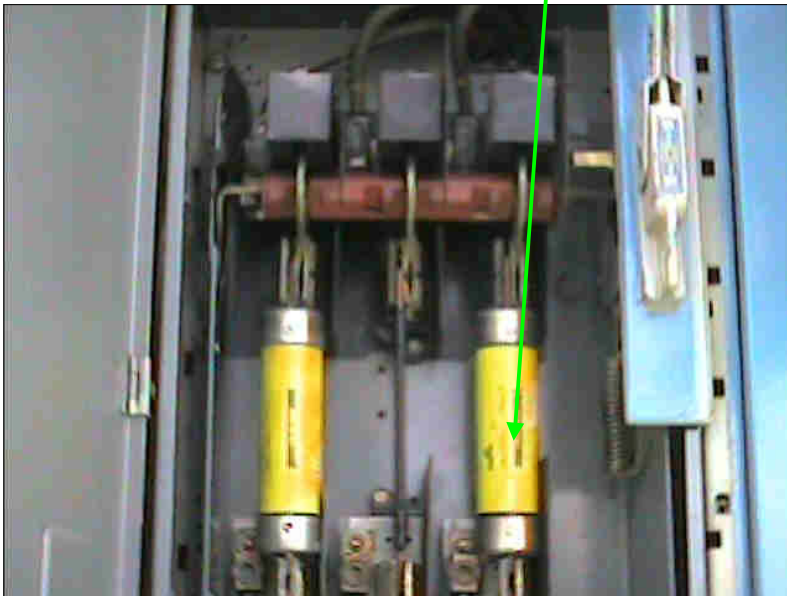
| Component | Equipment/Bucket ID | Plant/Area | Date |
|---|---|---|---|
| 2nd Neut. TK Agi. | MCC 1 ECF | HCN | 12-26-19 |

| <b>Fault</b> | Bad Switch Connection |
| <b>Defect Rating</b> | Class 3 |

Bad connection at the switch in A phase. Excessive heat. Recomend cleaning, inspecting, and repairing/replacing ASAP.

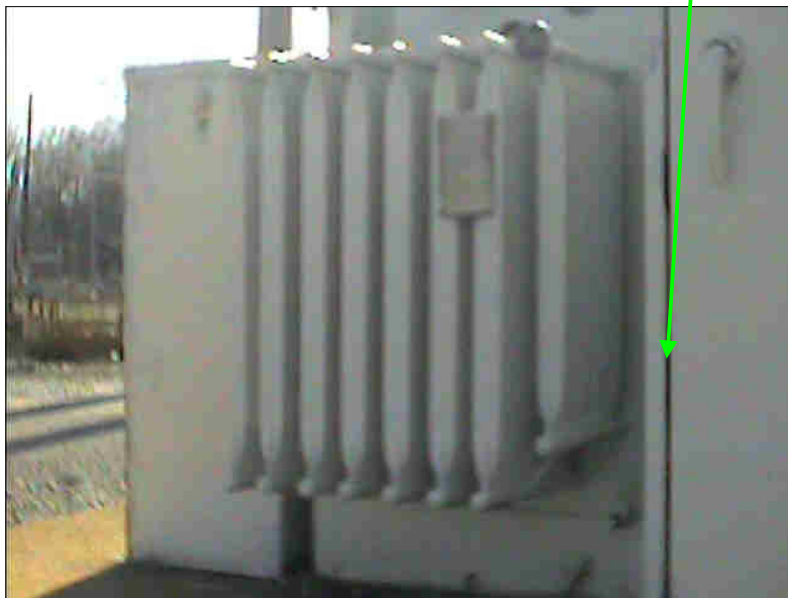
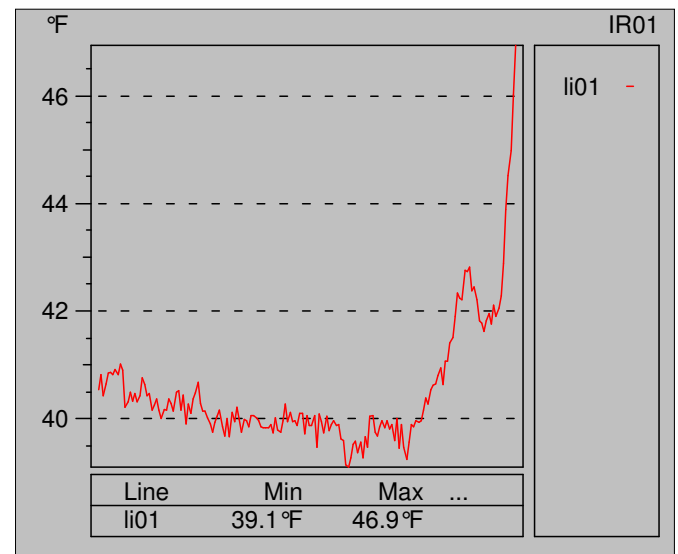
| Component | Equipment/Bucket ID | Plant/Area | Date |
|---|---|---|---|
| North Radiator | SUB 257 | HCN | 12-26-19 |

| <b>Fault</b> | Cooling Issue |
| <b>Defect Rating</b> | Class 2 |

Level appears to be below top tubes of radiator. Recommend checking coolant level.

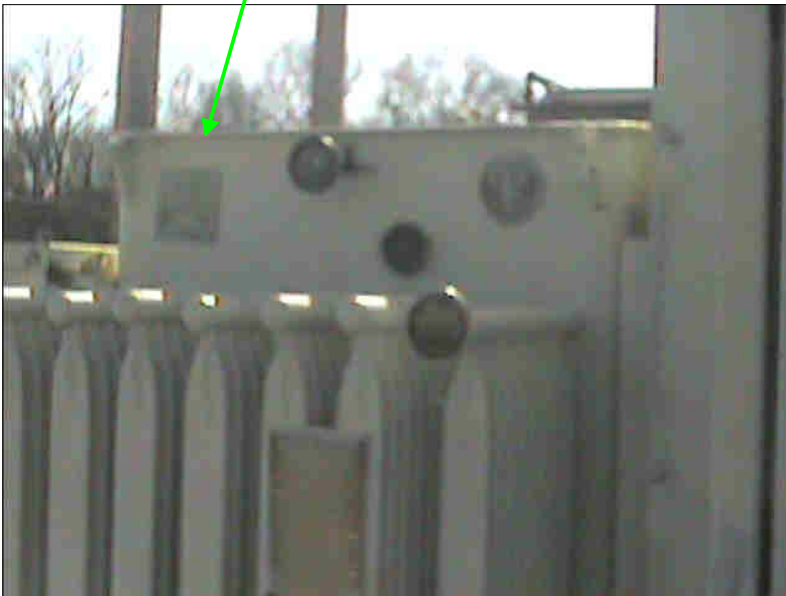
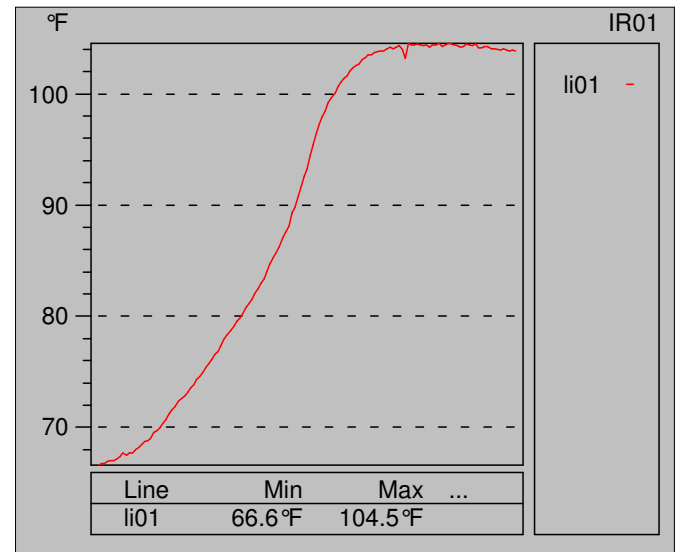
| Component | Equipment/Bucket ID | Plant/Area | Date |
|---|---|---|---|
| North Trans Body | SUB 257 | HCN | 12-26-19 |

| <b>Fault</b> | Coolant issue |
| <b>Defect Rating</b> | Class 2 |

Level appears to be slightly low at bottom of top tubes. Recommend checking coolant level.

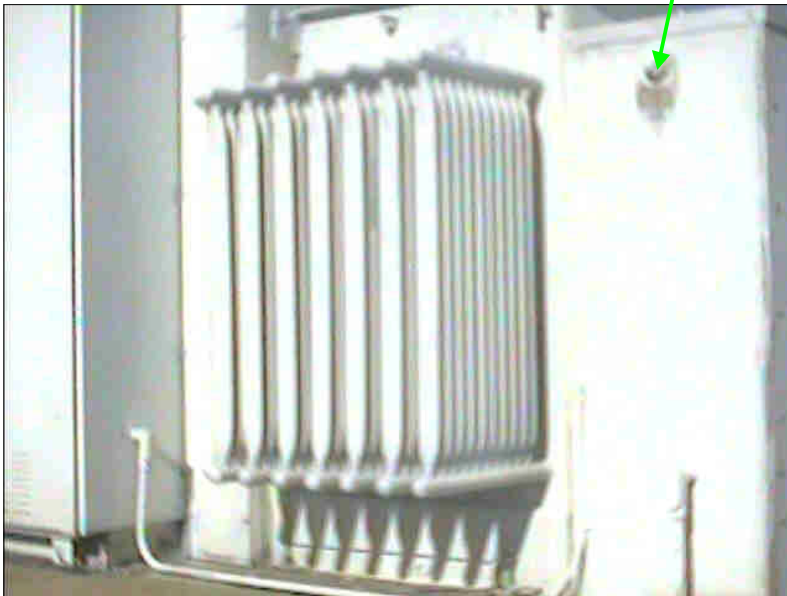
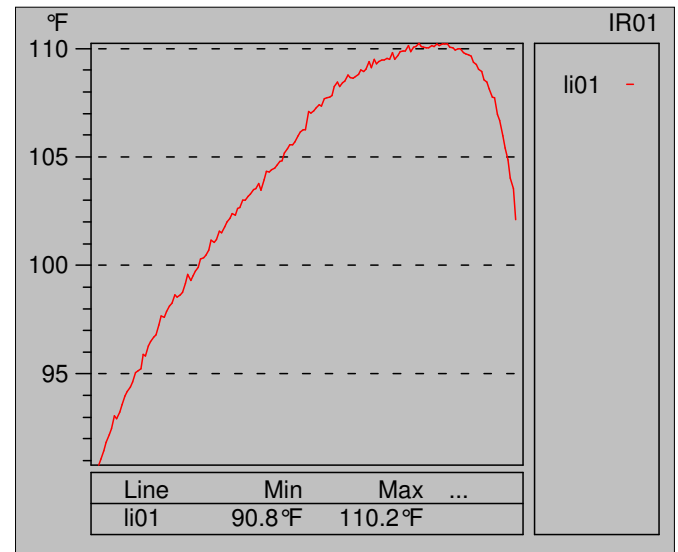
| Component | Equipment/Bucket ID | Plant/Area | Date |
|---|---|---|---|
| South Radiator | SUB 257 | HCN | 12-26-19 |

| <b>Fault</b> | Coolant issue |
| <b>Defect Rating</b> | Class 3 |

Coolant level appears to be low. Recommend checking coolant level ASAP.

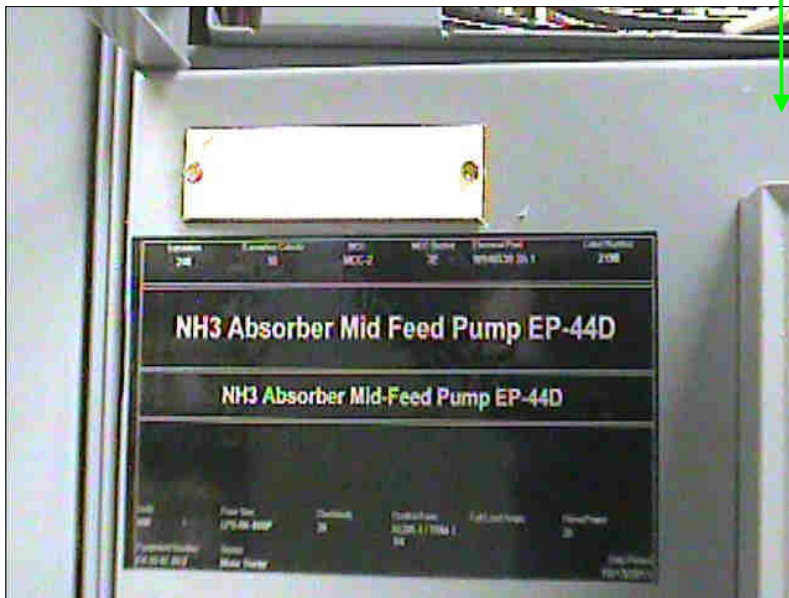
| Component | Equipment/Bucket ID | Plant/Area | Date |
|---|---|---|---|
| Abs. Mid Feed Pmp. | EP-44D | HCN | 12-26-19 |

| <b>Fault</b> | Bad Fuse Connection |
| <b>Defect Rating</b> | Class 2 |

Connection at A phase lower fuse clip appears to be bad. Recommend inspecting, cleaning, and repairing/replacing at the next opportunity.

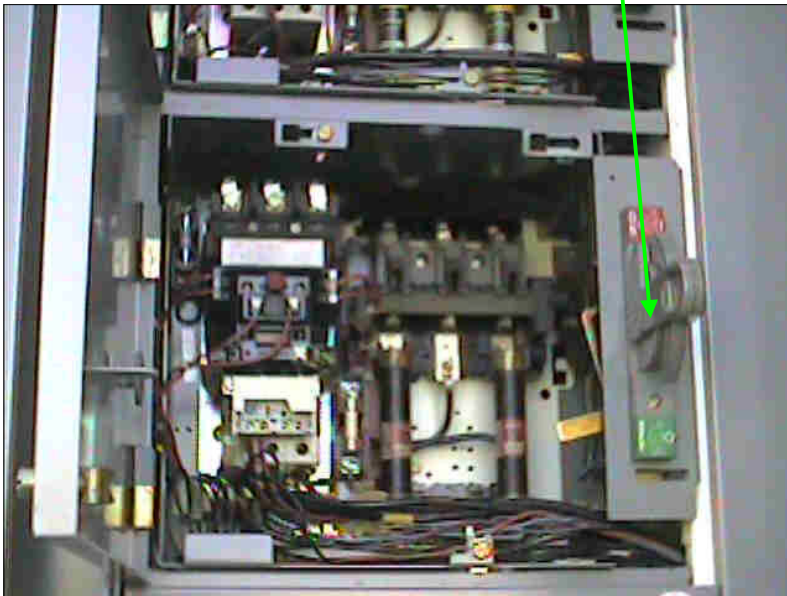
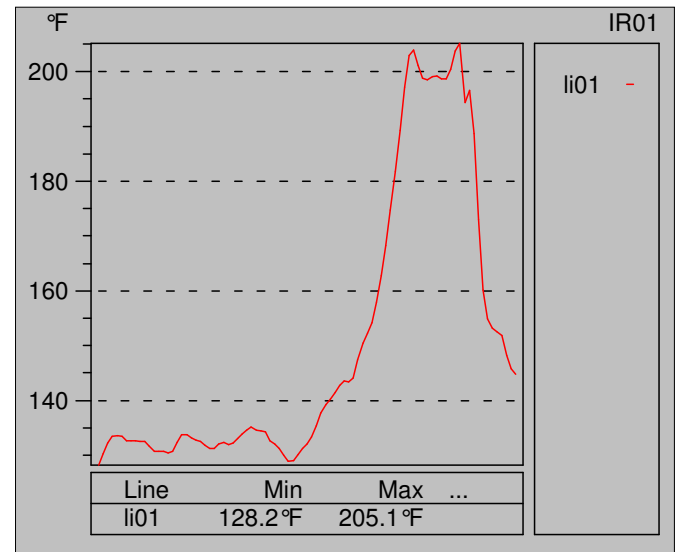
| Component | Equipment/Bucket ID | Plant/Area | Date |
|---|---|---|---|
| E HCN Circ. Pump | MCC E | HCN Tank Farm | 12-26-19 |

| <b>Fault</b> | Bad Switch Connection |
| <b>Defect Rating</b> | Class 3 |

Excessive heat in C phase switch. Recommend inspecting, cleaning, repairing/replacing ASAP

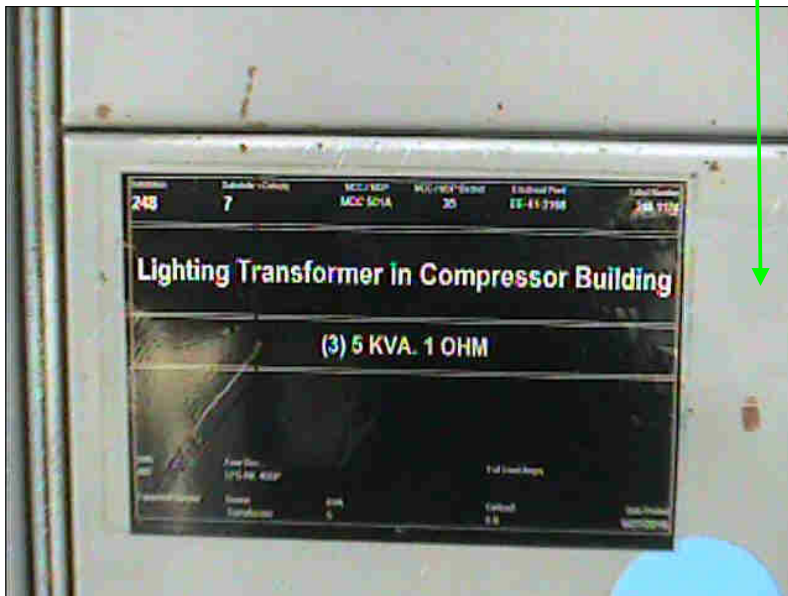
| Component | Equipment/Bucket ID | Plant/Area | Date |
|---|---|---|---|
| Lighting Trans. | MCC 501A | HCN TK. Farm | 12-26-19 |

| <b>Fault</b> | Poor Connection |
| <b>Defect Rating</b> | Class 1 |

Minor heat increase in B phase switch. Showing a 25 degree Delta. Recommend inspecting, cleaning; repair or replace as necessary in the near future.

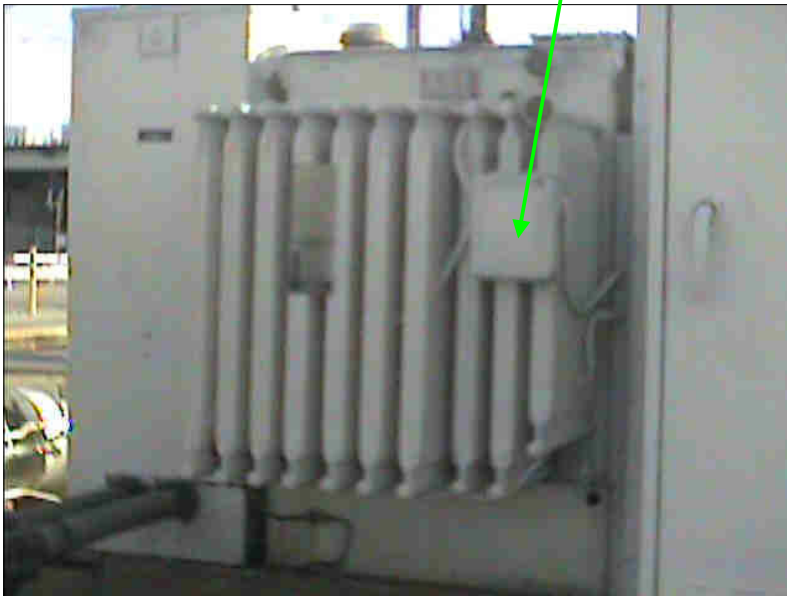
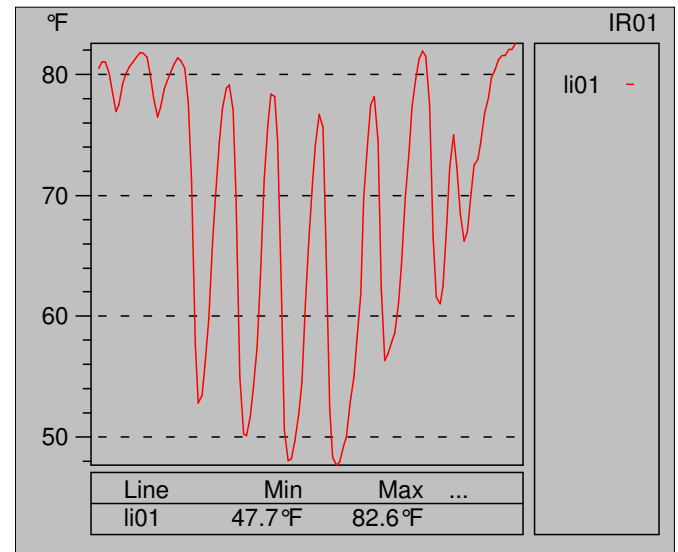
| Component | Equipment/Bucket ID | Plant/Area | Date |
|---|---|---|---|
| North Radiator | SUB 248 | HCN | 12-26-19 |

| <b>Fault</b> | Possible Low Coolant |
| <b>Defect Rating</b> | Class 1 |

Check coolant level. Cooling but only across half. Recommend checking coolant levels.

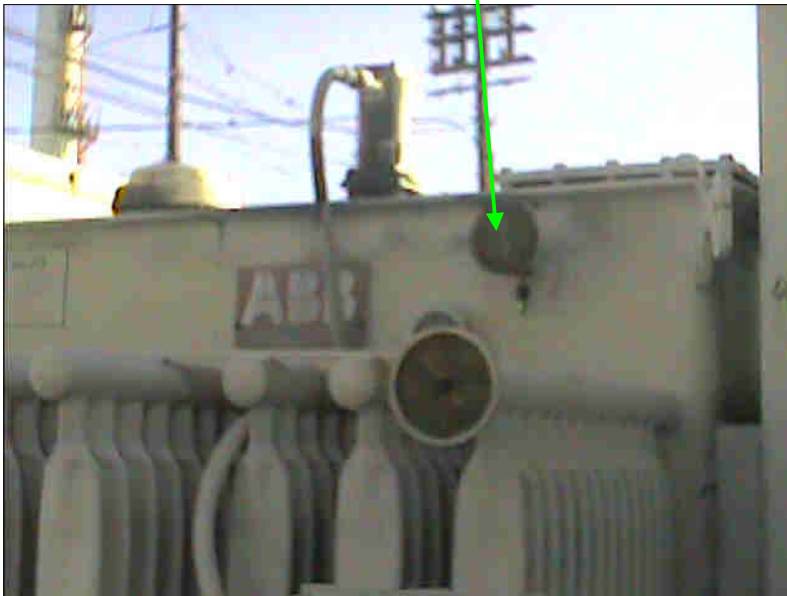
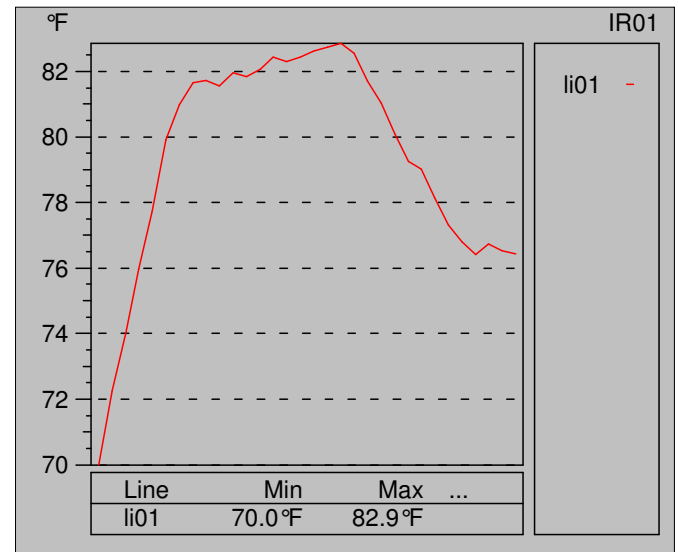
| Component | Equipment/Bucket ID | Plant/Area | Date |
|---|---|---|---|
| North Rad. Body | SUB 248 | HCN | 12-26-19 |

| <b>Fault</b> | Possible Low Coolant |
| <b>Defect Rating</b> | Class 1 |

Recommend checking coolant level.

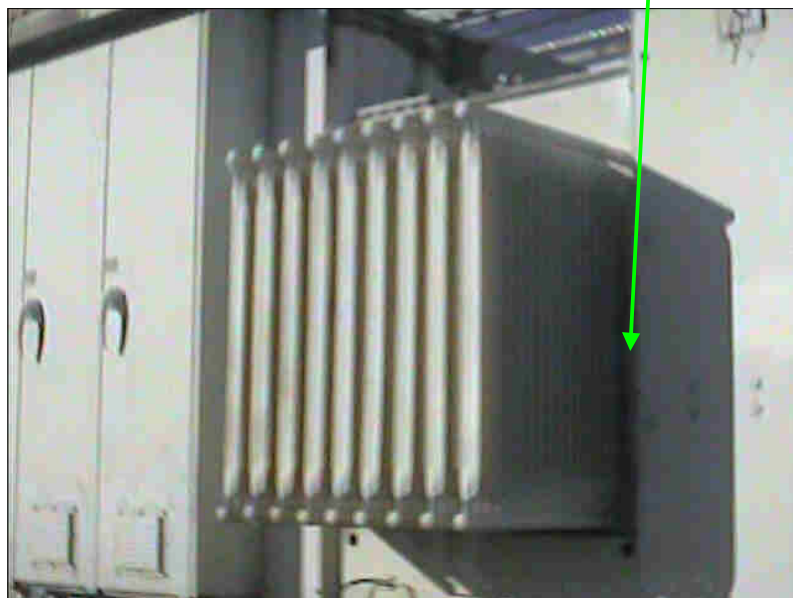
| Component | Equipment/Bucket ID | Plant/Area | Date |
|---|---|---|---|
| South Radiator | SUB 248 | HCN | 12-26-19 |

| <b>Fault</b> | Possible Blocked Tube |
| <b>Defect Rating</b> | Class 1 |

Operating normally; however, one or more tubes may be blocked. Recommend inspecting and checking coolant levels.
