## Infrared Thermography Report

Chemours NaCN September 23, 2020

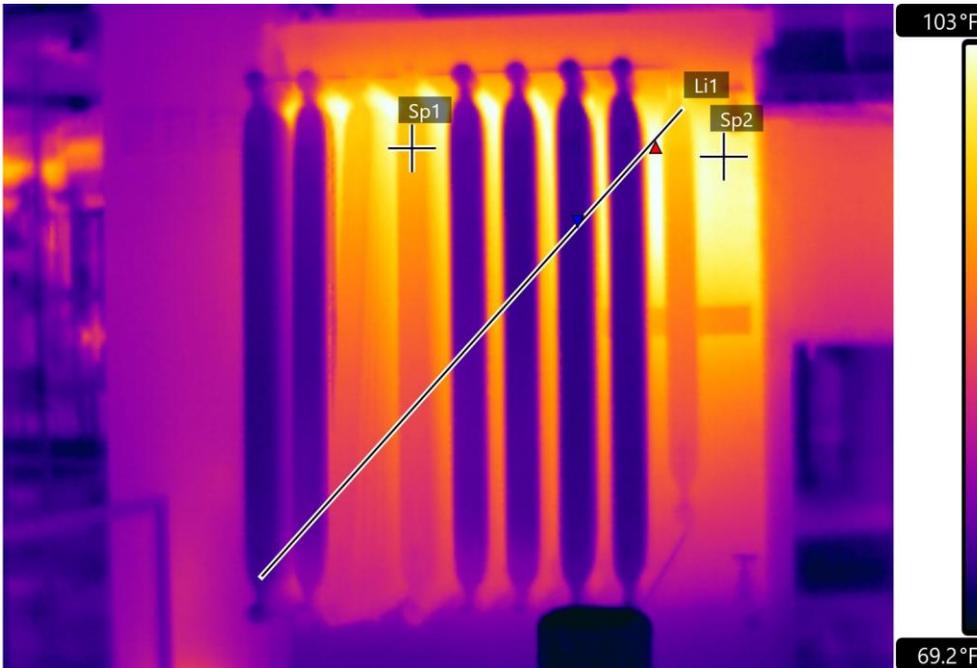
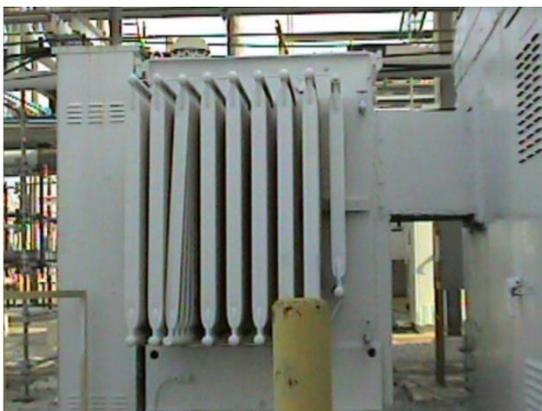
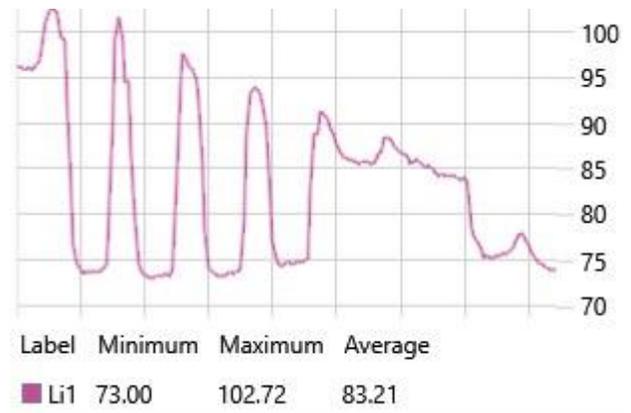
<b>Component</b>	South side cooling fins and transformer body
<b>Equipment/Bucket ID</b>	Sub 252-B

Sp1	93.9 °F
Sp2	100.9 °F
Li1 Minimum	73.0 °F
Li1 Maximum	102.7 °F
Areas	-

<b>Fault</b>	Multiple non-functional cooling fins
<b>Defect Rating</b>	Class I

<b>Recommendations</b>	Check the coolant level and fins for plugging. Replace damaged fin section.
------------------------	---

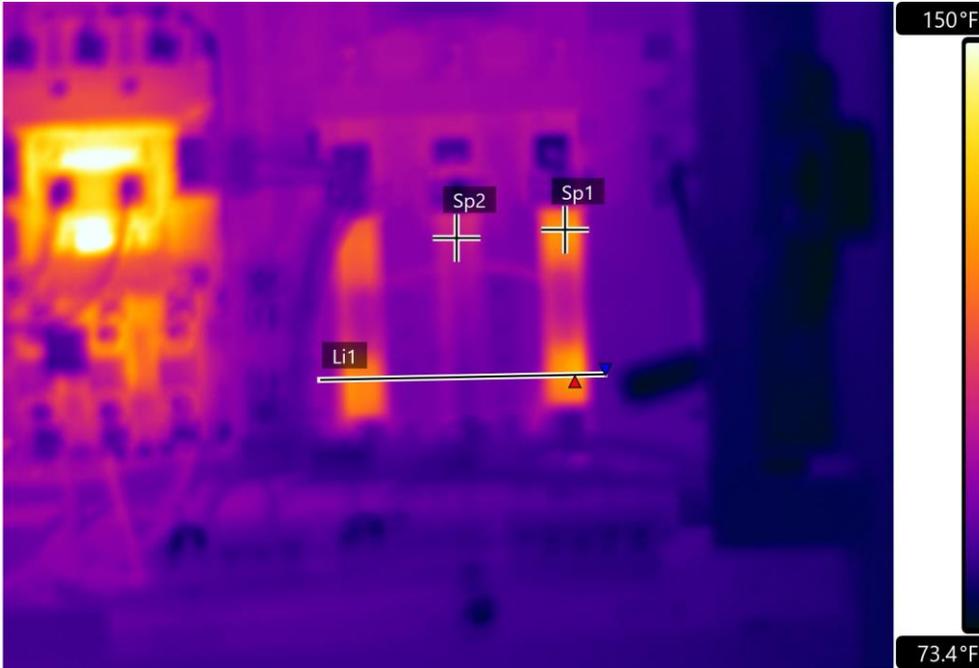
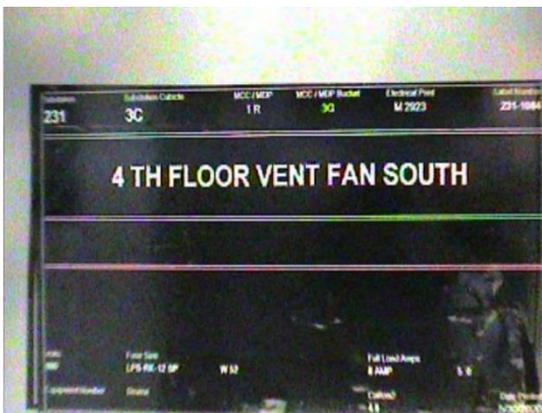
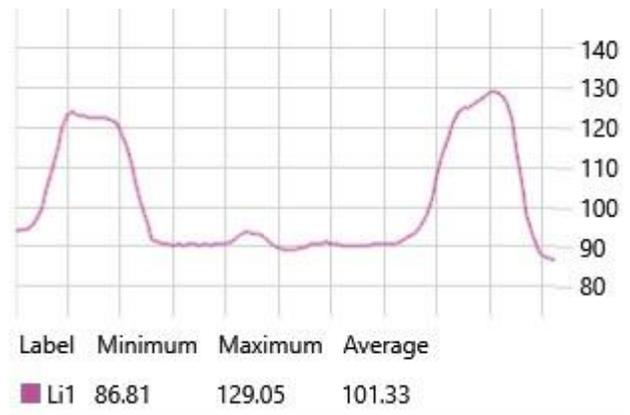
<b>Component</b>	Fuse clips
<b>Equipment/Bucket ID</b>	ECR MCC 1R 4 <sup>th</sup> floor vent fan South

Sp1	125.6 °F
Sp2	101.7 °F
Li1 Minimum	86.8 °F
Li1 Maximum	129.1 °F
Areas	-

<b>Fault</b>	Weak fuse clips
<b>Defect Rating</b>	Class I

Inspect the fuse block clips for tension and surface wear, as well as the fuses. Check for load balance. Replace worn components as time allows.

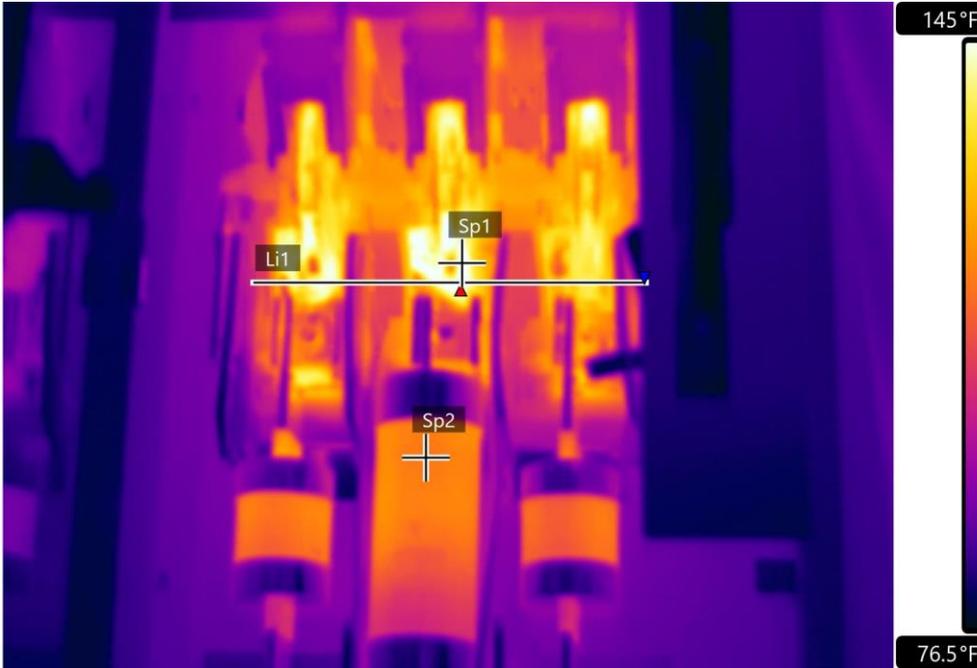
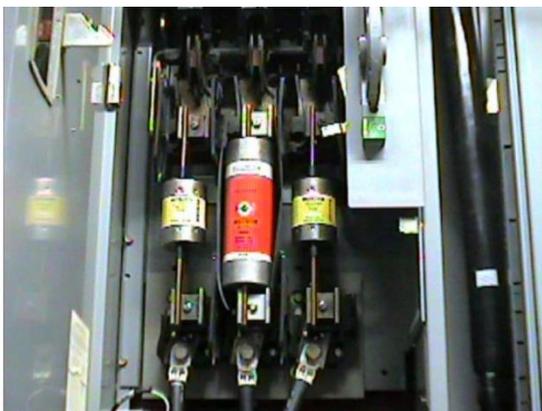
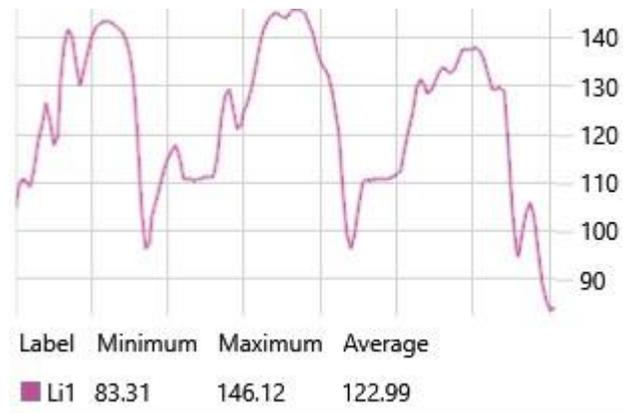
<b>Component</b>	Switch
<b>Equipment/Bucket ID</b>	ECR MCC 2F Recycle Scrubber Blower

Sp1	146.7 °F
Sp2	118.5 °F
Li1 Minimum	83.3 °F
Li1 Maximum	146.1 °F
Areas	-

<b>Fault</b>	Poor contact at switch
<b>Defect Rating</b>	Class I

Large temperature delta between fuse body and switch contact area leads us to believe the switch contacts are worn. Inspect the switch. Service or replace by years end.

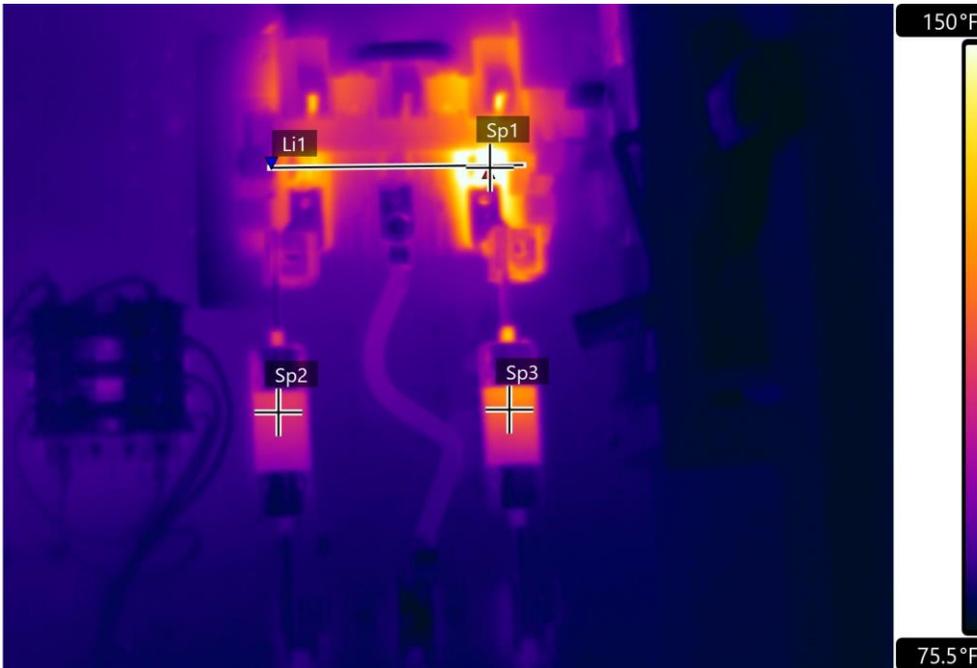
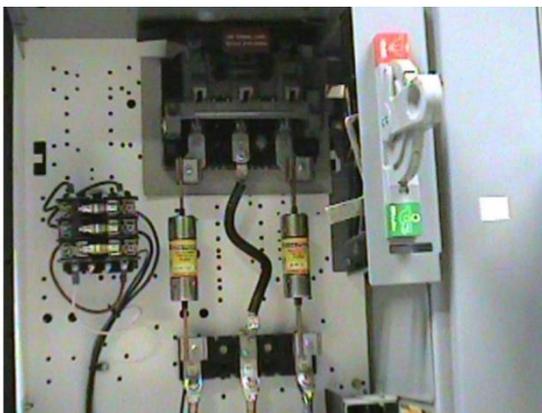
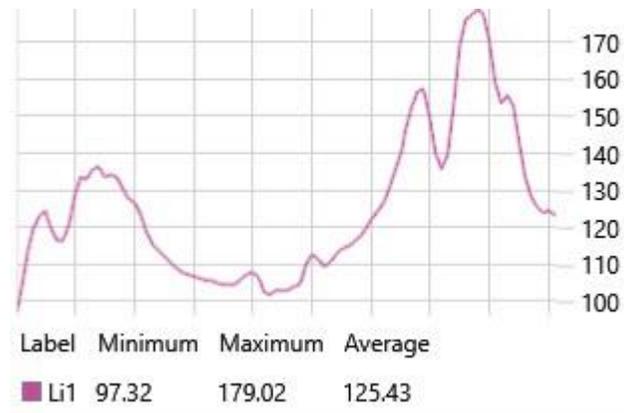
<b>Component</b>	Switch
<b>Equipment/Bucket ID</b>	ECR MCC 4 HVAC RTU #1 North Side

Sp1	178.5 °F
Sp2	108.4 °F
Sp3	119.2 °F
Li1 Minimum	97.3 °F
Li1 Maximum	179.0 °F
Areas	-

<b>Fault</b>	Poor connection at switch contacts or lugs on C phase
<b>Defect Rating</b>	Class II

**Recommendations**  
 Excessive heat is being generated at the C phase contact or just adjacent to it in a lug connection. Inspect the switch for defects as well as adjacent components. Service or replace the switch at the next opportunity.

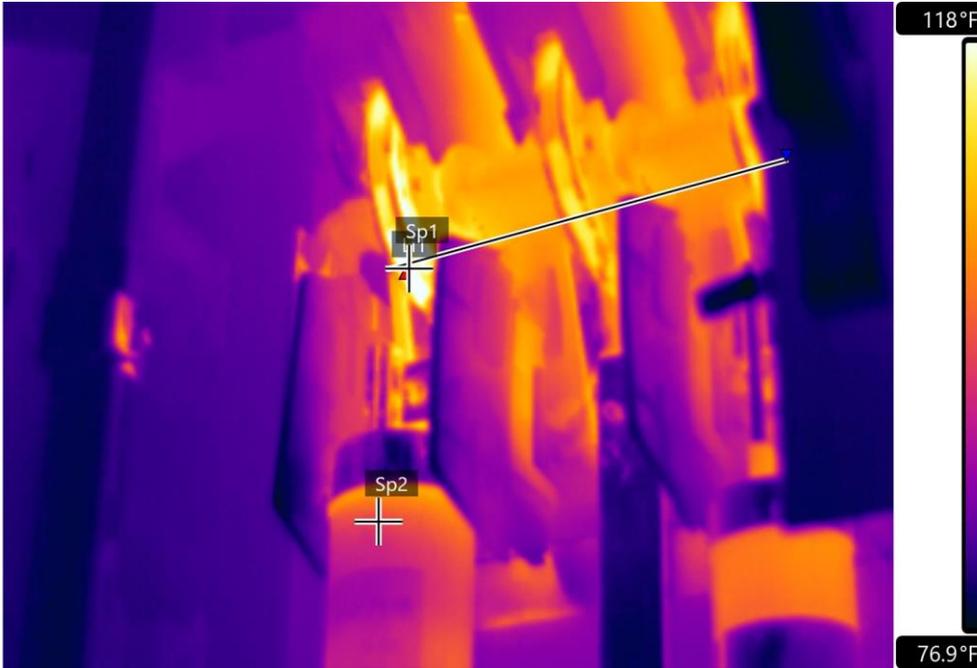
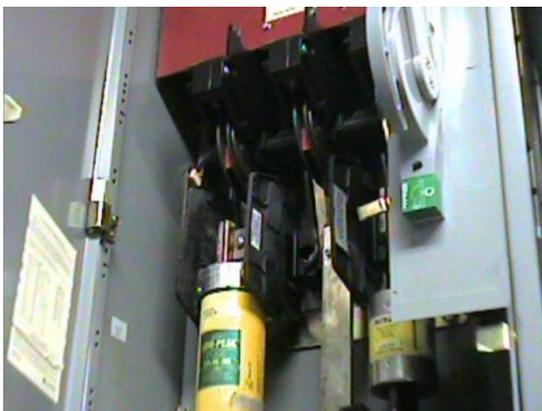
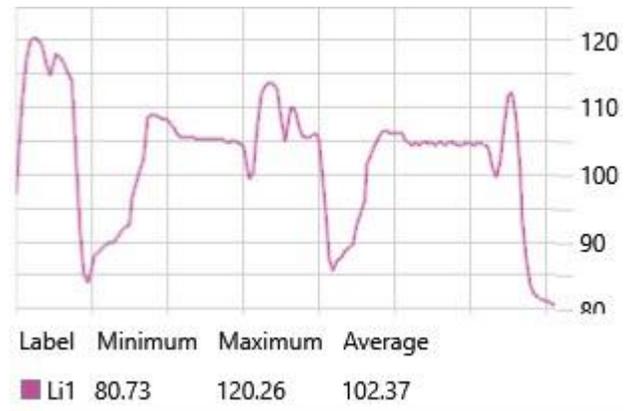
<b>Component</b>	Switch
<b>Equipment/Bucket ID</b>	ECR MCC 6 Vacuum Pump #2

Sp1	120.3 °F
Sp2	96.6 °F
Li1 Minimum	80.7 °F
Li1 Maximum	120.3 °F
Areas	-

<b>Fault</b>	Poor contact at switch A phase
<b>Defect Rating</b>	Class I

<b>Recommendations</b>	Small hot spot On the A phase of the switch indicates a poor connection there. Inspect the switch. Repair or replace. Check all adjacent connections. Perform as time allows.
------------------------	---

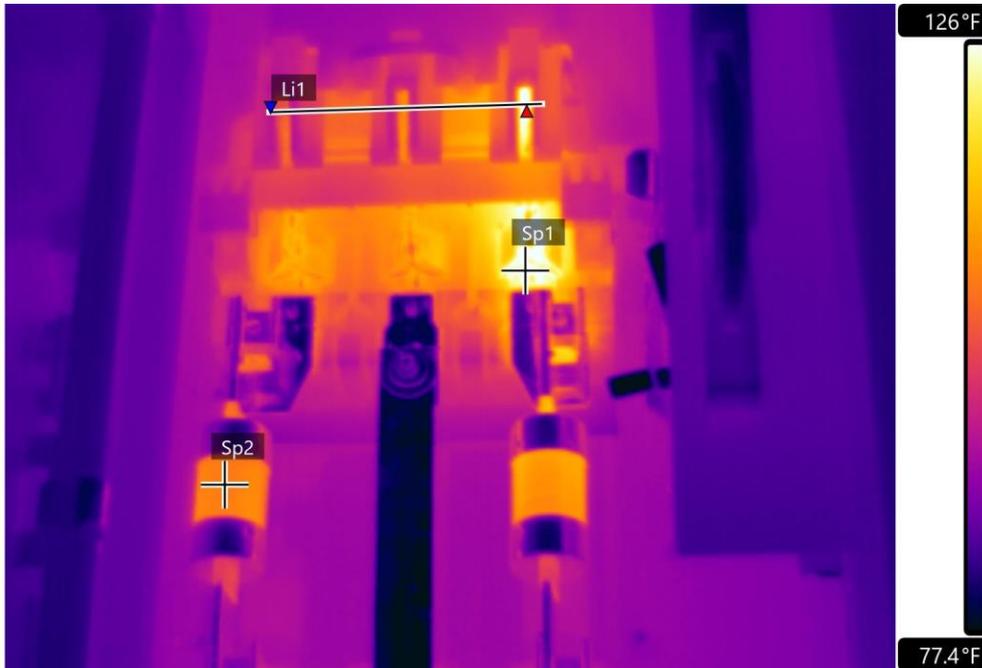
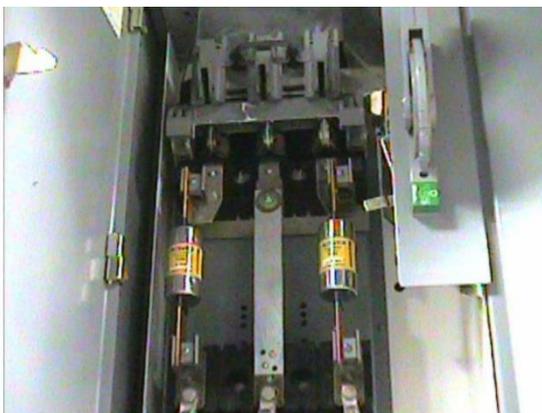
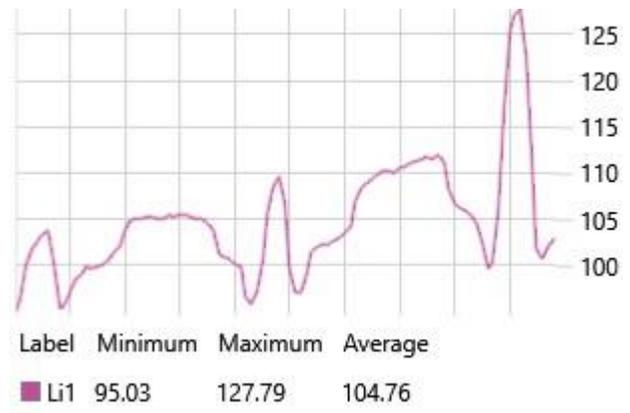
<b>Component</b>	Switch
<b>Equipment/Bucket ID</b>	ECR MCC 3 Dust and Fume Blower

Sp1	130.8 °F
Sp2	107.0 °F
Li1 Minimum	95.0 °F
Li1 Maximum	127.8 °F
Areas	-

<b>Fault</b>	Poor contact at switch C phase
<b>Defect Rating</b>	Class I

<b>Recommendations</b>	Hot spot On the C phase of the switch indicates a poor connection there. Inspect the switch and adjacent components. Repair or replace. Check all adjacent connections. Perform as time allows.
------------------------	---

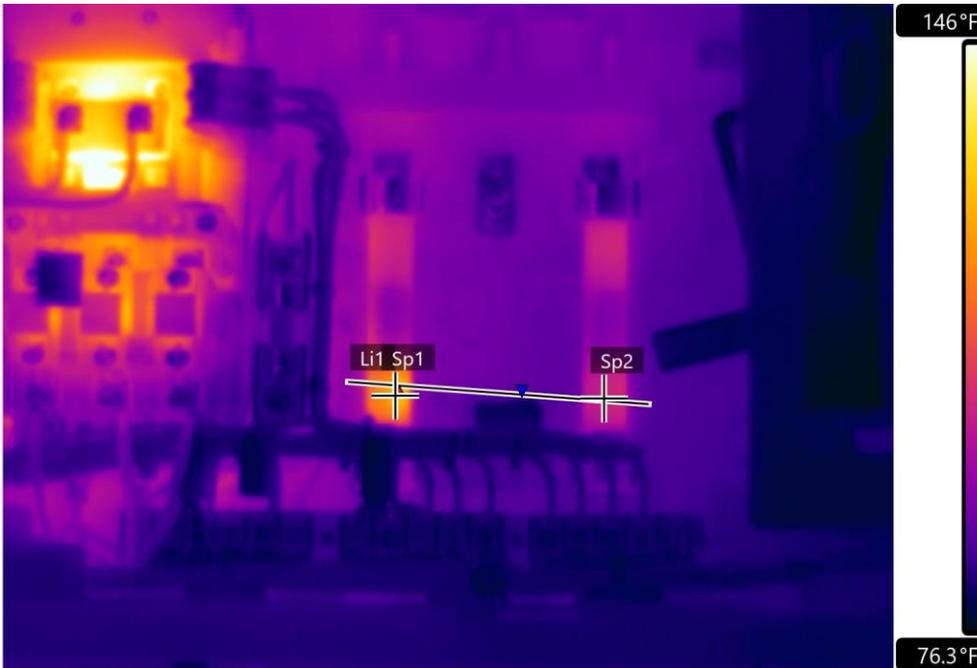
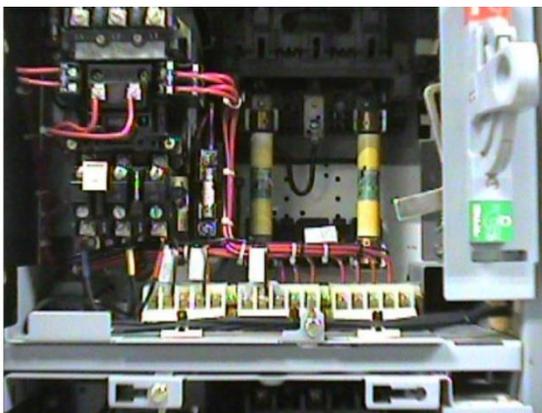
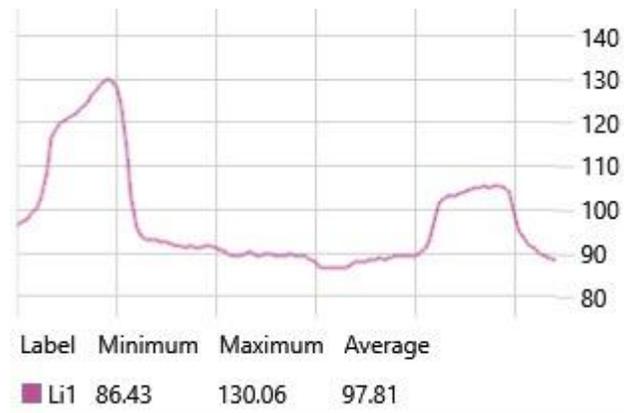
<b>Component</b>	Fuse clip
<b>Equipment/Bucket ID</b>	ECR MCC 3 4 <sup>th</sup> Floor Exhaust Fan Middle

Sp1	130.0 °F
Sp2	105.1 °F
Li1 Minimum	86.4 °F
Li1 Maximum	130.1 °F
Areas	-

<b>Fault</b>	Weak fuse clip or loose lug connection
<b>Defect Rating</b>	Class I

**Recommendations**  
 Inspect the fuse block clips for tension and surface wear, as well as the fuses. Check for load balance. Replace worn components as time allows.

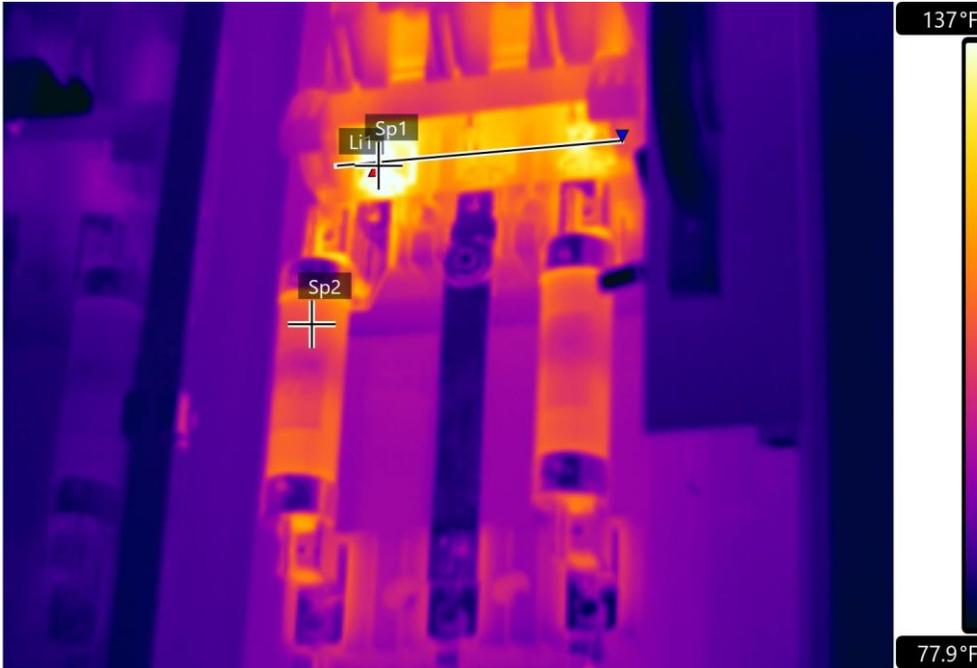
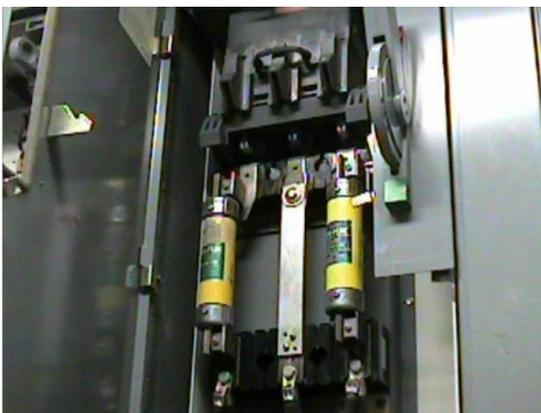
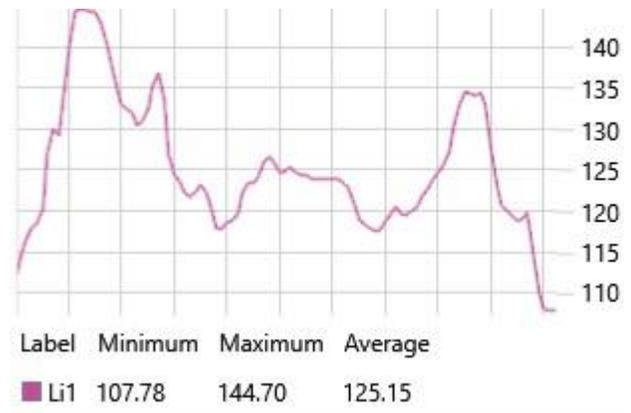
<b>Component</b>	Switch
<b>Equipment/Bucket ID</b>	ECR MCC7 Crystallizer Circulation Pump

Sp1	144.8 °F
Sp2	108.6 °F
Li1 Minimum	107.8 °F
Li1 Maximum	144.7 °F
Areas	-

<b>Fault</b>	Weak connection at switch
<b>Defect Rating</b>	Class I

<b>Recommendations</b>	Hot spot On the A phase of the switch indicates a poor connection there. Inspect the switch and adjacent components. Repair or replace. Check all adjacent connections. Perform as time allows.
------------------------	---

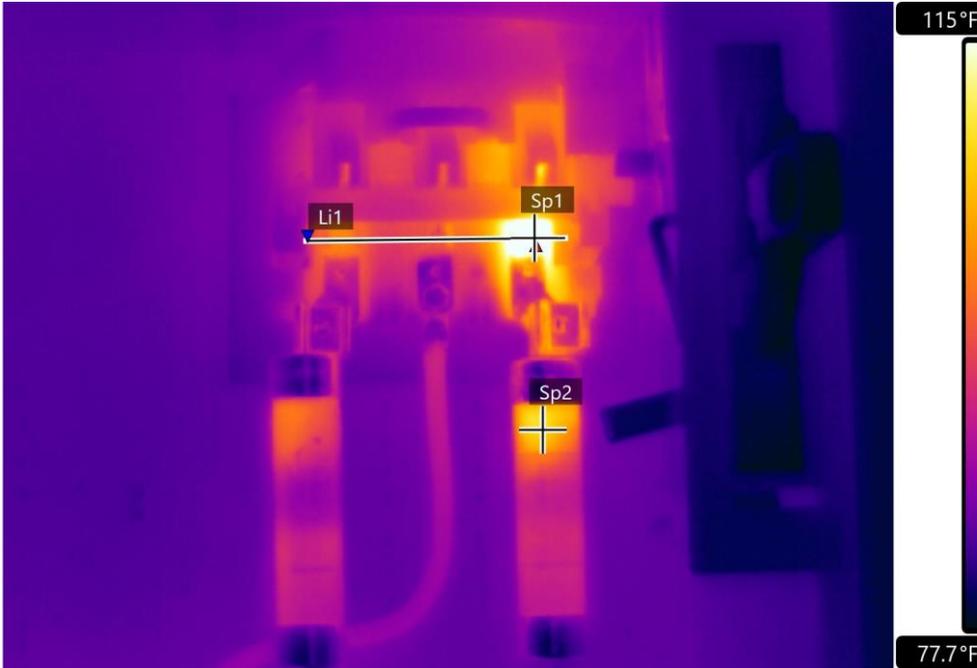
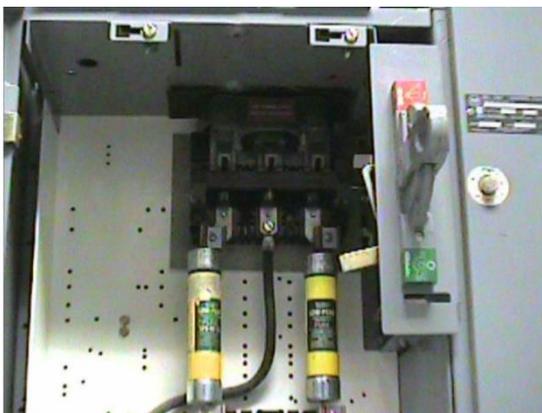
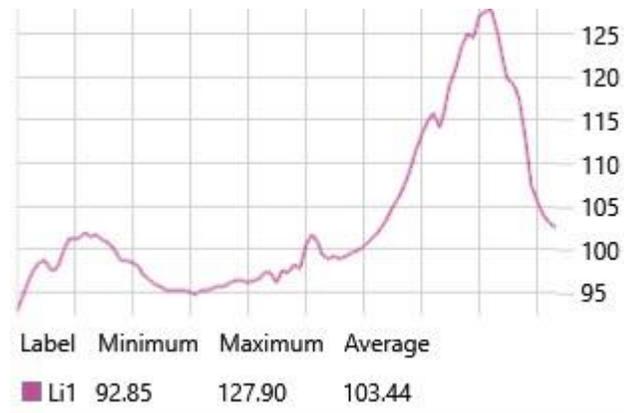
<b>Component</b>	Switch
<b>Equipment/Bucket ID</b>	ECR MCC 7 Filter Feed Pump

Sp1	127.9 °F
Sp2	108.4 °F
Li1 Minimum	92.9 °F
Li1 Maximum	127.9 °F
Areas	-

<b>Fault</b>	Poor connection at switch or adjacent lug
<b>Defect Rating</b>	Class I

<b>Recommendations</b>	Hot spot On the C phase of the switch indicates a poor connection there. Inspect the switch and adjacent components. Repair or replace. Check all adjacent connections. Perform as time allows.
------------------------	---

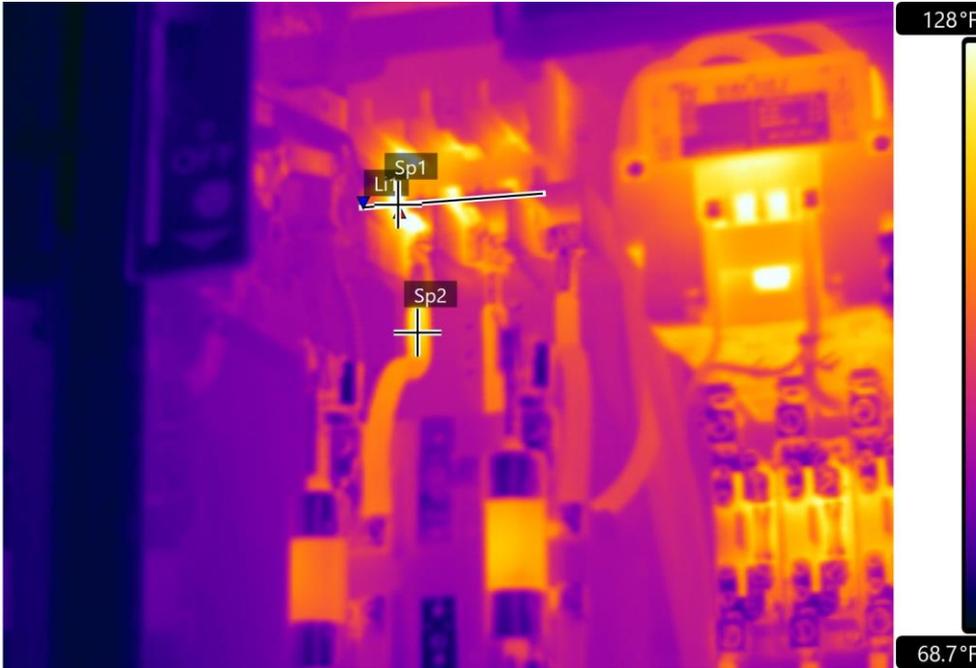
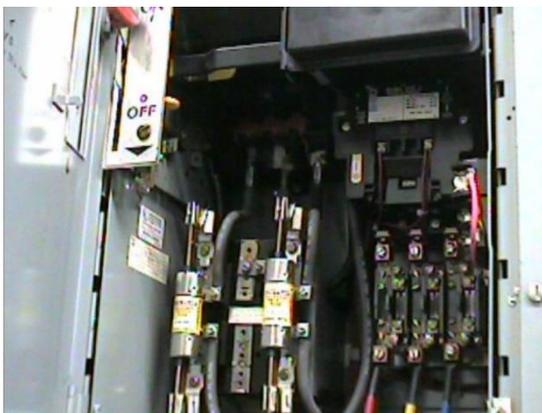
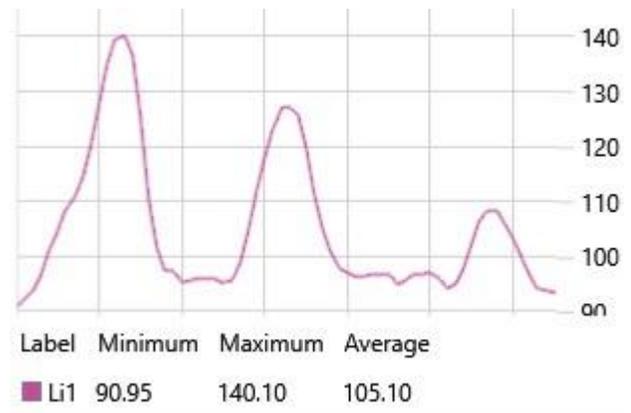
<b>Component</b>	Switch
<b>Equipment/Bucket ID</b>	Caustic Unloading Middle Caustic Transfer Pump

Sp1	140.1 °F
Sp2	117.5 °F
Li1 Minimum	91.0 °F
Li1 Maximum	140.1 °F
Areas	-

<b>Fault</b>	Poor connections at switch or adjacent lugs.
<b>Defect Rating</b>	Class I

<b>Recommendations</b>	Hot spot On the A phase of the switch indicates a poor connection there. Inspect the switch and adjacent components. B phase also shows some heat. Repair or replace. Check all adjacent connections. Perform as time allows.
------------------------	---

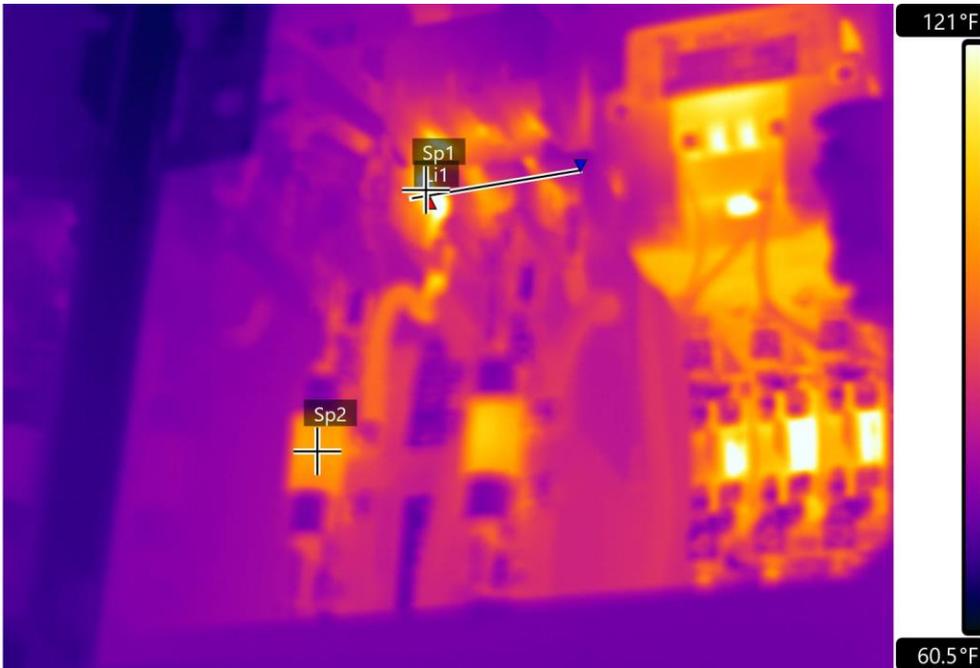
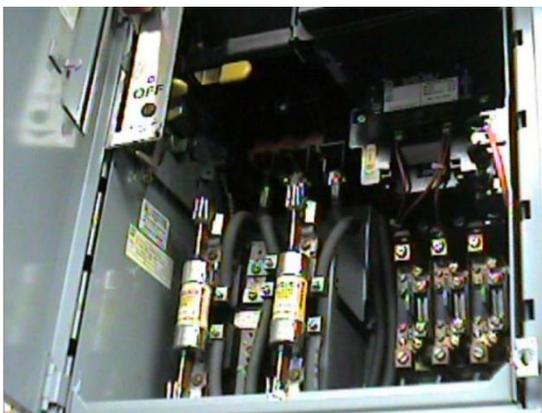
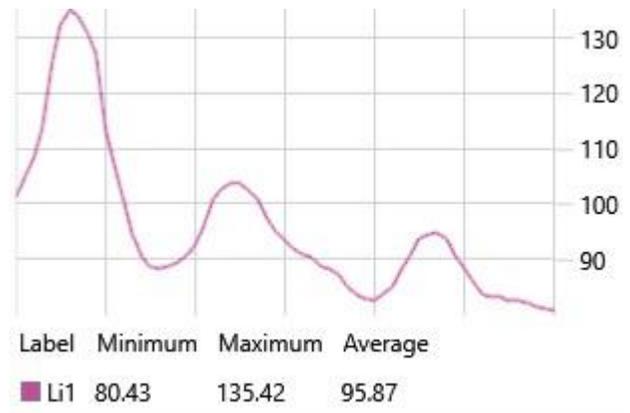
<b>Component</b>	Switch
<b>Equipment/Bucket ID</b>	Caustic Unloading East Caustic Pump

Sp1	136.5 °F
Sp2	102.7 °F
Li1 Minimum	80.4 °F
Li1 Maximum	135.4 °F
Areas	-

<b>Fault</b>	Poor switch contact
<b>Defect Rating</b>	Class I

<b>Recommendations</b>	Hot spot On the A phase of the switch indicates a poor connection there. Inspect the switch and adjacent components. Repair or replace. Check all adjacent connections. Perform as time allows.
------------------------	---

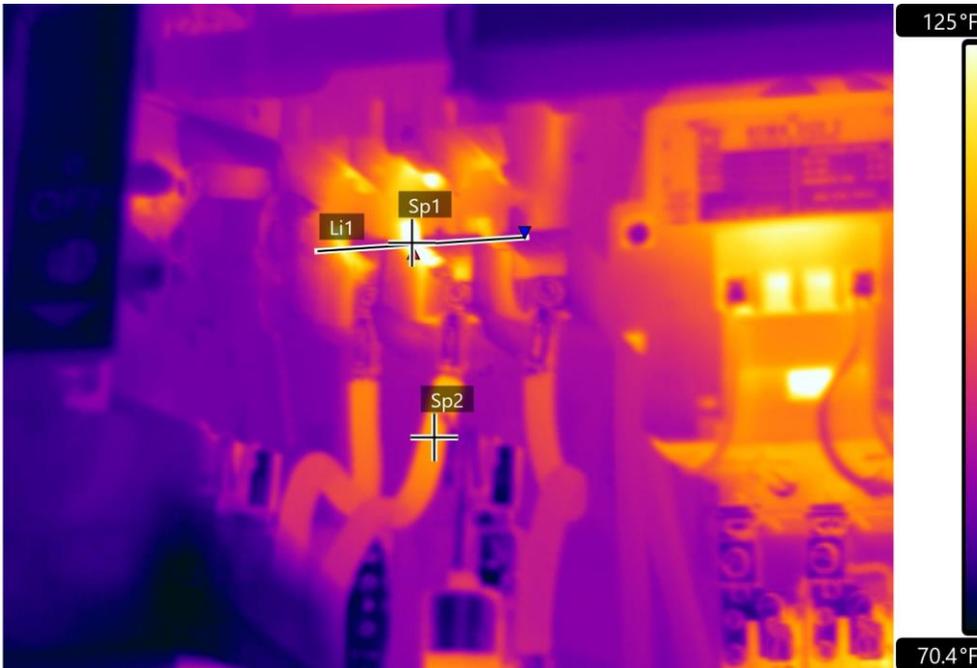
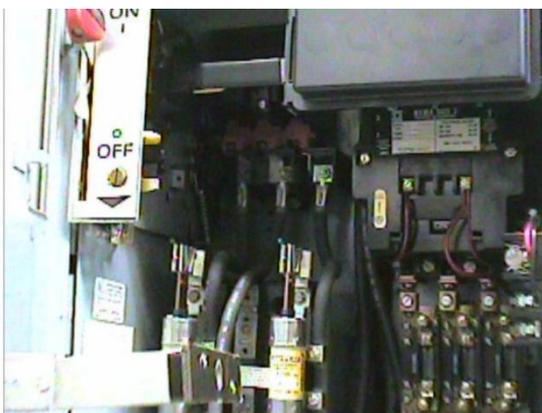
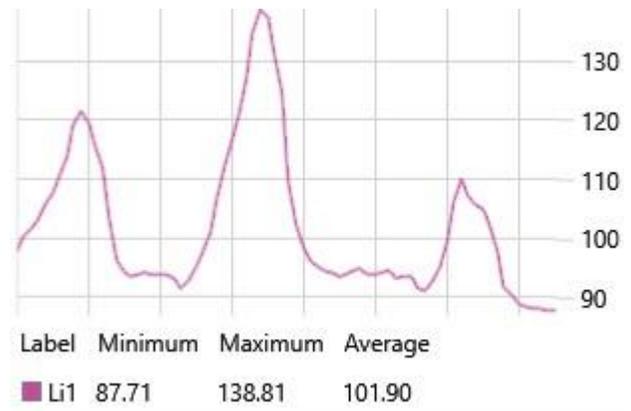
<b>Component</b>	Switch
<b>Equipment/Bucket ID</b>	Caustic Unloading West Caustic Pump

Sp1	137.6 °F
Sp2	108.7 °F
Li1 Minimum	87.7 °F
Li1 Maximum	138.8 °F
Areas	-

<b>Fault</b>	Poor connections at switch
<b>Defect Rating</b>	Class I

**Recommendations**  
 Hot spot On the B phase of the switch indicates a poor connection there. Inspect the switch and adjacent components. A phase also shows some heat. Repair or replace. Check all adjacent connections. Perform as time allows.
