QualiTest IR Radiometric Survey Report

Chemours
NaCN

Job Number	141056
Survey Date	10-29-19
Report Date	10-29-19

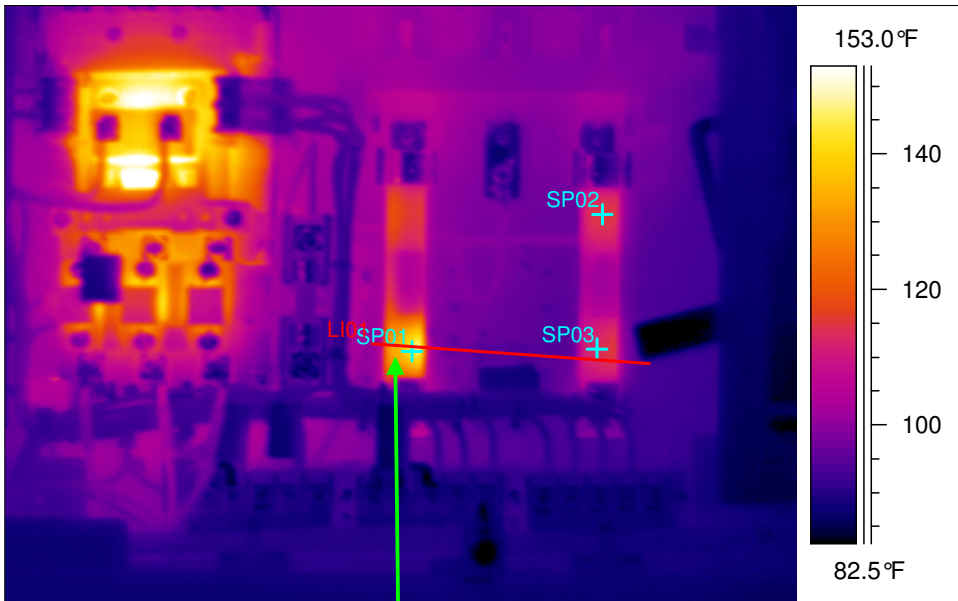
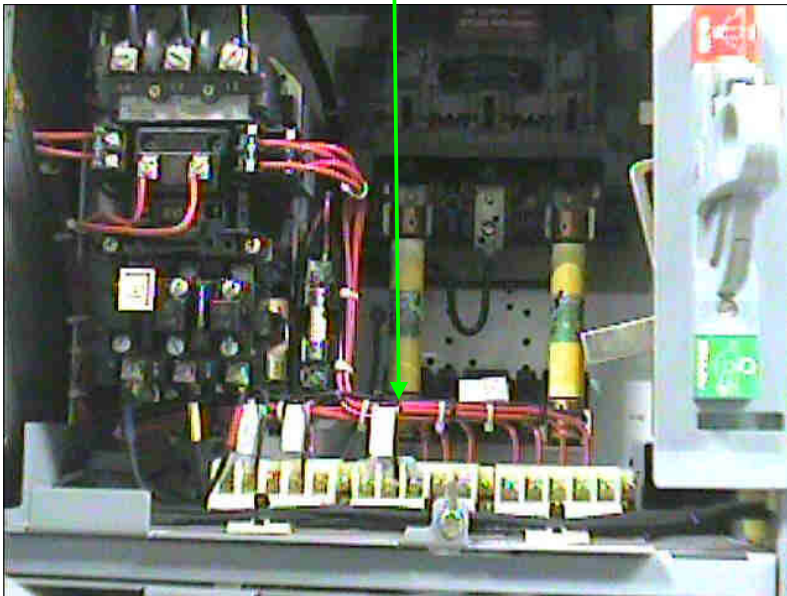
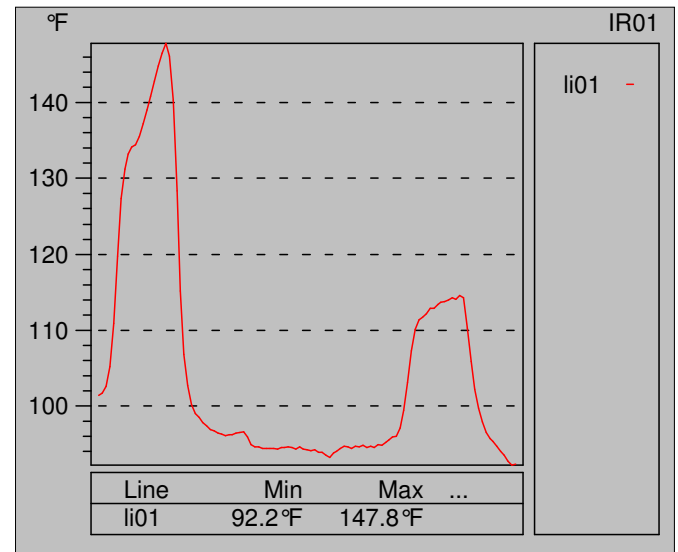
Component	Equipment/Bucket ID	Plant/Area	Date
Fuse Clip	4th Floor Exhaust Fan	NaCN MCC 3	10-29-19

Label	Value
IR : max	173.5°F
IR : min	82.0°F
SP01	144.7°F
SP02	115.4°F
SP03	113.7°F
LI01 : max	147.8°F
LI01 : min	92.2°F

Fault	Weak connection
Defect Rating	Class I

Temperure delta across fuses indicates a possible weak fuse clip/poor connection at the bottom of A phase. Clean and inspect, repair or replace as required.

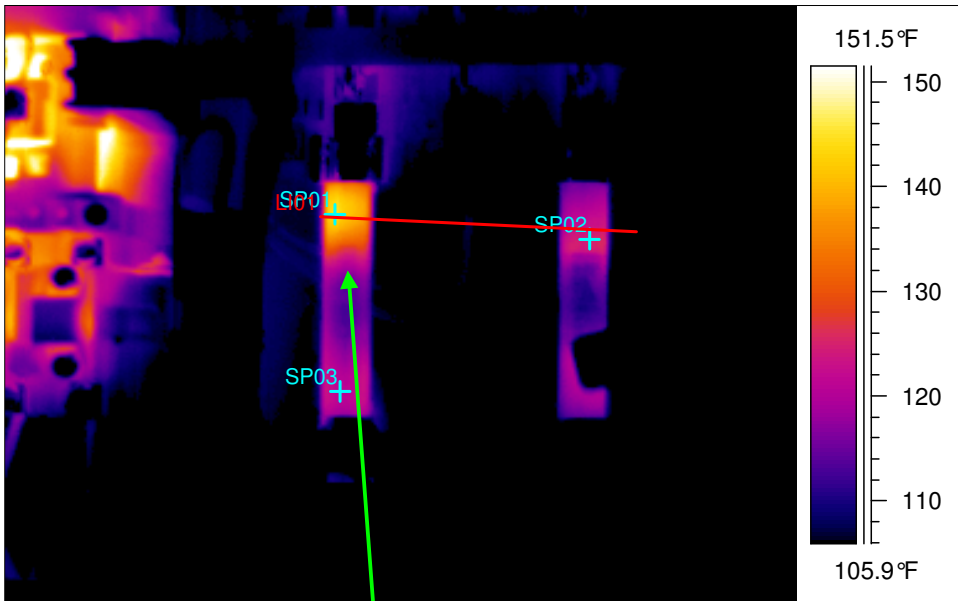
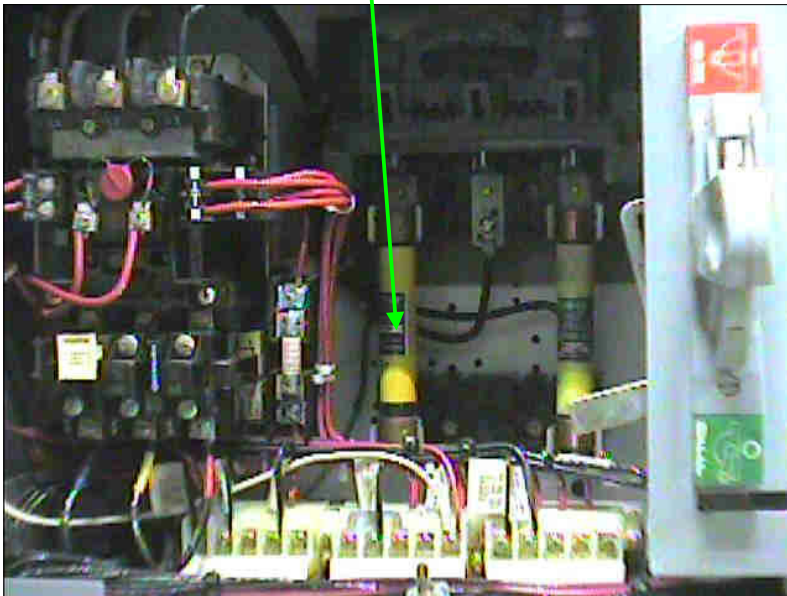
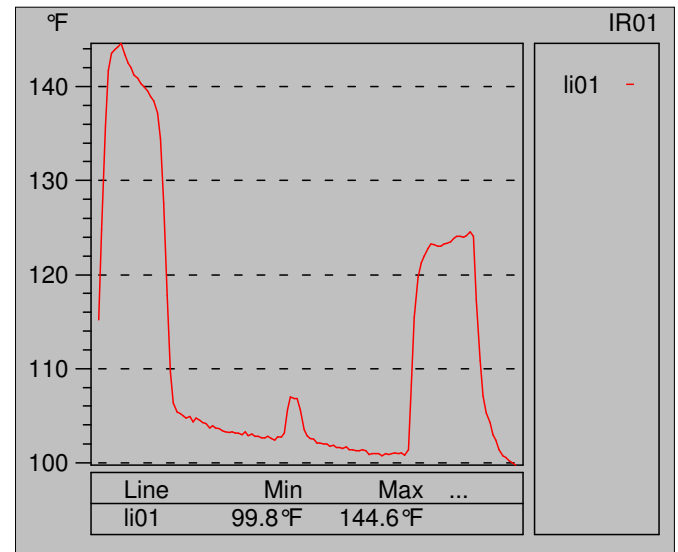
Component	Equipment/Bucket ID	Plant/Area	Date
Fuse Clip	Filter Air Blower	NaCN MCC	10-29-19

Label	Value
IR : max	164.3°F
IR : min	83.5°F
SP01	144.6°F
SP02	124.8°F
SP03	121.0°F
LI01 : max	144.6°F
LI01 : min	99.8°F

Fault	Weak Fuse Clip
Defect Rating	Class I

Temperature delta across fuses could indicate a weak fuse clip/poor contact on the A phase of the upper switch body. Inspect the switch fuses and fuse clips. Repair or replace items as needed.

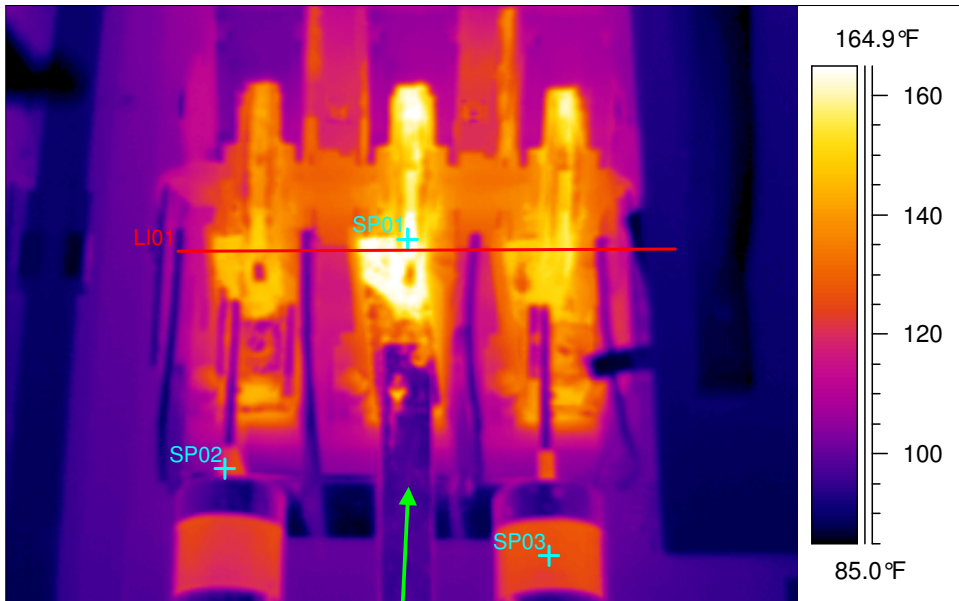
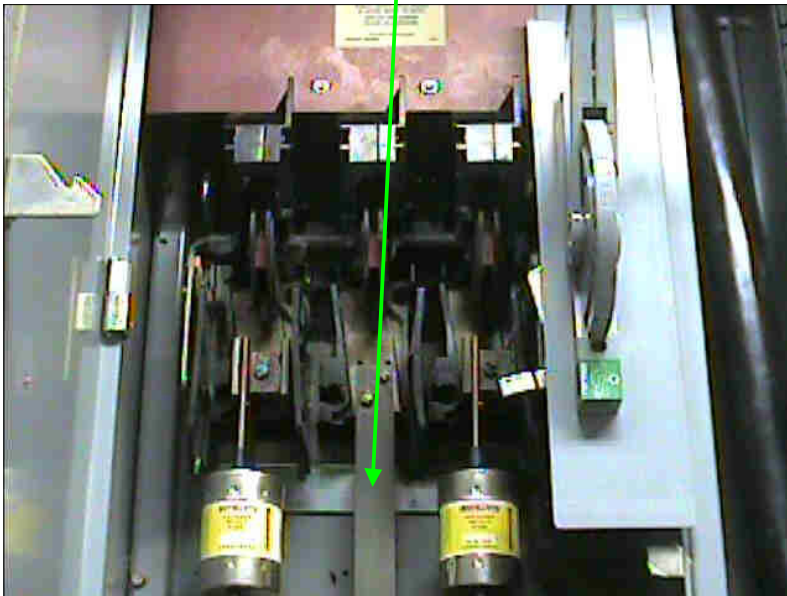
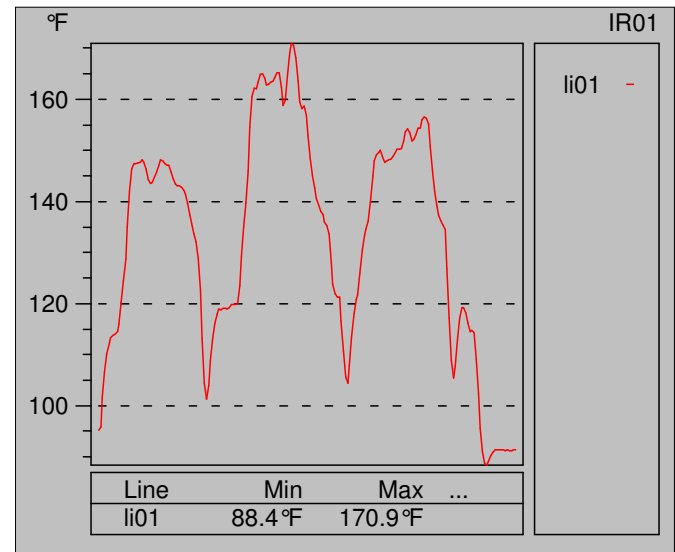
Component	Equipment/Bucket ID	Plant/Area	Date
Disconnect Switch	Recycle Scrubber Blwr	NaCN MCC 2F	10-29-19

Label	Value
IR : max	173.6°F
IR : min	84.5°F
SP01	172.8°F
SP02	122.7°F
SP03	125.5°F
LI01 : max	170.9°F
LI01 : min	88.4°F

Fault	Poor contact at switch
Defect Rating	Class II

Temperature delta at B phase of the switch, as well as excessive temperature.
Clean and inspect switch. Repair or replace the switch as needed.

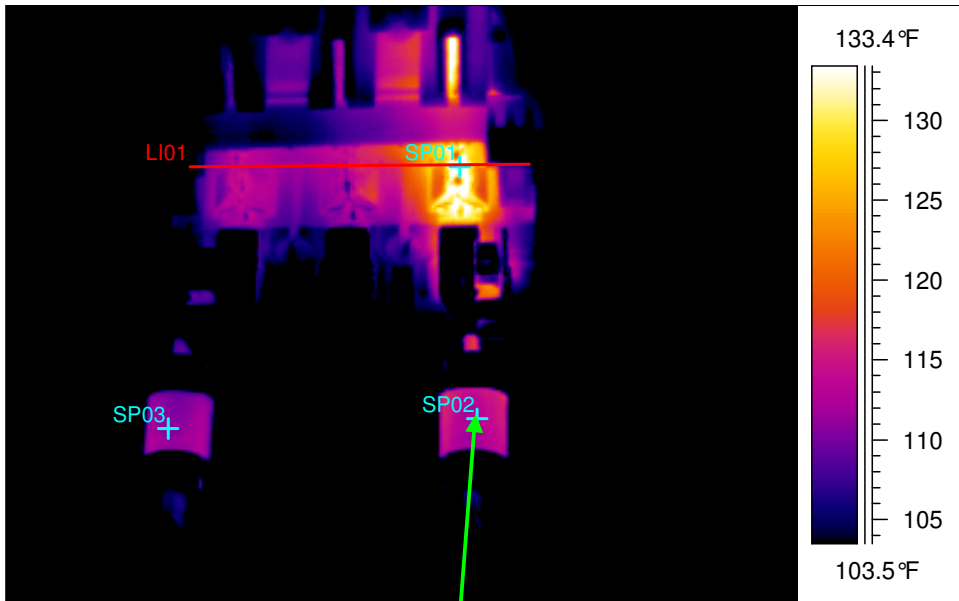
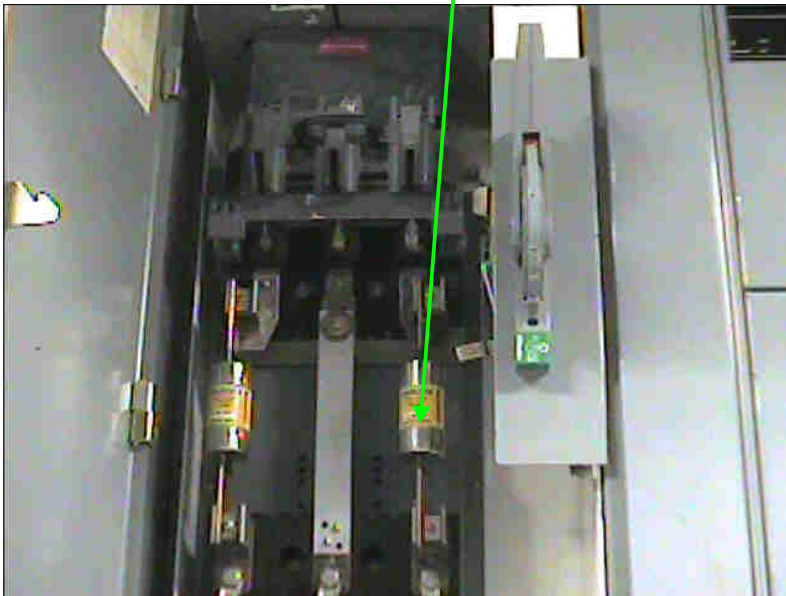
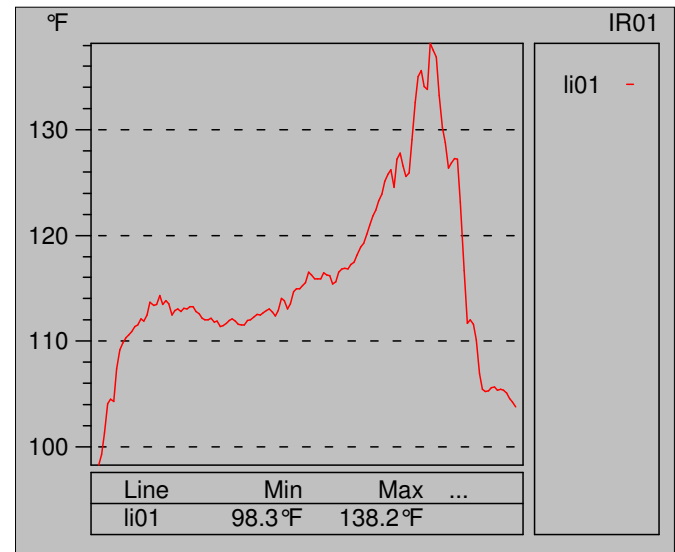
Component	Equipment/Bucket ID	Plant/Area	Date
Disconnect Switch	Dust and Fume Blower	NaCN MCC 3	10-29-19

Label	Value
IR : max	138.2°F
IR : min	82.6°F
SP01	137.6°F
SP02	112.9°F
SP03	111.0°F
LI01 : max	138.2°F
LI01 : min	98.3°F

Fault	Poor contact at switch
Defect Rating	Class I

Temperature delta at disconnect switch indicates poor contact at C phase.
Clean and inspect. Repair or replace switch as needed.

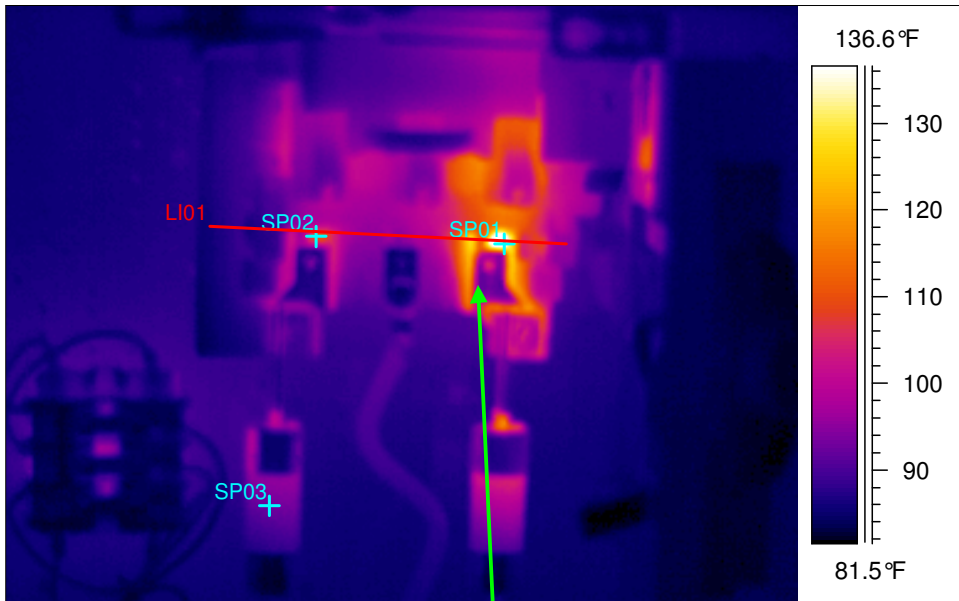
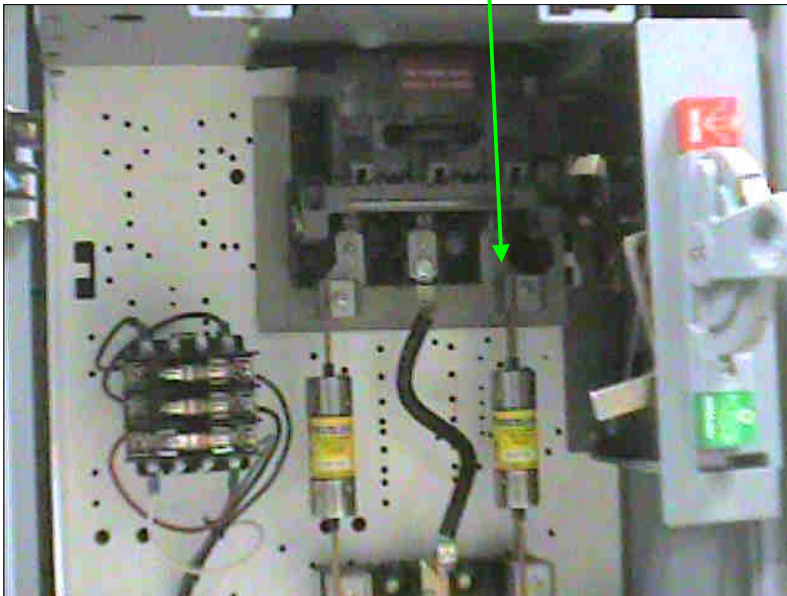
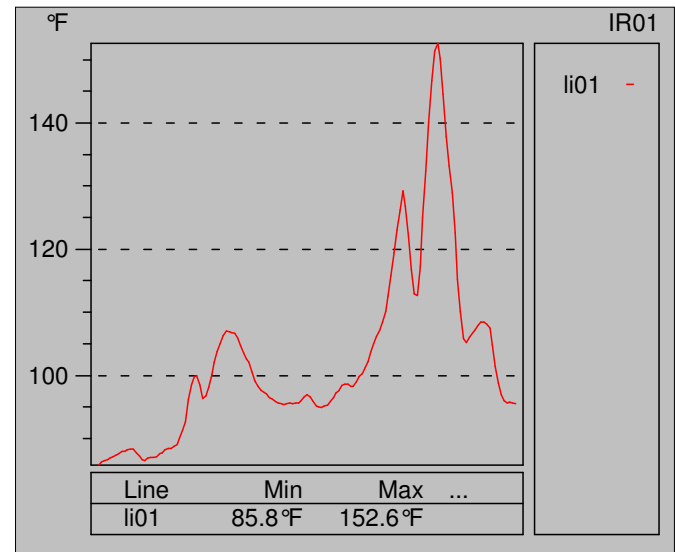
Component	Equipment/Bucket ID	Plant/Area	Date
Disconnect Switch	ECR HVAC RTU 1 N	NaCN MCC 4	10-29-19

Label	Value
IR : max	152.6°F
IR : min	81.5°F
SP01	141.8°F
SP02	109.6°F
SP03	92.8°F
LI01 : max	152.6°F
LI01 : min	85.8°F

Fault	Poor contact at switch
Defect Rating	Class II

Large temperature delta at C phase of switch. Clean and inspect. Repair or replace the Switch as needed.

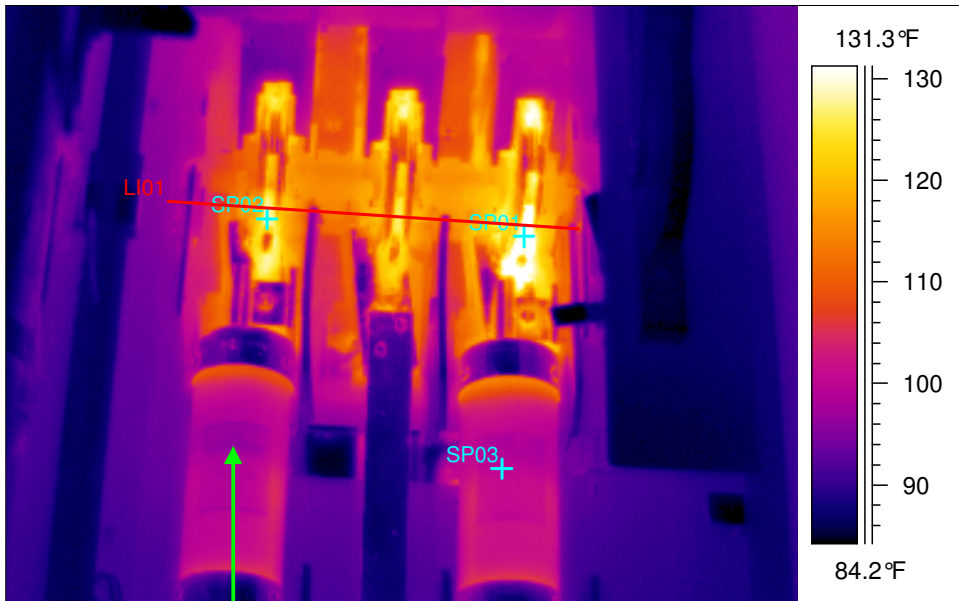
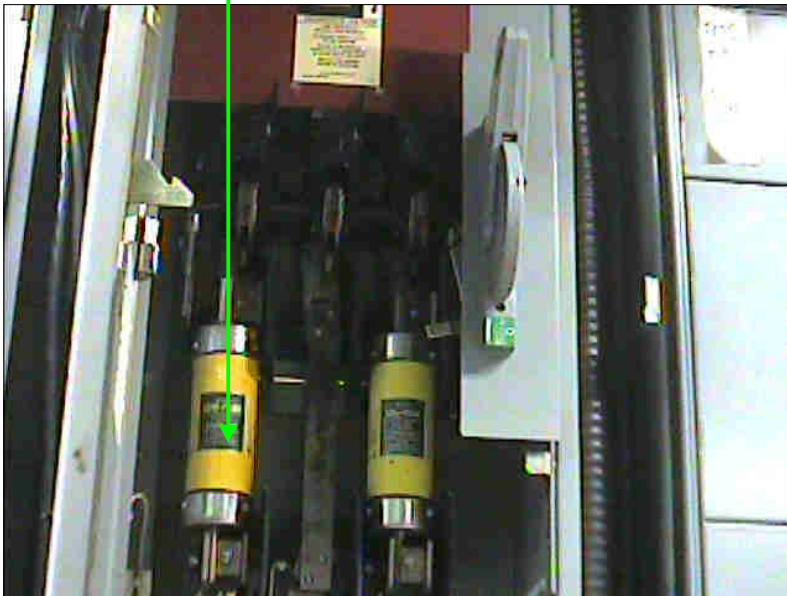
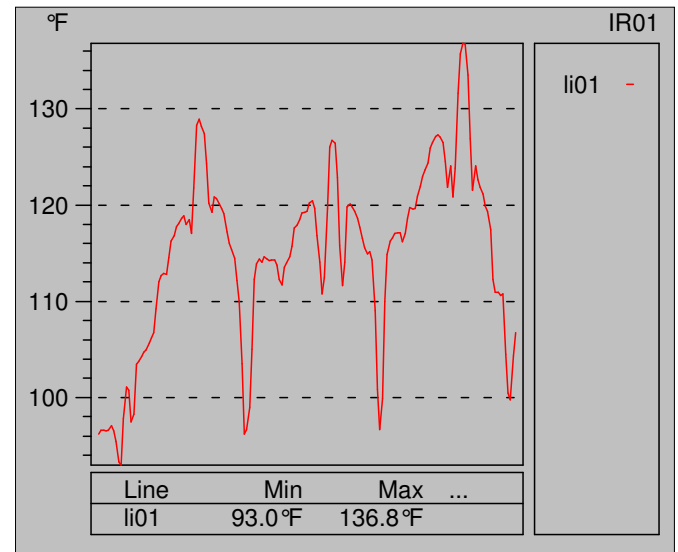
Component	Equipment/Bucket ID	Plant/Area	Date
Disconnect Switch	Vacuum Pump 5	NaCN MCC 5	10-29-19

Label	Value
IR : max	137.5°F
IR : min	82.9°F
SP01	136.6°F
SP02	129.1°F
SP03	100.3°F
LI01 : max	136.8°F
LI01 : min	93.0°F

Fault	Slight issue at switch contacts
Defect Rating	Class I

Temperature delta between fuse and switch contacts. Clean and inspect the switch. Repair or replace if required.

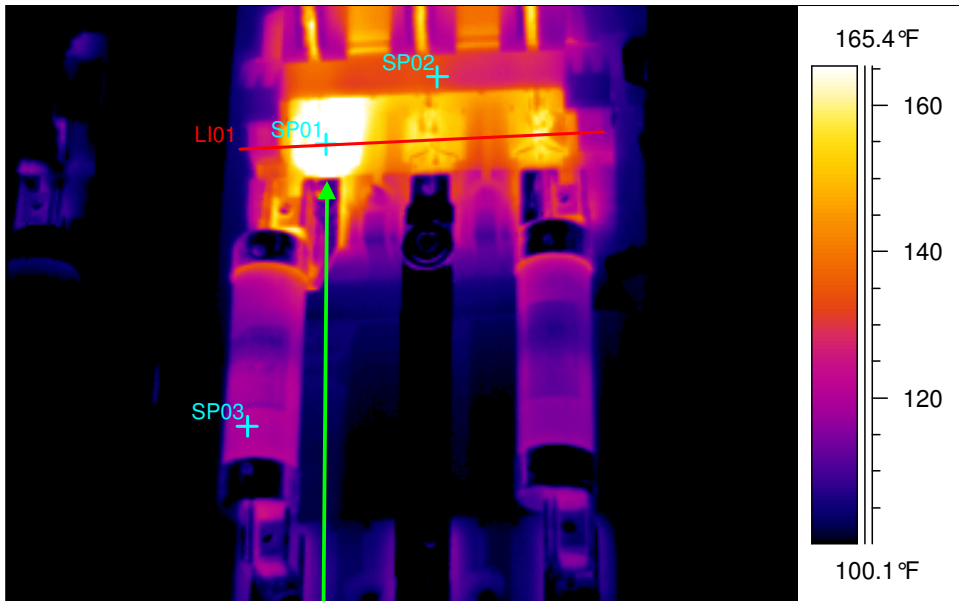
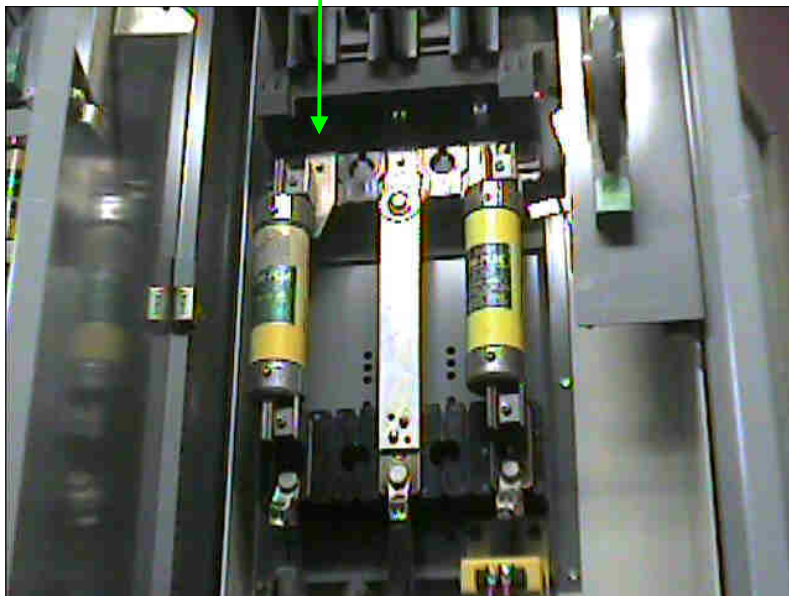
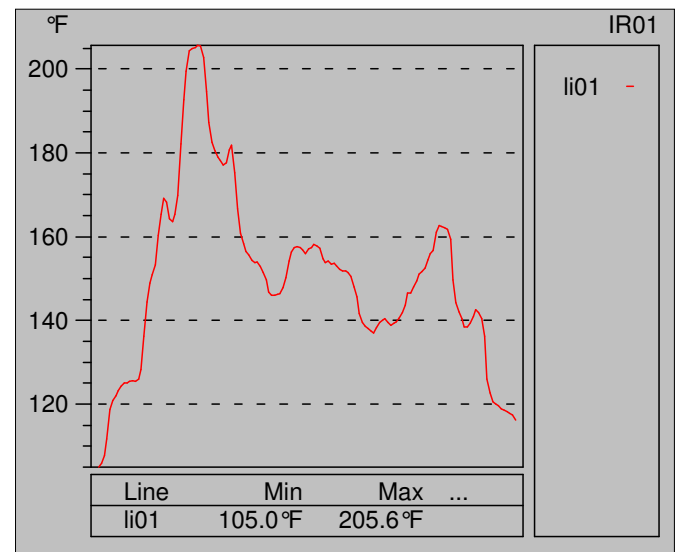
Component	Equipment/Bucket ID	Plant/Area	Date
Disconnect Switch	Crystalizer Circ Pump	NaCN MCC 7	10-29-19

Label	Value
IR : max	205.9°F
IR : min	84.5°F
SP01	205.6°F
SP02	132.4°F
SP03	119.8°F
LI01 : max	205.6°F
LI01 : min	105.0°F

Fault	Poor Connection at switch
Defect Rating	Class III

Large temperature delta between A phase top side switch contact to B and C.
Large delta also to A phase fuse body. Excessive heat. Clean and inspect. Repair or replace switch as soon as possible.

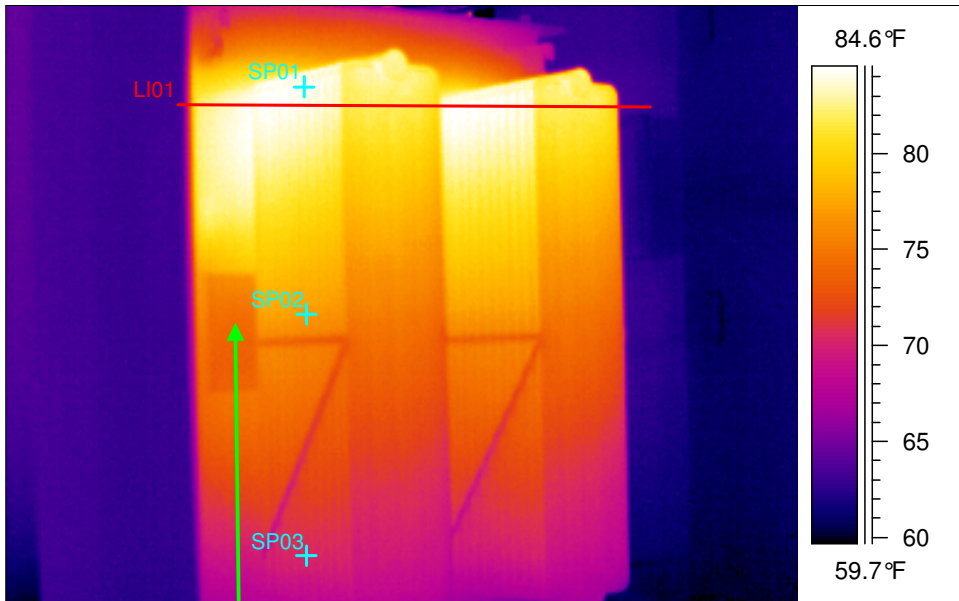
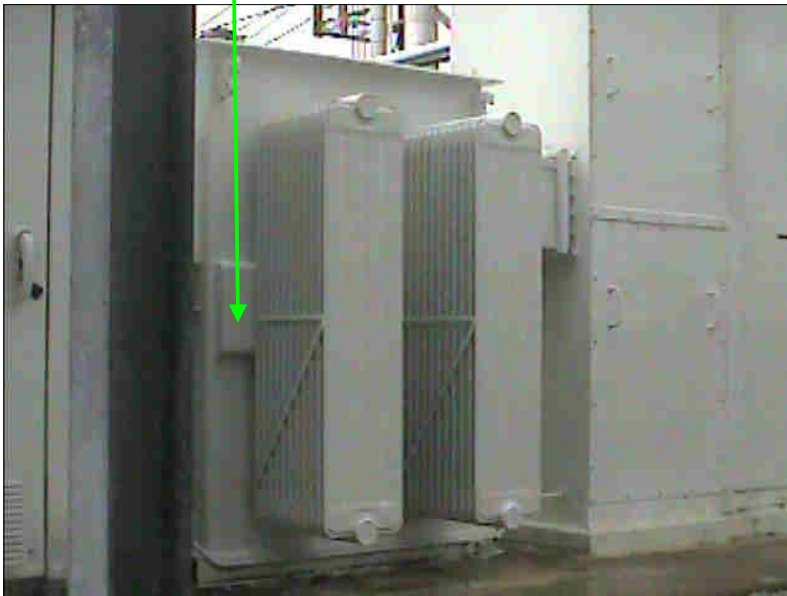
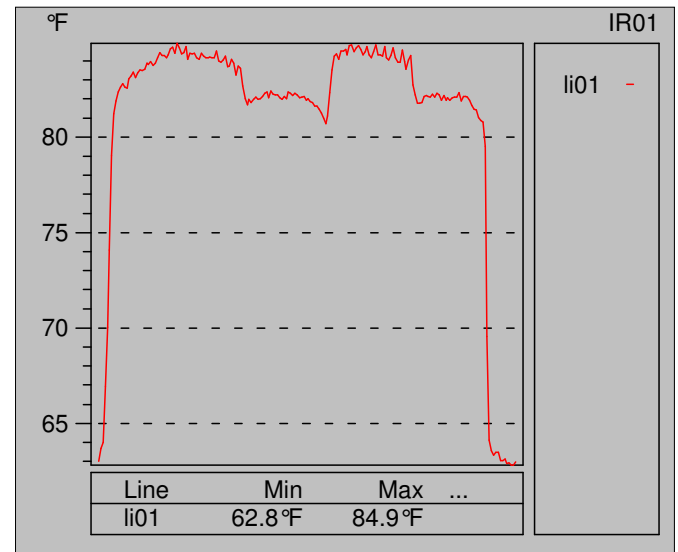
Component	Equipment/Bucket ID	Plant/Area	Date
North Radiator	Transformer 252A	NaCN	10-29-19

Label	Value
IR : max	85.0°F
IR : min	55.7°F
SP01	84.5°F
SP02	77.1°F
SP03	70.5°F
LI01 : max	84.9°F
LI01 : min	62.8°F

Fault	None
Defect Rating	NA

Unit appears to be operating normally. Check oil level just as a precaution.

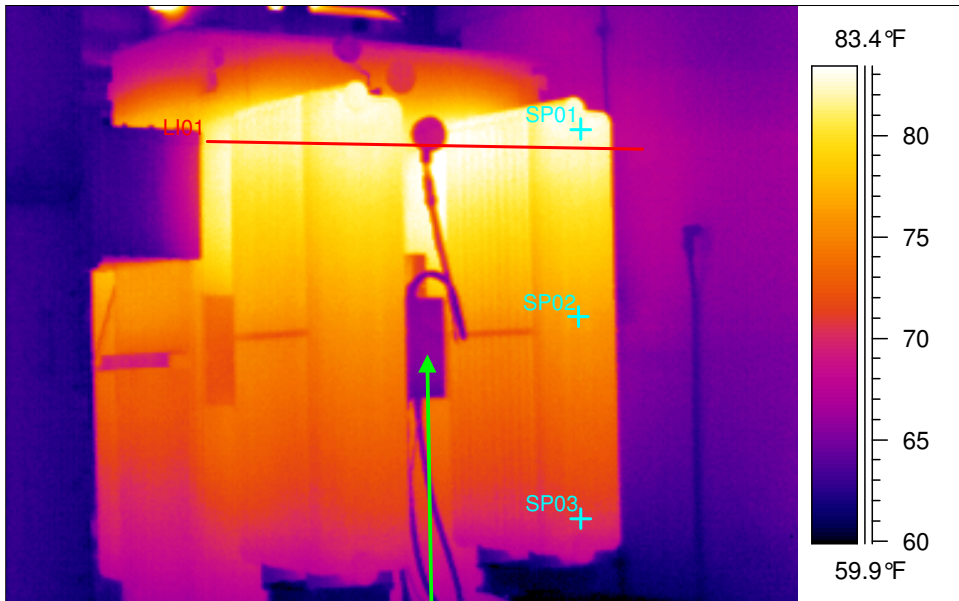
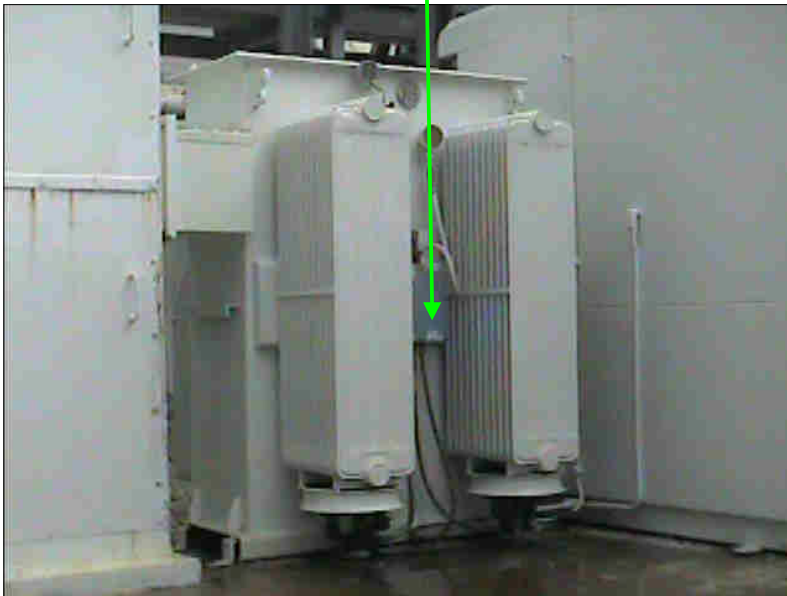
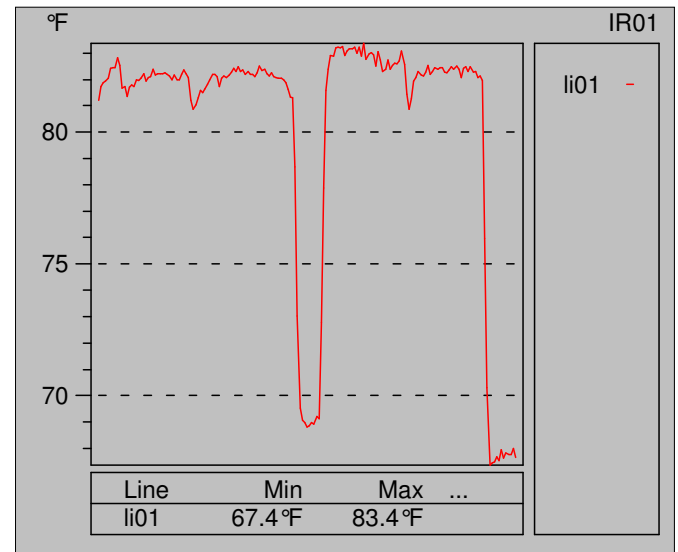
Component	Equipment/Bucket ID	Plant/Area	Date
South Radiator	Transformer 252A	NaCN	10-29-19

Label	Value
IR : max	112.9°F
IR : min	58.7°F
SP01	83.1°F
SP02	76.5°F
SP03	70.6°F
LI01 : max	83.4°F
LI01 : min	67.4°F

Fault	None
Defect Rating	NA

Unit appears to be operating normally. Check oil level just as a precaution.

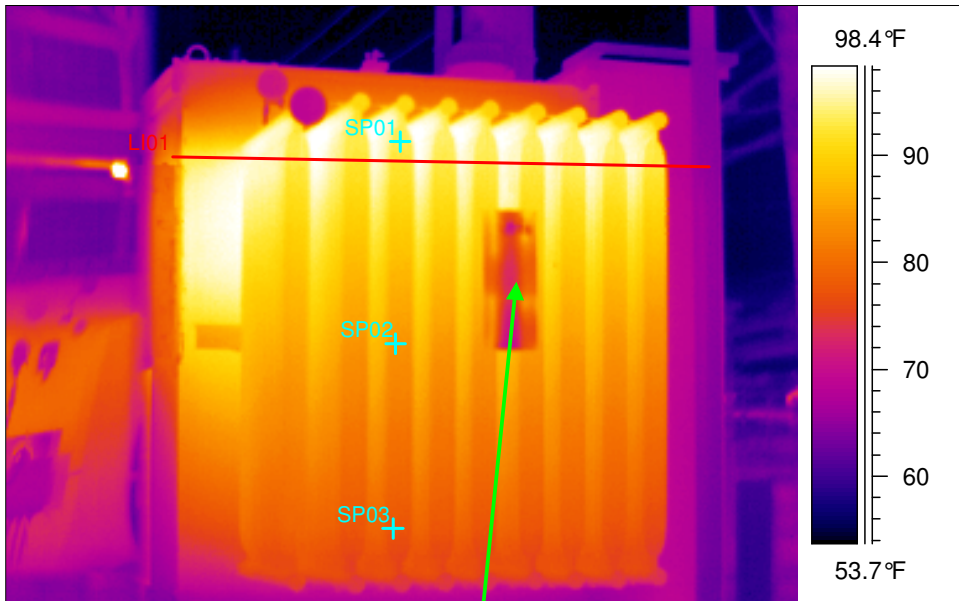
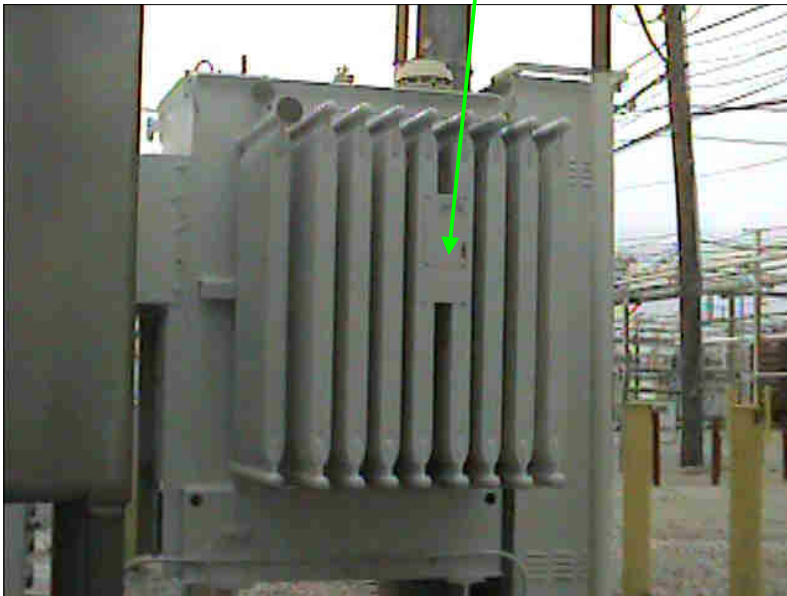
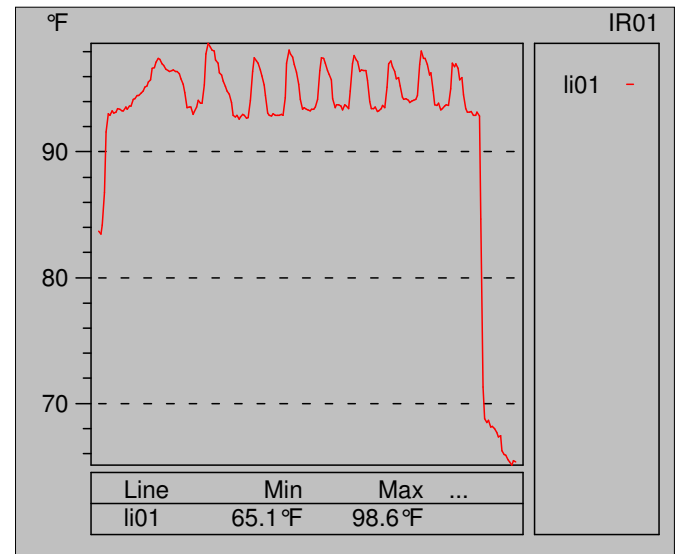
Component	Equipment/Bucket ID	Plant/Area	Date
North Radiator	Transformer 252B	NaCN	10-29-19

Label	Value
IR : max	120.9°F
IR : min	53.2°F
SP01	93.8°F
SP02	84.3°F
SP03	77.6°F
LI01 : max	98.6°F
LI01 : min	65.1°F

Fault	None
Defect Rating	NA

Unit appears to be operating normally. Check oil level as a precaution.

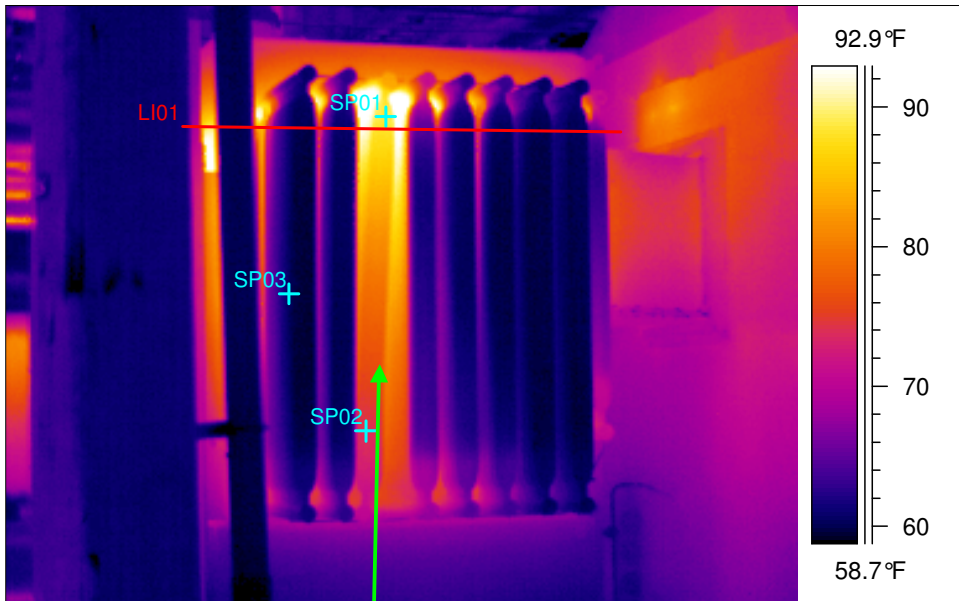
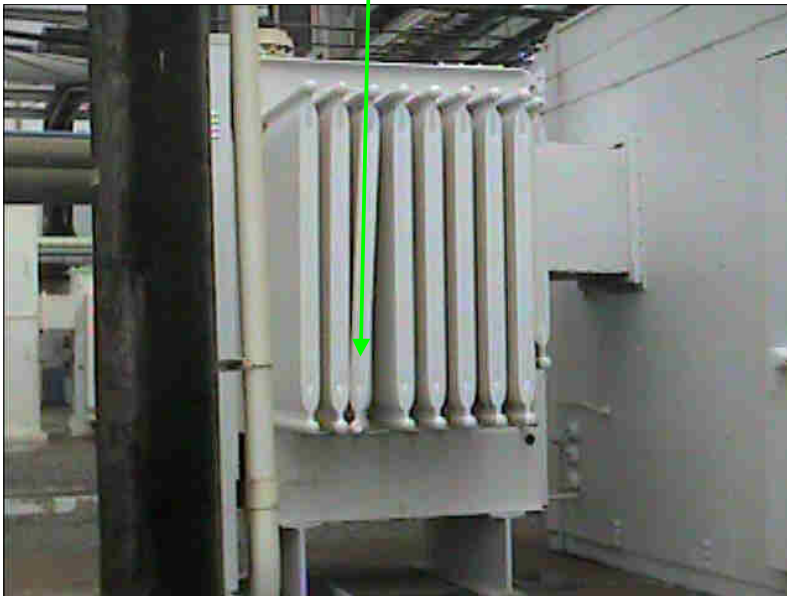
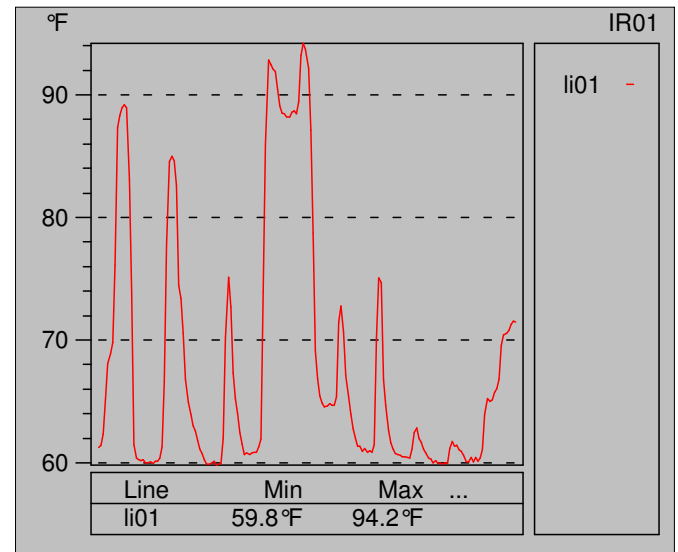
Component	Equipment/Bucket ID	Plant/Area	Date
South Radiator	Transformer 252B	NaCN	10-29-19

Label	Value
IR : max	97.2°F
IR : min	55.6°F
SP01	89.1°F
SP02	74.2°F
SP03	60.4°F
LI01 : max	94.2°F
LI01 : min	59.8°F

Fault	Blocked fins or low oil level and mechanical damage
Defect Rating	Class II

The South radiator appears to have contact damage as well as either plugged cooling fins, or low oil level, preventing convection flow.

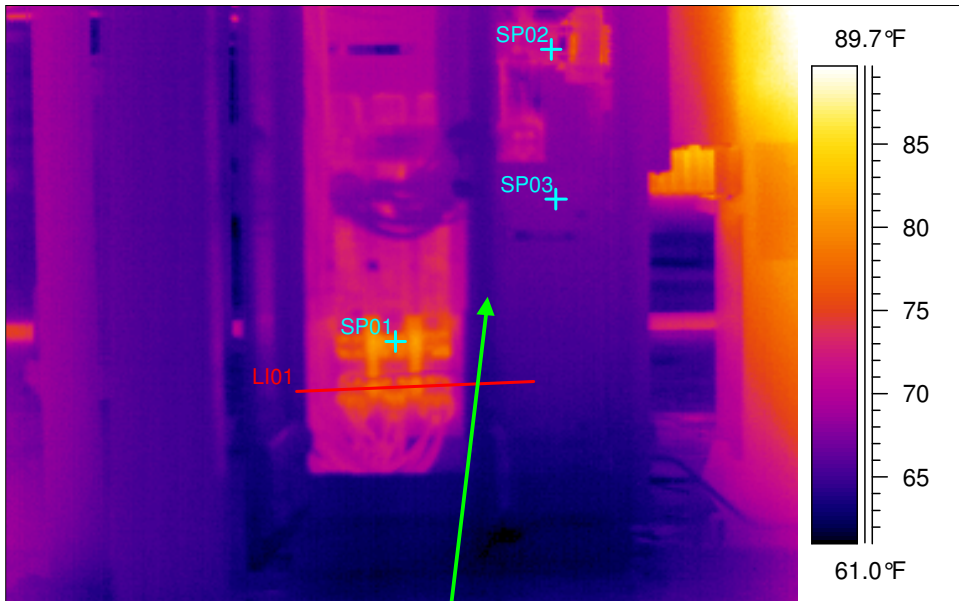
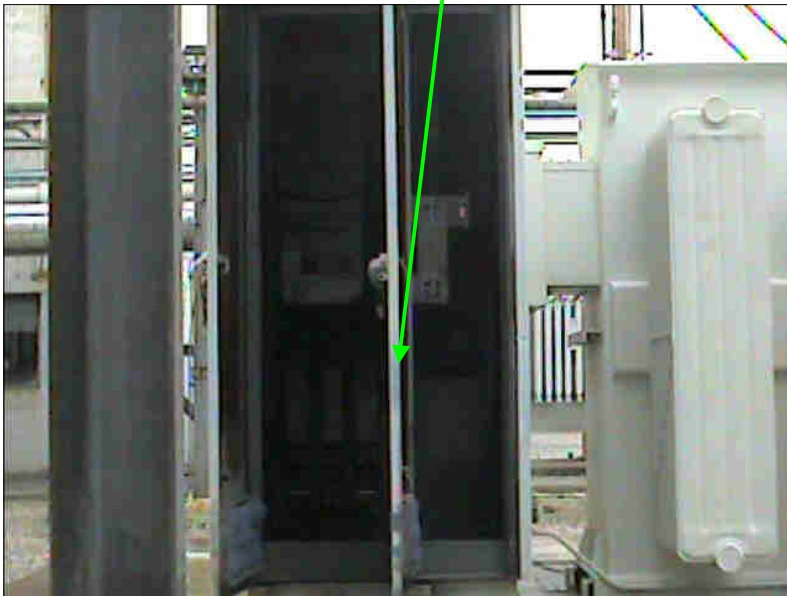
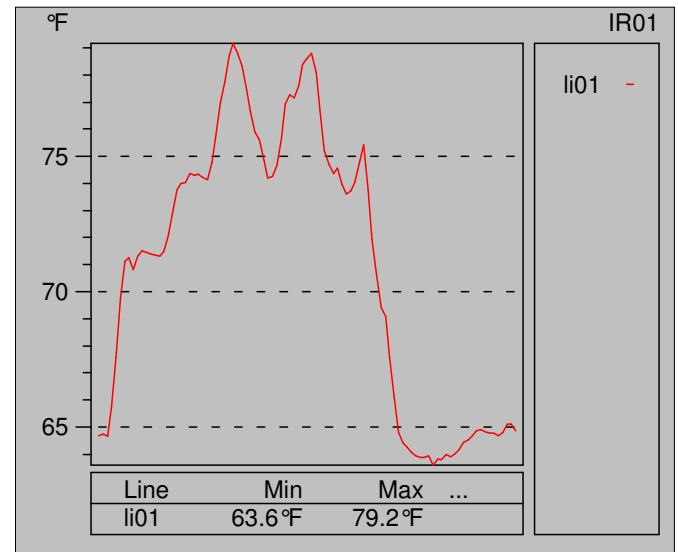
Component	Equipment/Bucket ID	Plant/Area	Date
Load Side	Transformer 252A	NaCN	10-29-19

Label	Value
IR : max	90.1°F
IR : min	60.9°F
SP01	79.0°F
SP02	71.7°F
SP03	67.6°F
LI01 : max	79.2°F
LI01 : min	63.6°F

Fault	None
Defect Rating	NA

No Immediate issues.

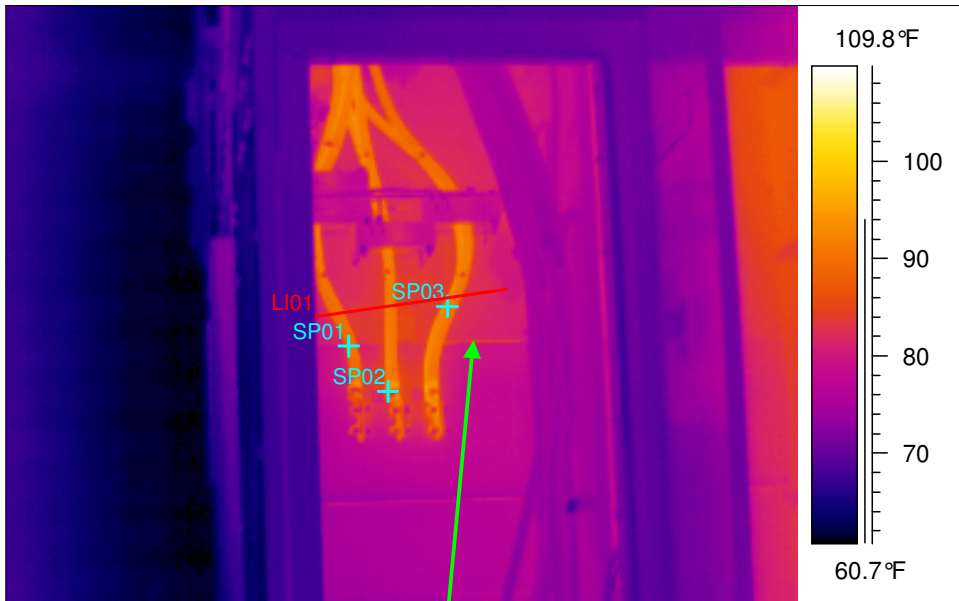
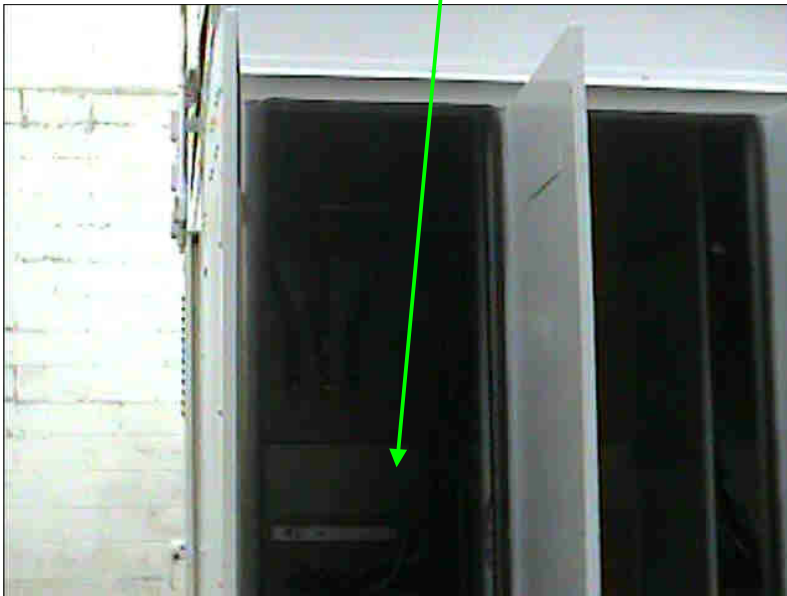
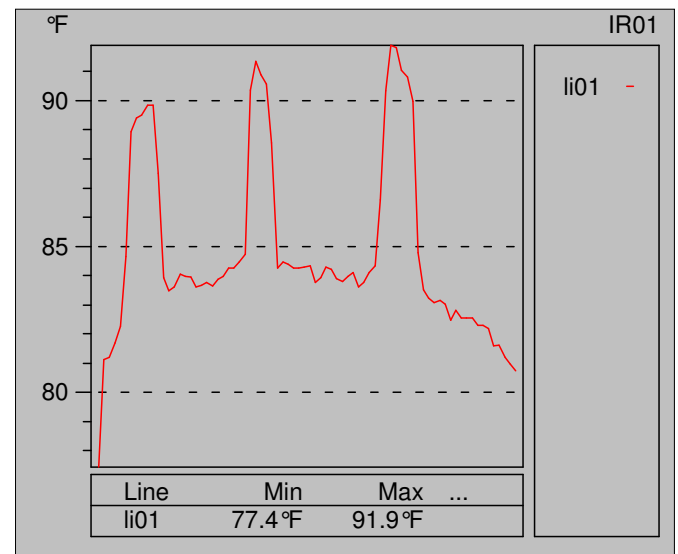
Component	Equipment/Bucket ID	Plant/Area	Date
Load Side Left Panel	Transformer 252B	NaCN	10-29-19

Label	Value
IR : max	94.9°F
IR : min	60.6°F
SP01	90.0°F
SP02	91.7°F
SP03	91.7°F
LI01 : max	91.9°F
LI01 : min	77.4°F

Fault	None
Defect Rating	NA

No immediate issues.

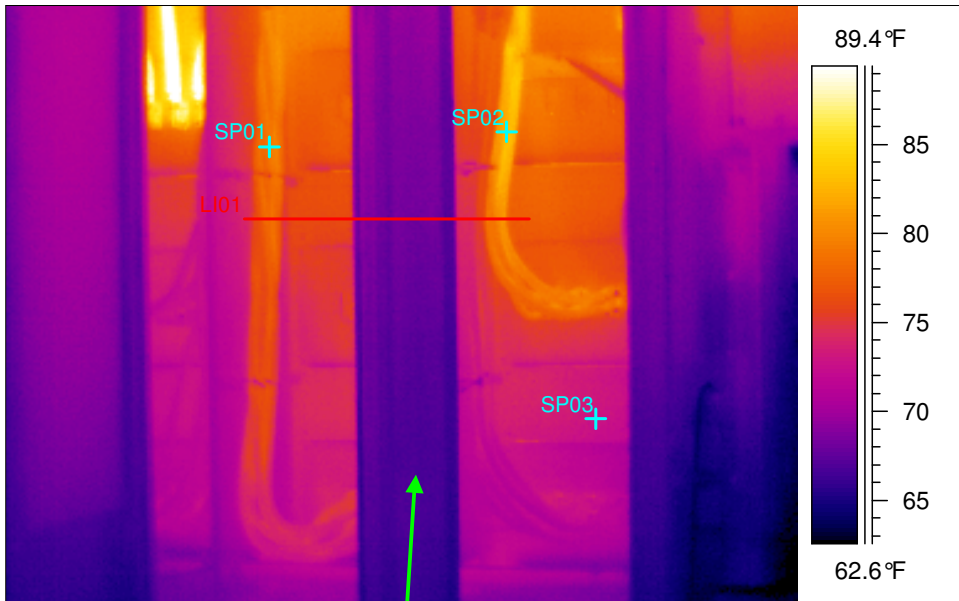
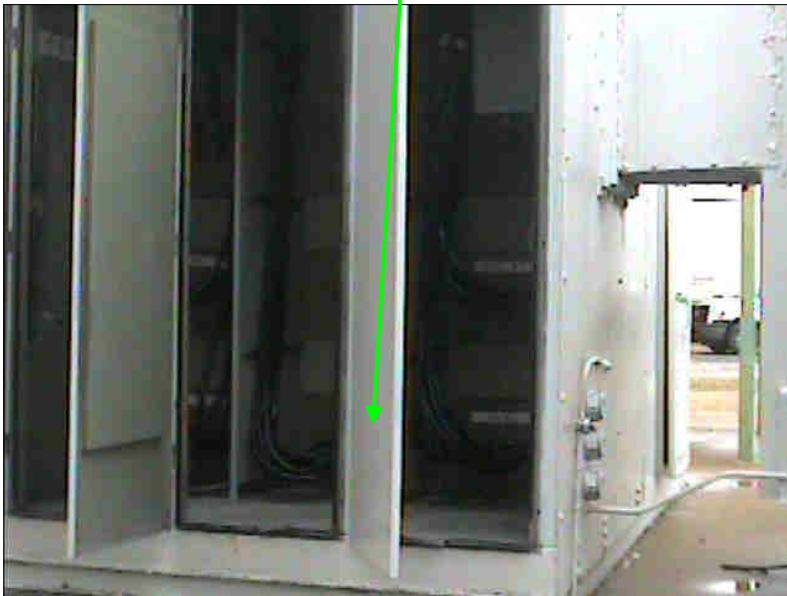
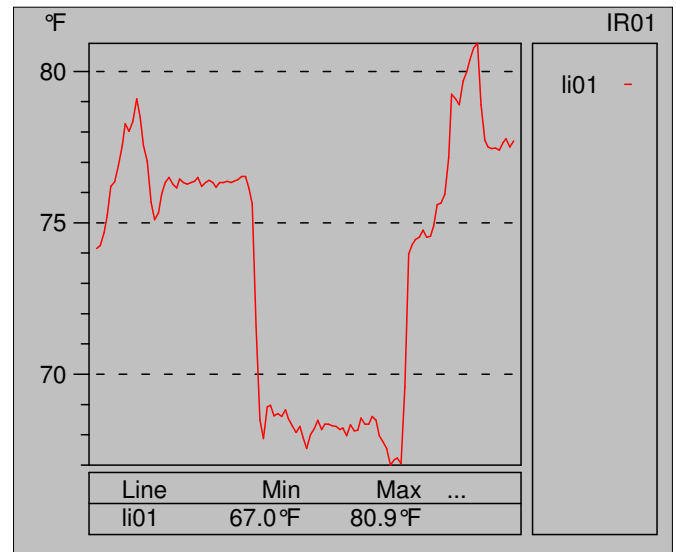
Component	Equipment/Bucket ID	Plant/Area	Date
Load Side Center/Right	Transformer 252B	NaCN	10-29-19

Label	Value
IR : max	92.9°F
IR : min	61.3°F
SP01	79.0°F
SP02	83.0°F
SP03	73.0°F
LI01 : max	80.9°F
LI01 : min	67.0°F

Fault	None
Defect Rating	NA

No immediate issues.
