# QualiTest IR Radiometric Survey Report

Chemours  
Power House, wells and sub stations

| Job Number | 141217 |
| Survey Date | 11/18-20/19 |

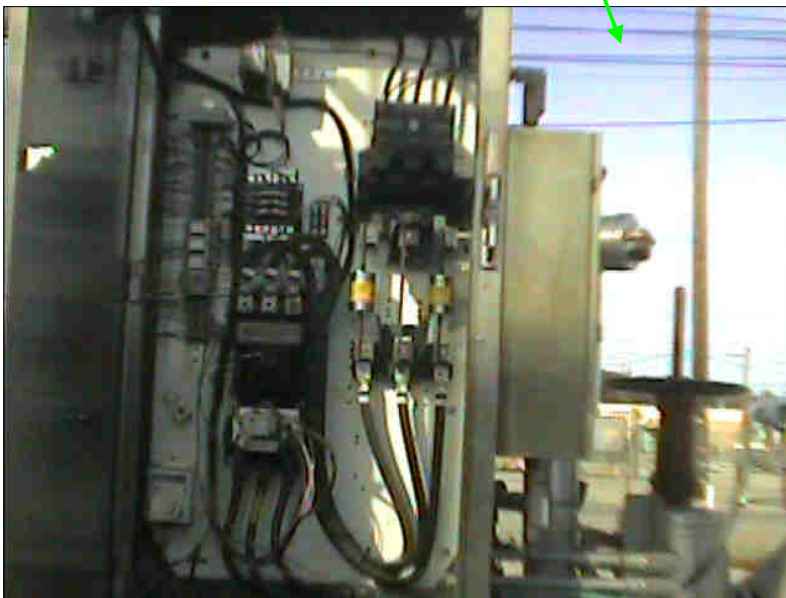
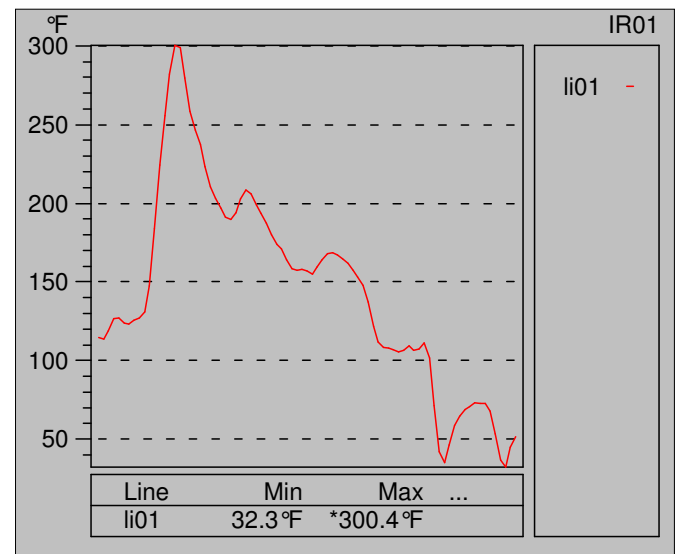
| Component | Equipment/Bucket ID | Plant/Area | Date |
|---|---|---|---|
| Main Switch | Well Pump 1 | Chemours | 11-18-19 |

| Label | Value |
|---|---|
| IR : max | *301.8°F |
| SP01 | *300.4°F |

| <b>Fault</b> | Poor connection at switch |
| <b>Defect Rating</b> | Class III |

The unit should be inspected ASAP. A phase is showing a very large temperature delta compared to the other phases. Clean and inspect, repair or replace as required.

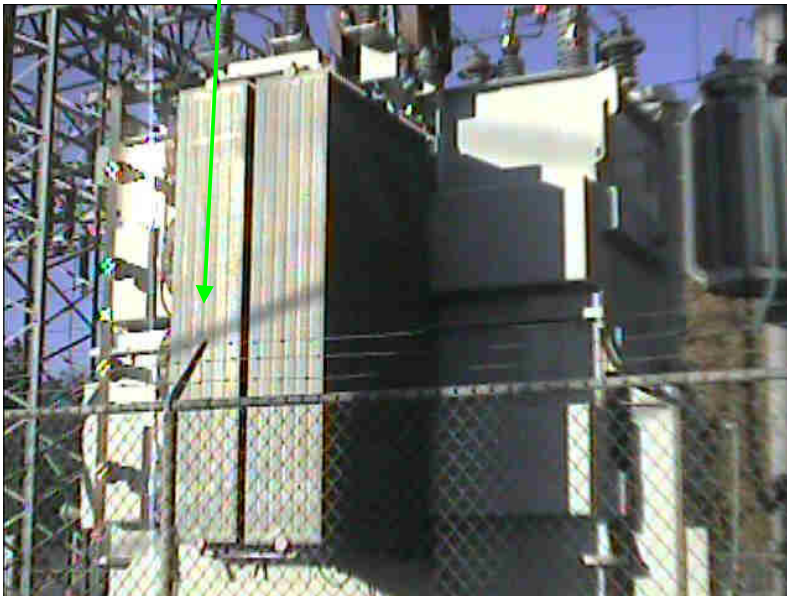
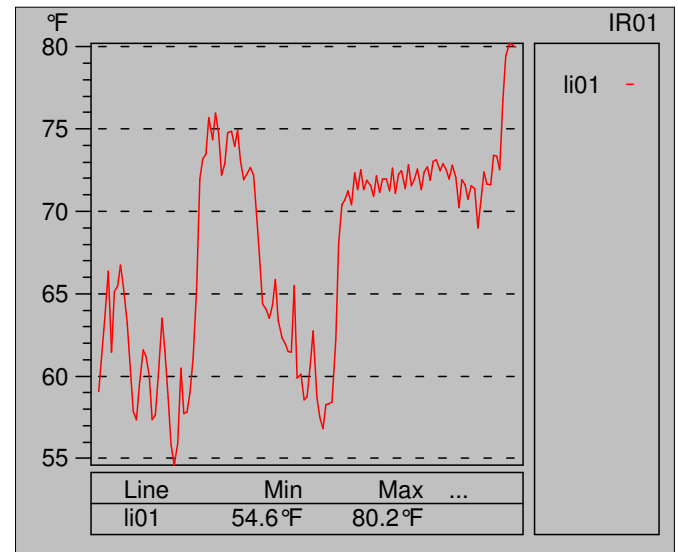
| Component | Equipment/Bucket ID | Plant/Area | Date |
|---|---|---|---|
| Middle Transformer | 4157 | Main Substation 24 | 11-19-19 |

| <b>Fault</b> | Possible cooling flow issue |
| <b>Defect Rating</b> | Class I |

Check oil level

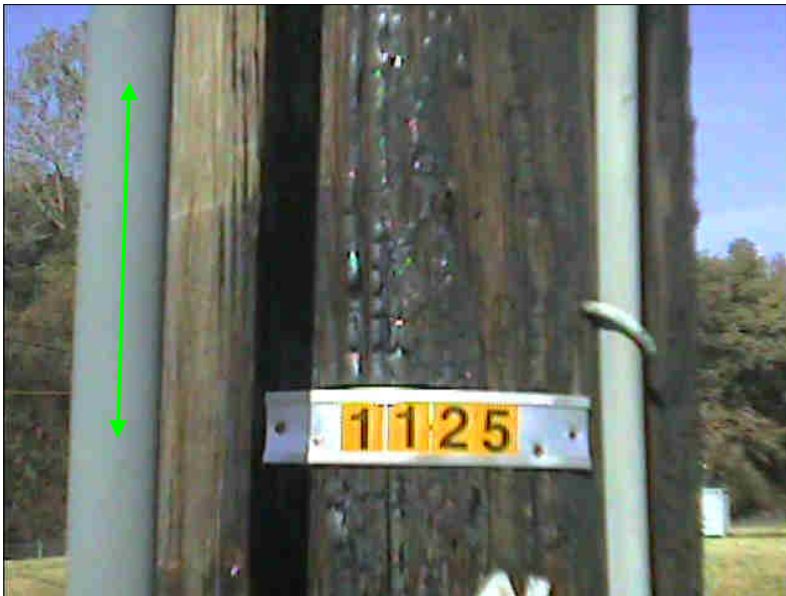
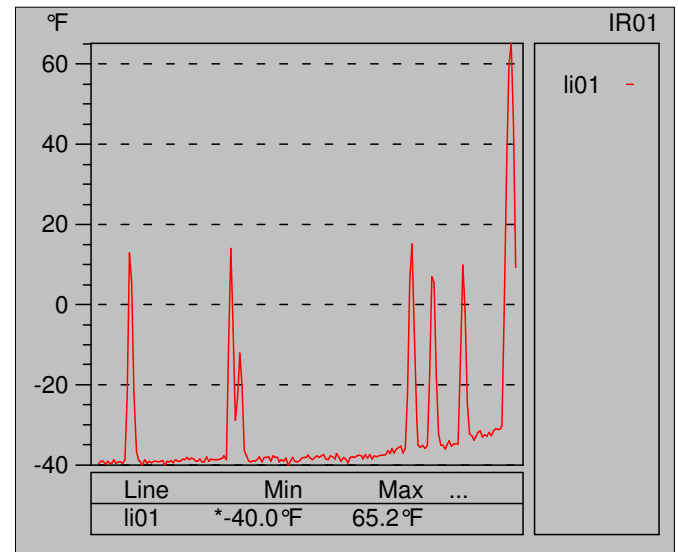
| Component | Equipment/Bucket ID | Plant/Area | Date |
|---|---|---|---|
| Connection | Pole 1125 | Chemours | 11-19-19 |

| <b>Fault</b> | Slight connection issue |
| <b>Defect Rating</b> | Class I |

Check top Line connectors.

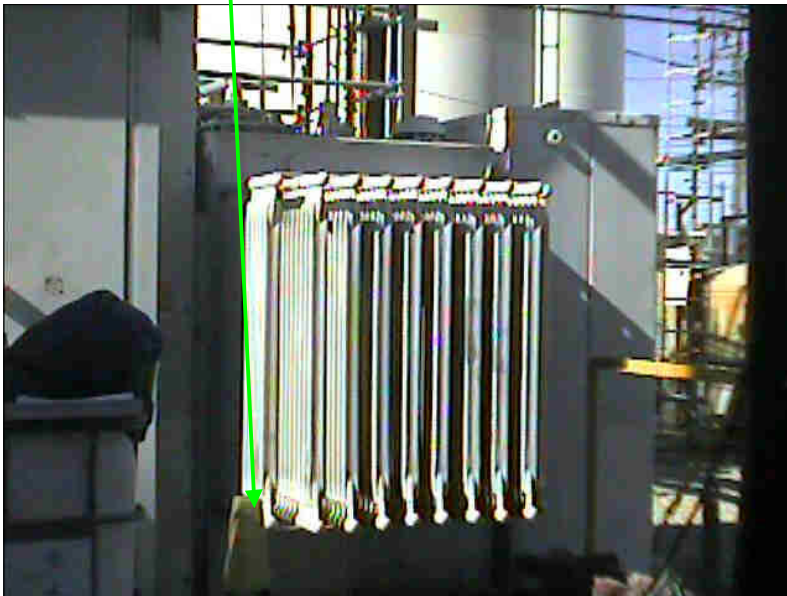
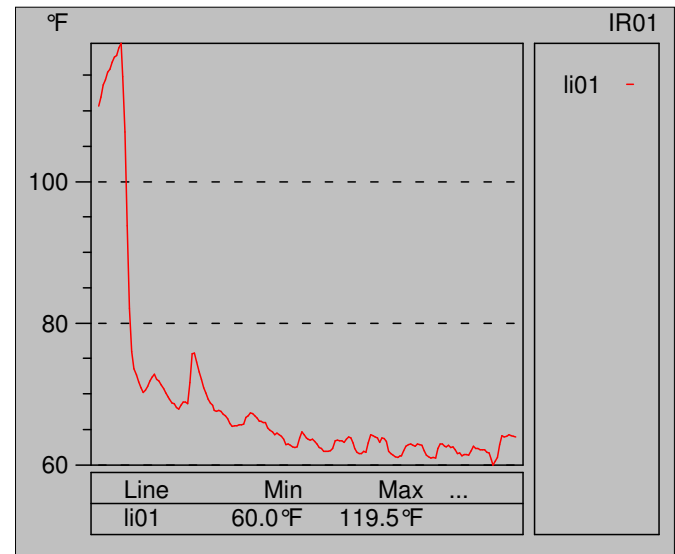
| Component | Equipment/Bucket ID | Plant/Area | Date |
|---|---|---|---|
| East Radiator | SUB 249A | Chemours | 11-19-19 |

| <b>Fault</b> | Cooling issue |
| <b>Defect Rating</b> | Class II |

Non-working radiator. Inspect in near future. Check oil level, valves, and associated controls if equipped. Fins could be plugged.

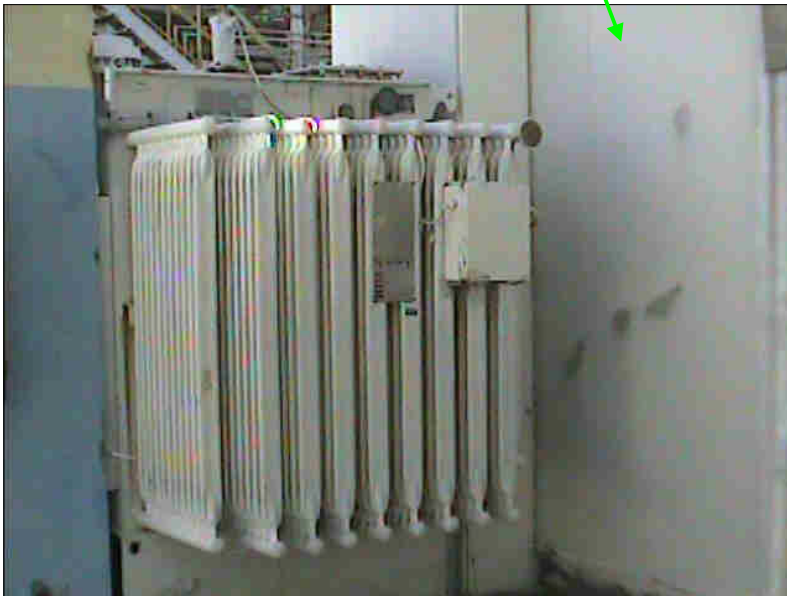
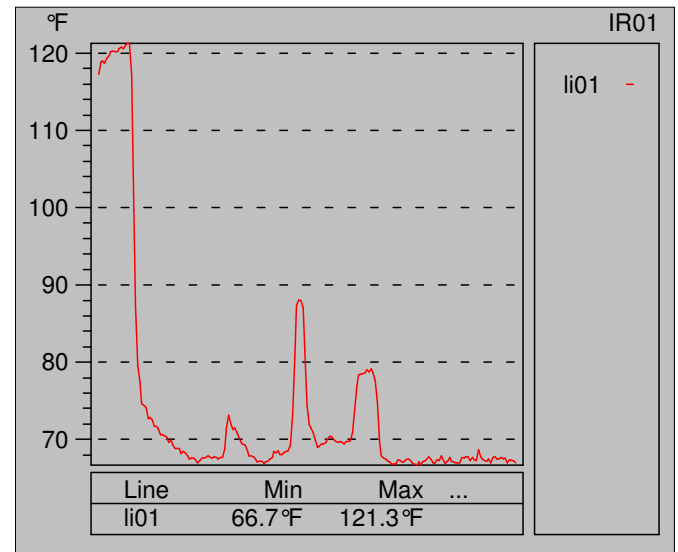
| Component | Equipment/Bucket ID | Plant/Area | Date |
|---|---|---|---|
| West Radiator | SUB 249A | Chemours | 11-19-19 |

| <b>Fault</b> | Cooling issues. |
| <b>Defect Rating</b> | Class II |

Multiple possible issues. Check for proper oil level and and plugges fins in the near future.

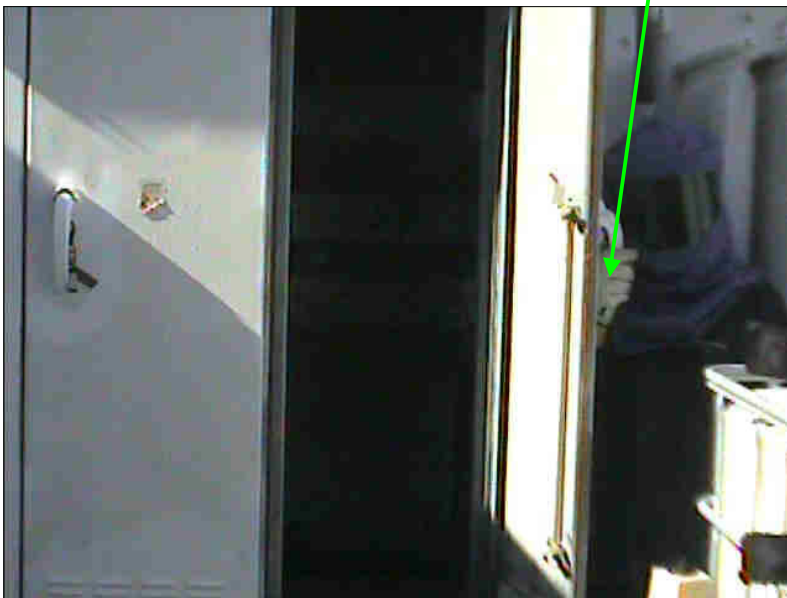
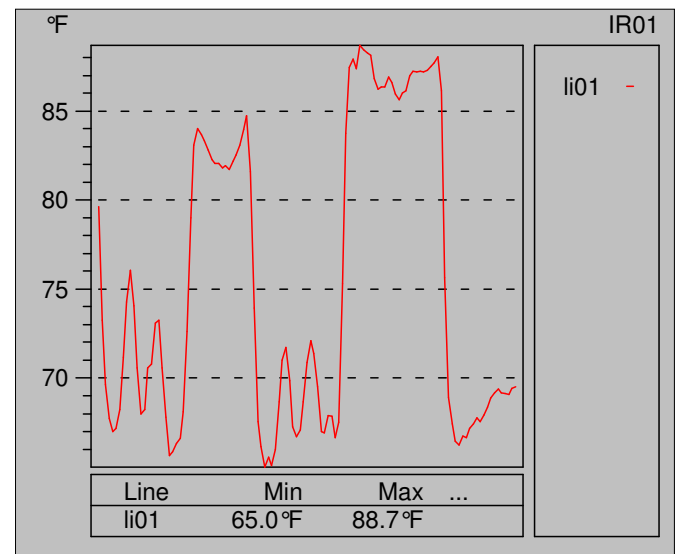
| Component | Equipment/Bucket ID | Plant/Area | Date |
|---|---|---|---|
| Right Panel | SUB 249A | Chemours | 11-19-19 |

Note:  
Hot spot is heater.

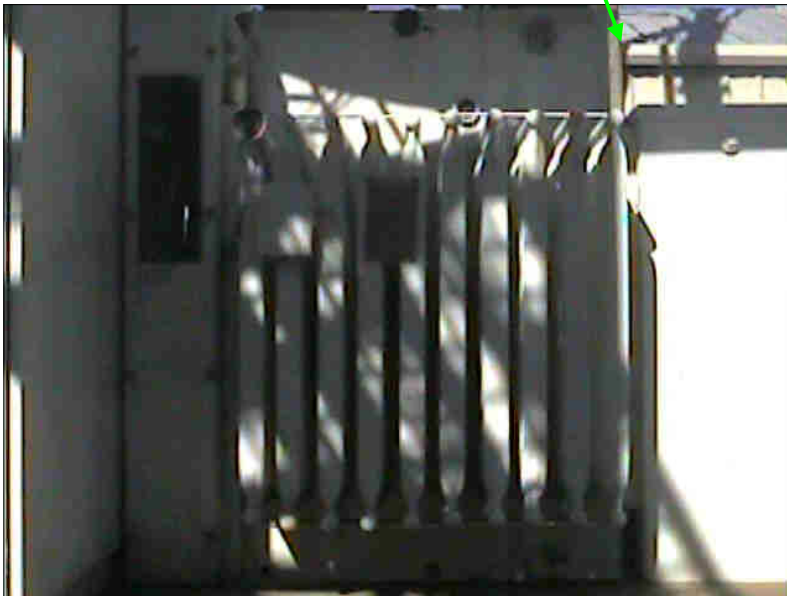
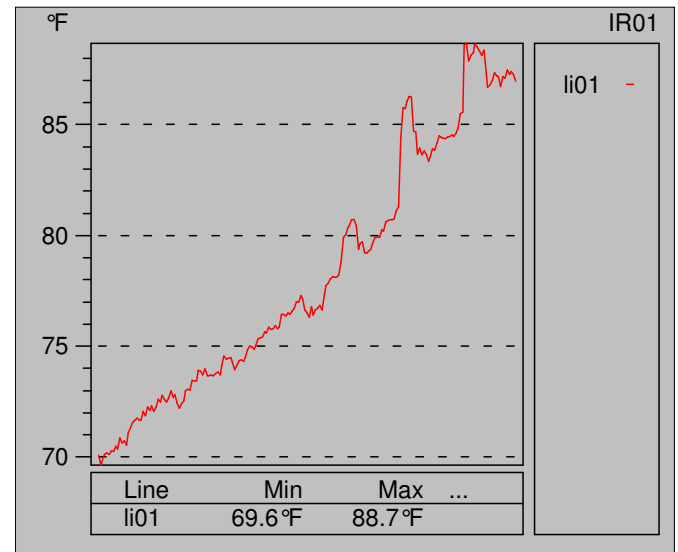
| Component | Equipment/Bucket ID | Plant/Area | Date |
|---|---|---|---|
| South Radiator | SUB 249C | Chemours | 11-19-19 |

| <b>Fault</b> | Slight variation in cooling fins |
| <b>Defect Rating</b> | none |

Check oil level for now.

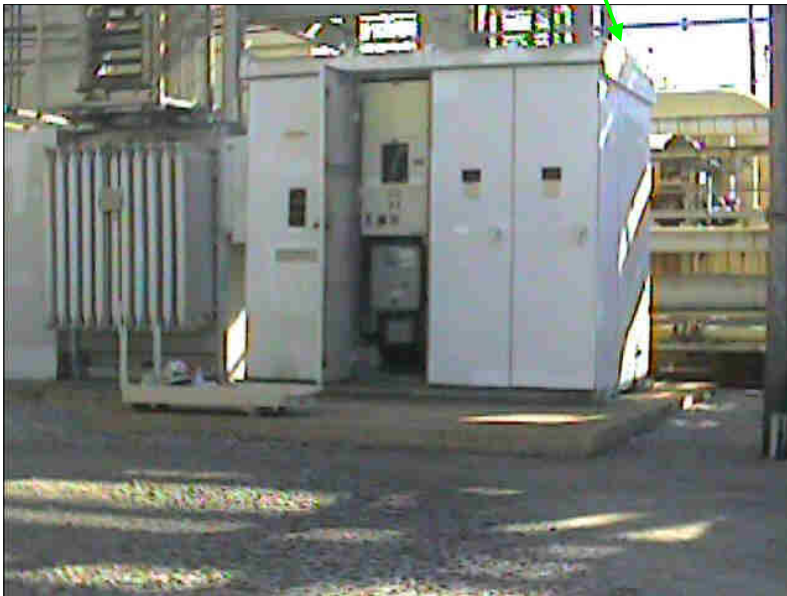
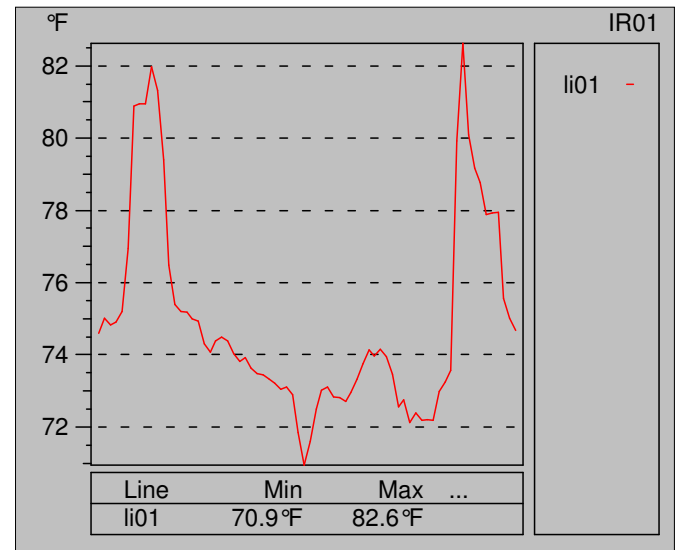
| Component | Equipment/Bucket ID | Plant/Area | Date |
|---|---|---|---|
| Left Center Panel | SUB 249D | Chemours | 11-19-19 |

Heater is the hot spot

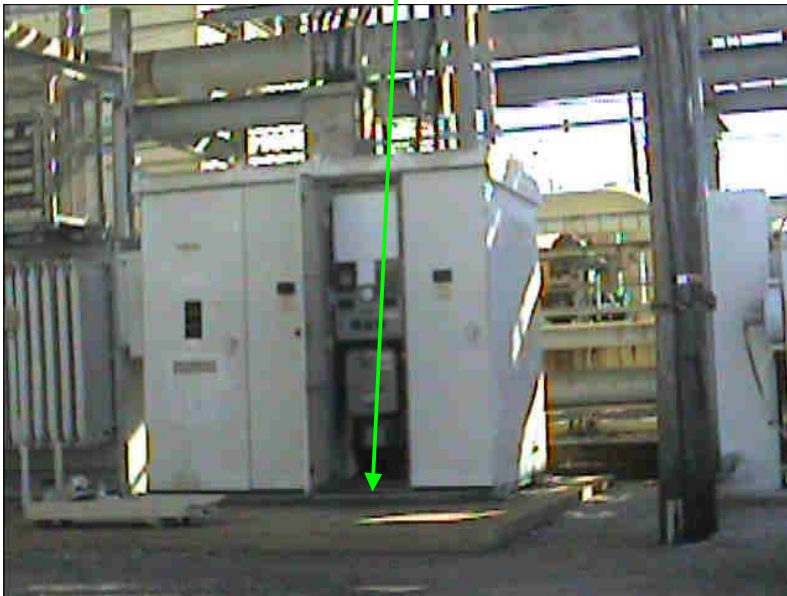
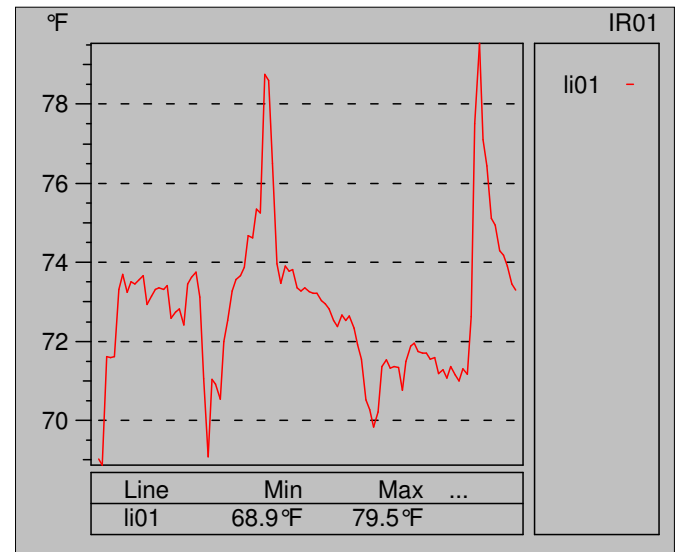
| Component | Equipment/Bucket ID | Plant/Area | Date |
|---|---|---|---|
| Right Center Panel | SUB 249D | Chemours | 11-19-19 |

Hot spot is the panel heater.

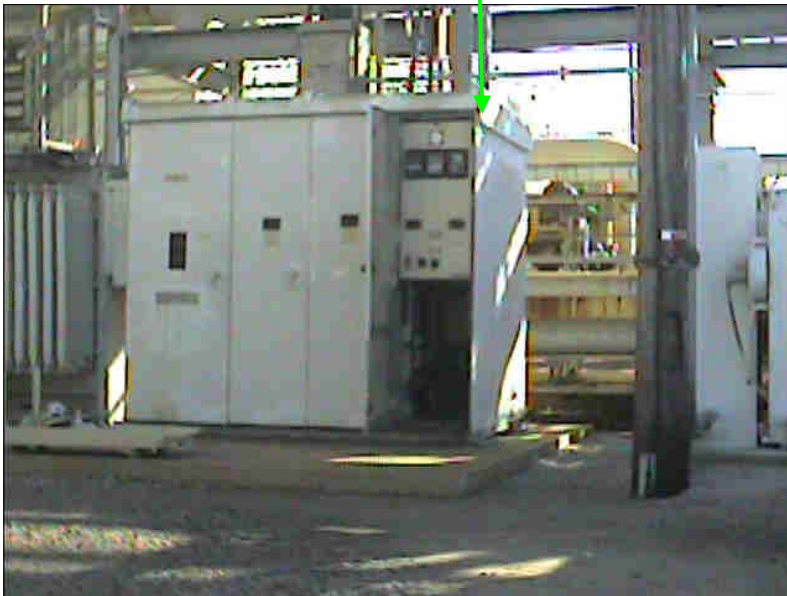
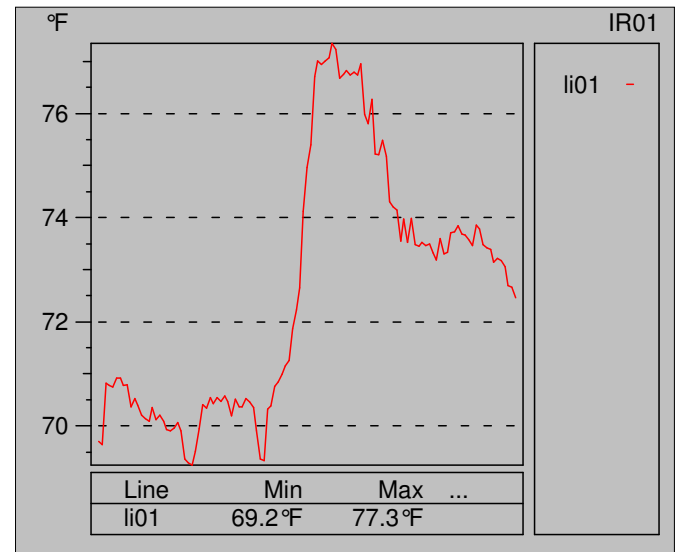
| Component | Equipment/Bucket ID | Plant/Area | Date |
|---|---|---|---|
| Right Panel | SUB 249D | Chemours | 11-19-19 |

Hot spot is the panel heater.

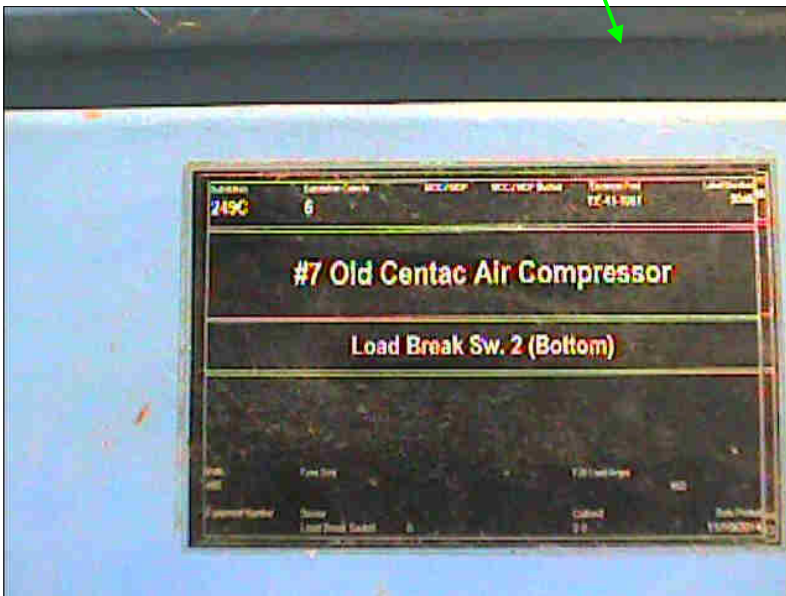
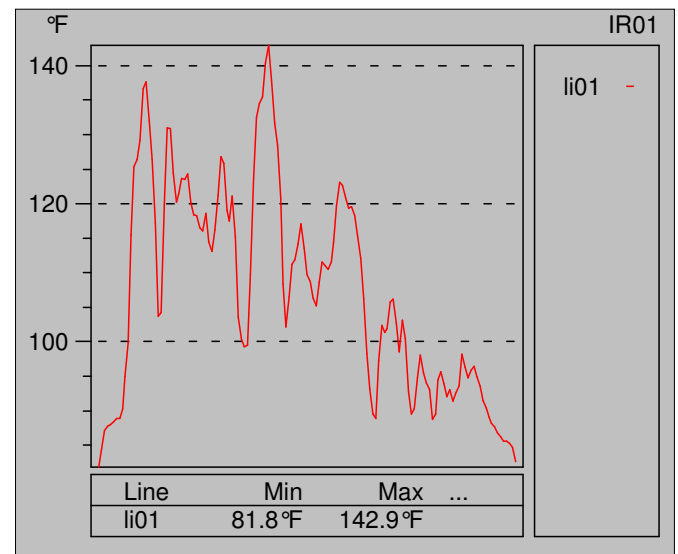
| Component | Equipment/Bucket ID | Plant/Area | Date |
|---|---|---|---|
| Switch Contacts | Load Break Switch 2 | Chemours | 11-19-19 |

| <b>Fault</b> | Temperature delta at switch contacts. |
| <b>Defect Rating</b> | Class I |

Inspect and Clean, repair or replace switch.

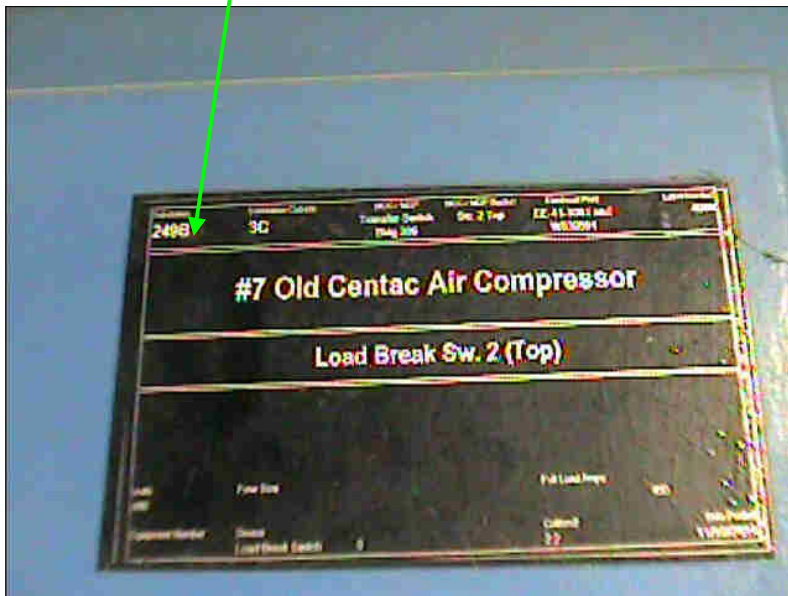
| Component | Equipment/Bucket ID | Plant/Area | Date |
|---|---|---|---|
| A/B phase from bottom | Load Break Switch 2 | Chemours | 11-19-19 |

| <b>Fault</b> | Bottom switch issue |
| <b>Defect Rating</b> | See previous sheet on Bottom Switch |

This view is from the top switch showing localized thermal issue coming from the bottom switch on A and B phases.

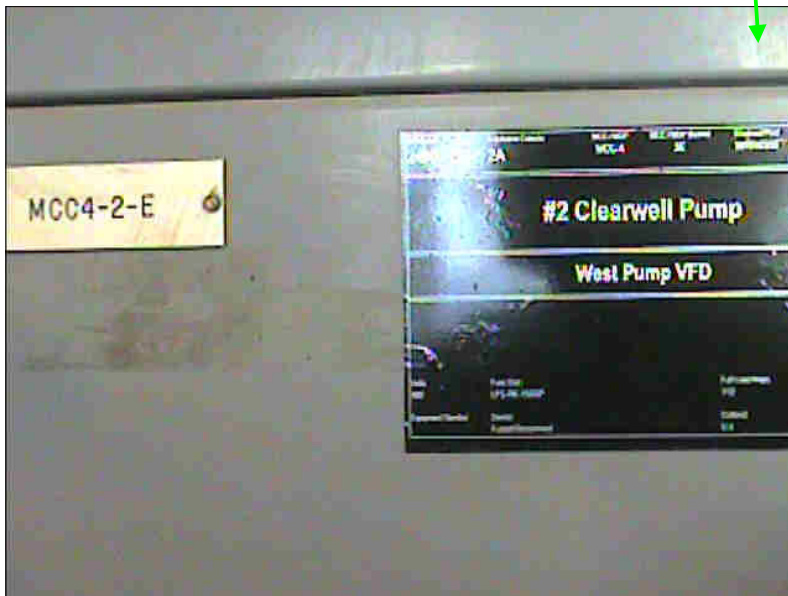
| Component | Equipment/Bucket ID | Plant/Area | Date |
|---|---|---|---|
| Switch/fuse clip | 2 E Clearwell Pump | MCC 4 | 11-20-19 |

| <b>Fault</b> | Poor connection at switch |
| <b>Defect Rating</b> | Class I |

The AC phase switch contact and/or fuse clip shows what looks to be a localized hot spot.  
Clean and inspect, repair or replace.

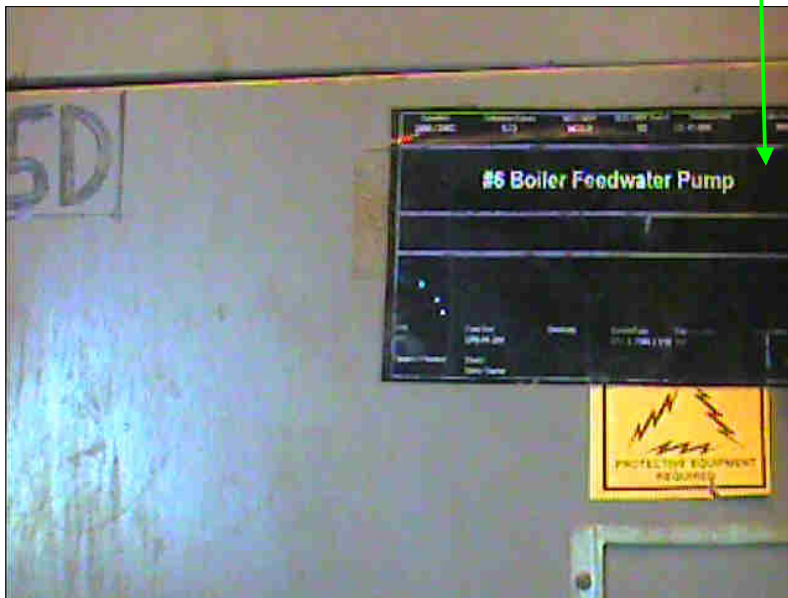
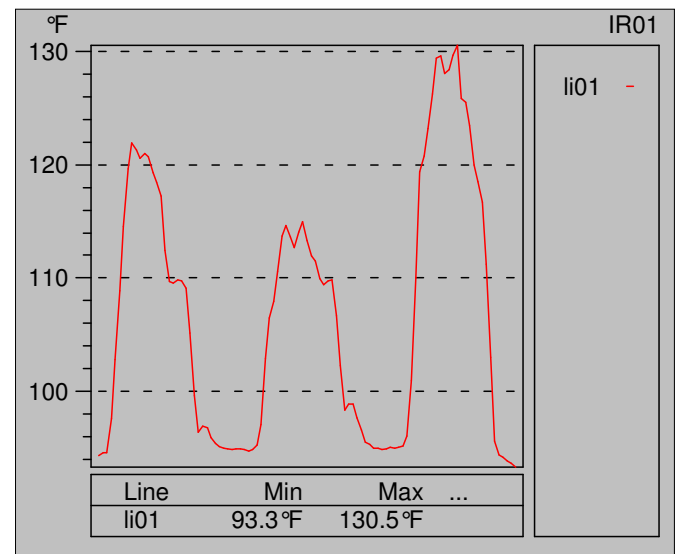
| Component | Equipment/Bucket ID | Plant/Area | Date |
|---|---|---|---|
| Switch | 5D #6 BFWP | MCC 2 | 11-20-19 |

| <b>Fault</b> | Poor connection at switch |
| <b>Defect Rating</b> | Class I |

Slight temperature delta at C phase switch contact suggests a poor connection.  
Clean and inspect, repair or replace.

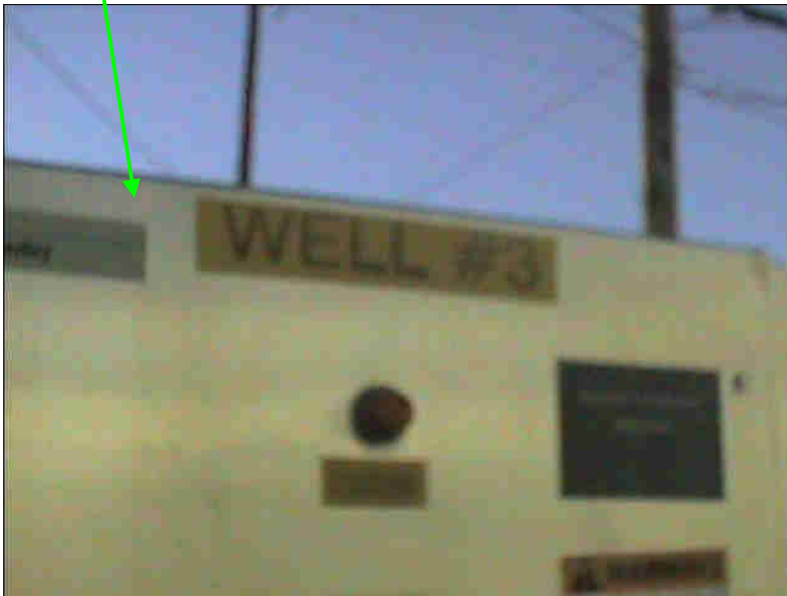
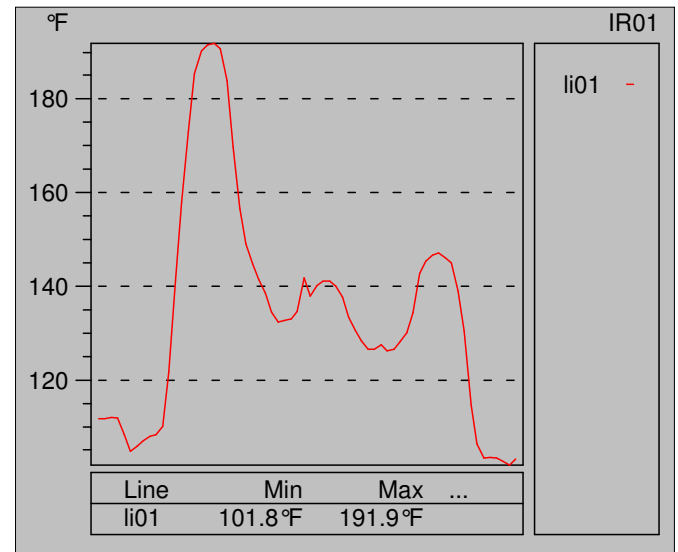
| Component | Equipment/Bucket ID | Plant/Area | Date |
|---|---|---|---|
| Switch | Well Pump 3 | Chemours | 11-20-19 |

| <b>Fault</b> | Poor connction at switch |
| <b>Defect Rating</b> | Class II |

The A phase shows a significant temperature delta. We believe the switch contacts are in poor condition. Clean and inspect, repair or replace.

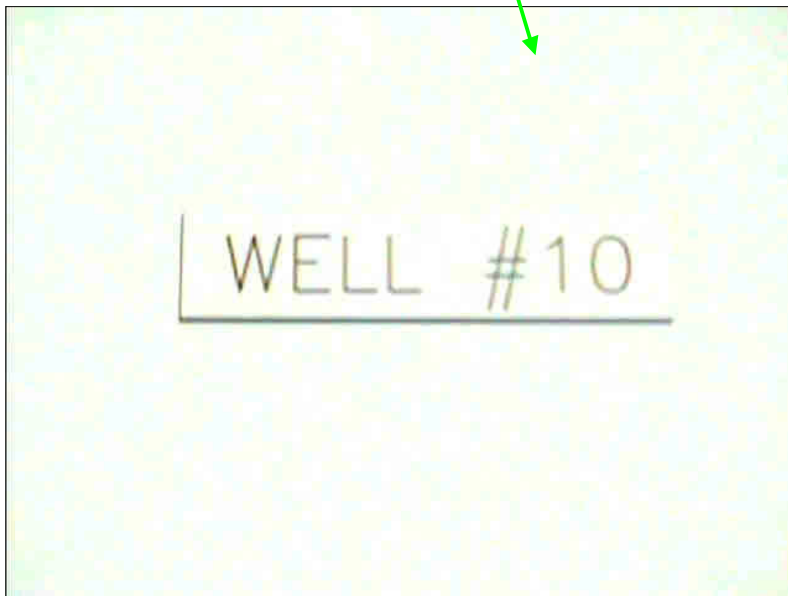
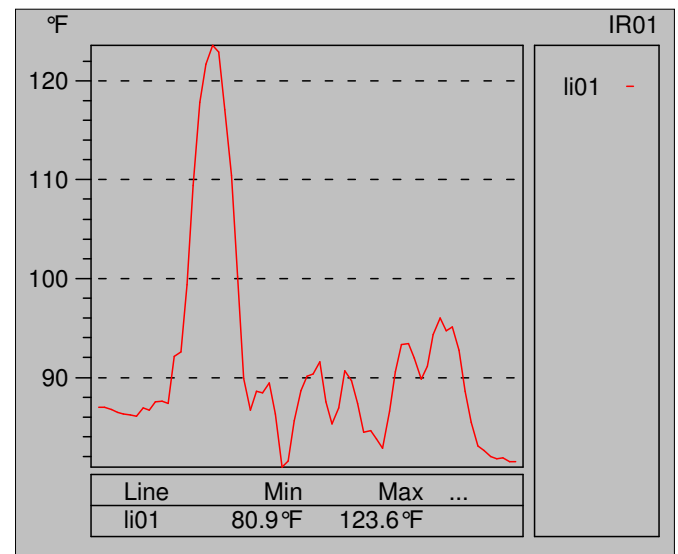
| Component | Equipment/Bucket ID | Plant/Area | Date |
|---|---|---|---|
| Switch conductors | Well Pump 10 | Chemours | 11-20-19 |

| <b>Fault</b> | SwitchConductor Connections |
| <b>Defect Rating</b> | Class I |

Temperature delta at or near the switch A phase. Check all connections, Clean and inspect, repair or replace.

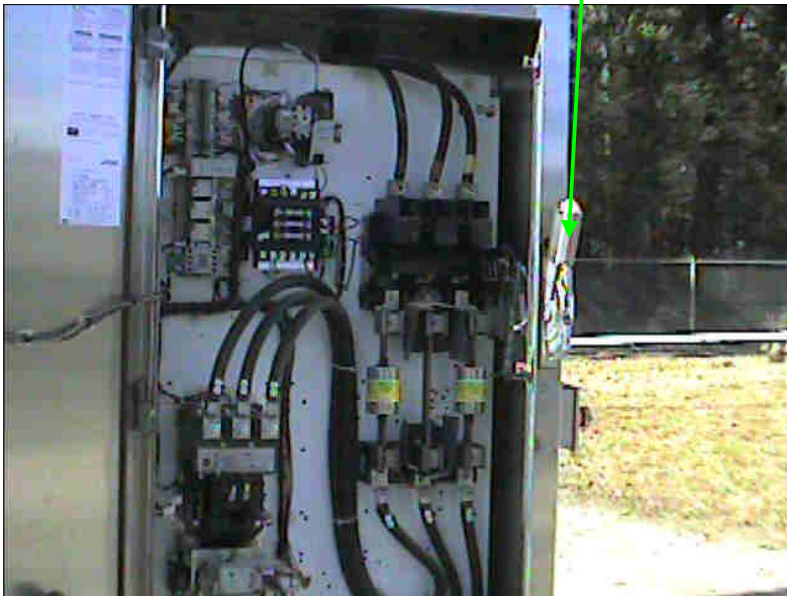
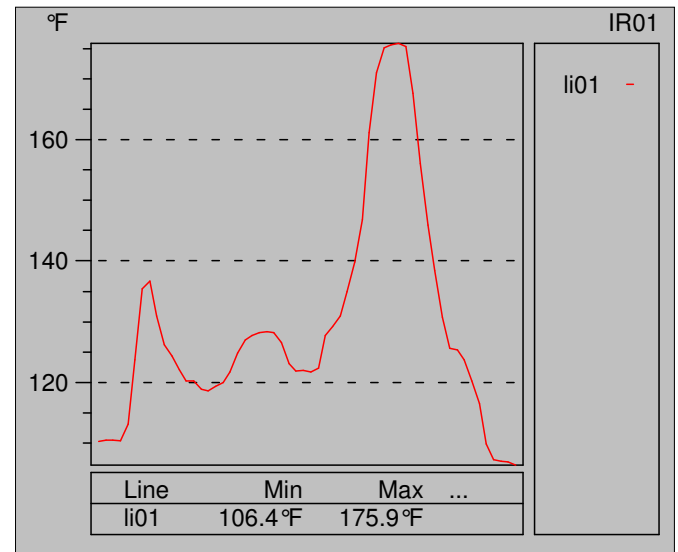
| Component | Equipment/Bucket ID | Plant/Area | Date |
|---|---|---|---|
| Switch | Well Pump 9 | Chemours | 11-20-19 |

| <b>Fault</b> | Poor switch connection |
| <b>Defect Rating</b> | Class II |

Unit shows temperature delta at switch C phase. We suspect a weak contact.  
Clean and inspect, repair or replace.
