# QualiTest IR Radiometric Survey Report

## Chemours Transformers

Job Number	141055
Survey Date	10-28-19
Report Date	10-28-19

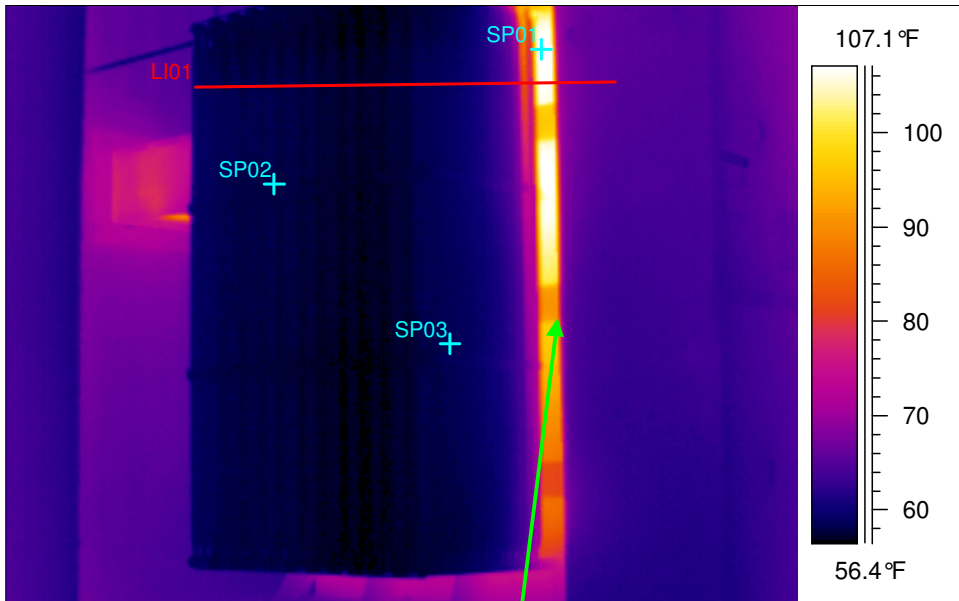
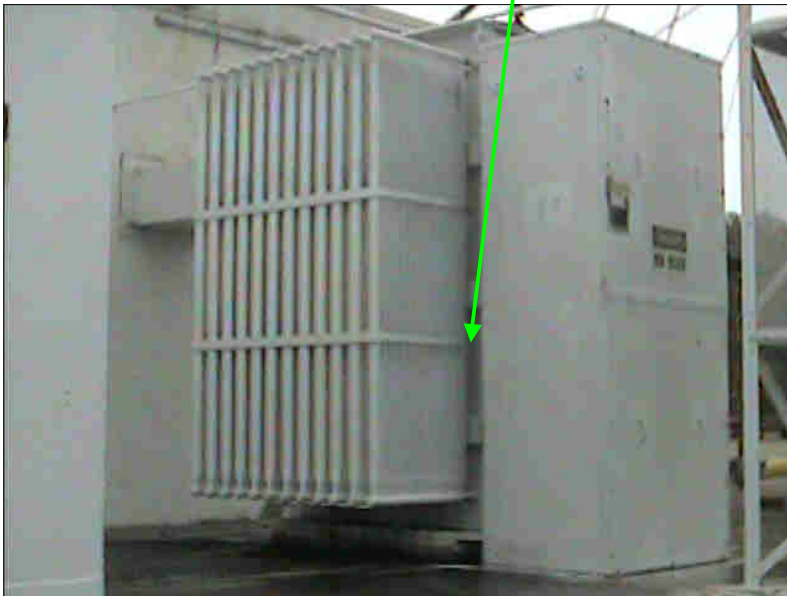
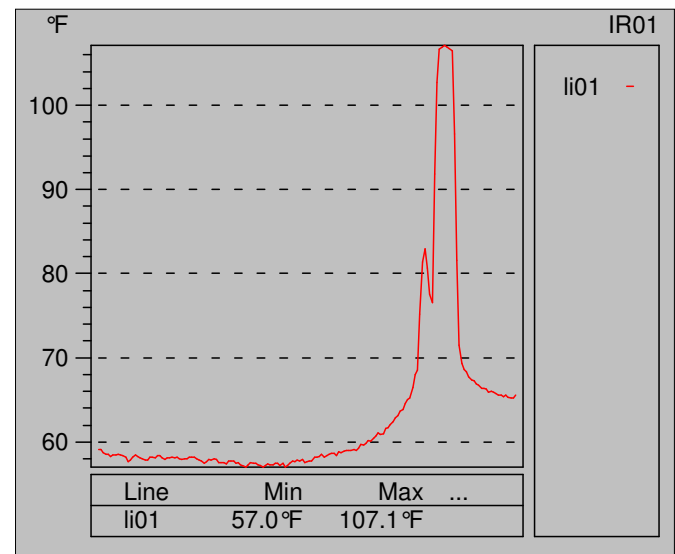
Component	Equipment/Bucket ID	Plant/Area	Date
Transformer	Sub E3 East Side	Chemours	10-28-19

Label	Value
IR : max	107.8°F
IR : min	56.4°F
SP01	107.6°F
SP02	57.9°F
SP03	58.4°F
LI01 : max	107.1°F
LI01 : min	57.0°F

<b>Fault</b>	No cooling
<b>Defect Rating</b>	Class III

East Radiator complete section is cold. Section could possibly be shut off manually, completely blocked or oil level is way too low. Recommend inspection ASAP to confirm status.

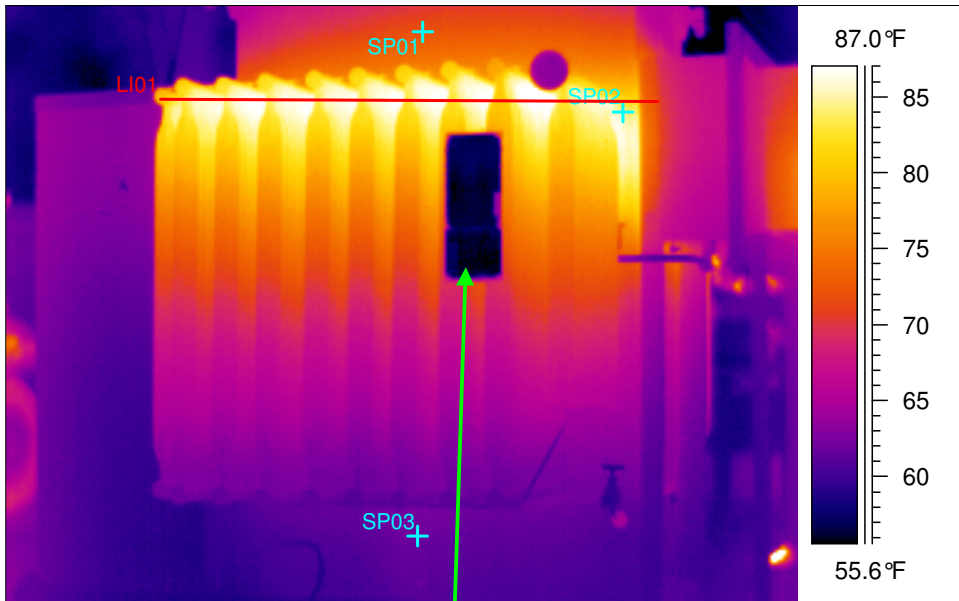
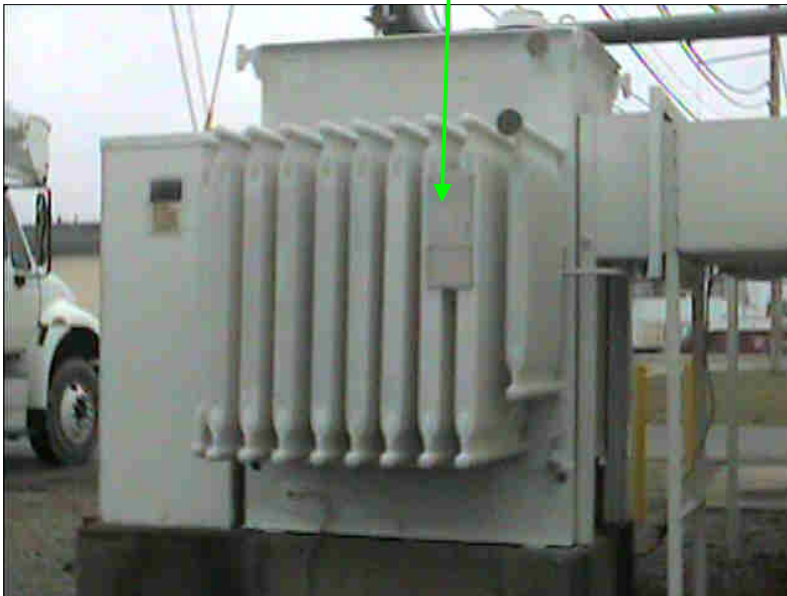
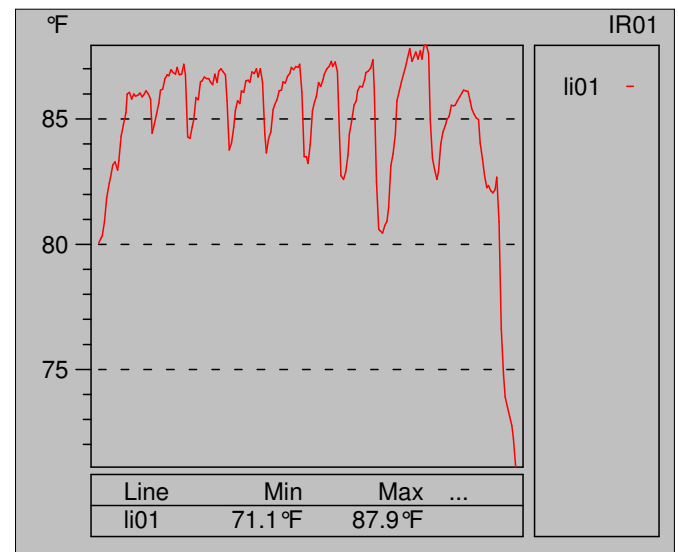
Component	Equipment/Bucket ID	Plant/Area	Date
Transformer	Sub E7 North Side	Chemours	10-28-19

Label	Value
IR : max	110.2°F
IR : min	54.7°F
SP01	72.2°F
SP02	84.5°F
SP03	62.0°F
LI01 : max	87.9°F
LI01 : min	71.1°F

<b>Fault</b>	None
<b>Defect Rating</b>	NA

Unit North radiator appears to be operating normally.

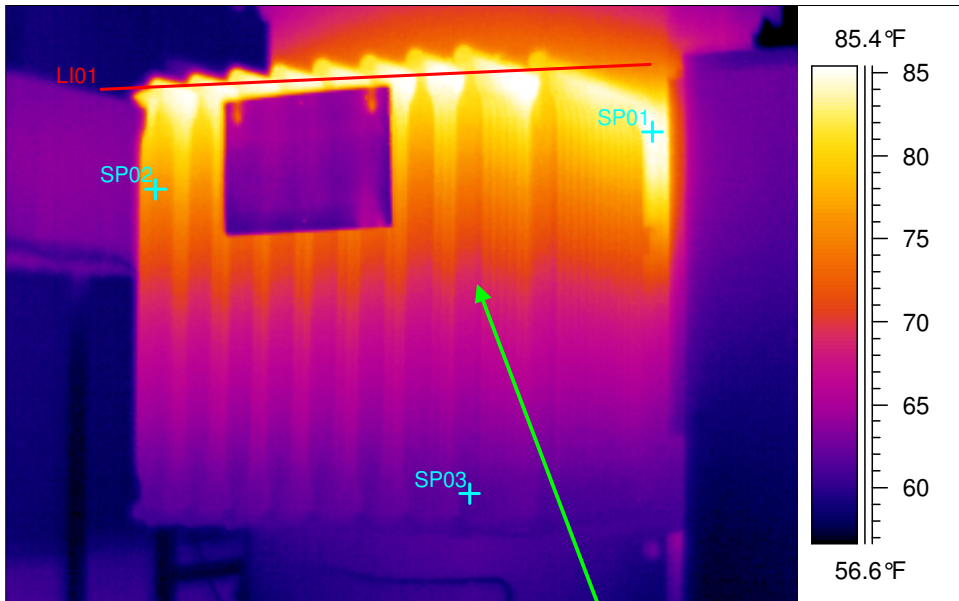
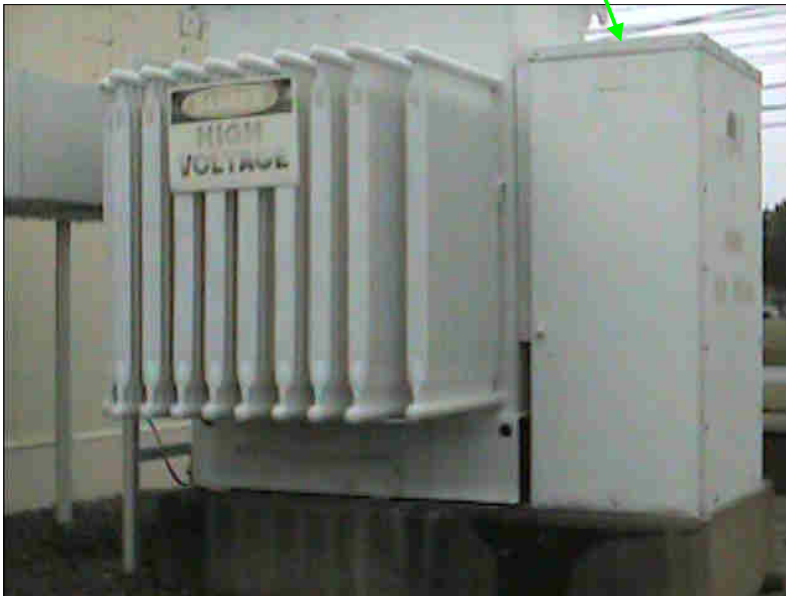
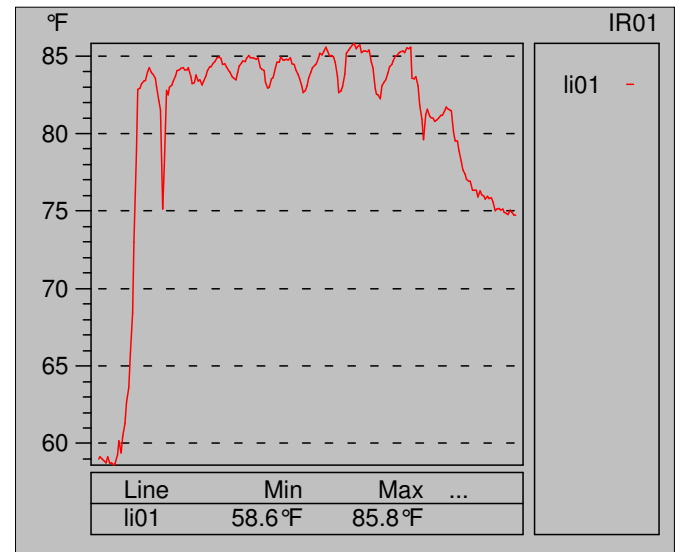
Component	Equipment/Bucket ID	Plant/Area	Date
Transformer	Sub E7 South Side	Chemours	10-28-19

Label	Value
IR : max	86.7°F
IR : min	52.8°F
SP01	85.5°F
SP02	76.2°F
SP03	61.3°F
LI01 : max	85.8°F
LI01 : min	58.6°F

<b>Fault</b>	None
<b>Defect Rating</b>	NA

Unit South radiator appears to be operating properly.

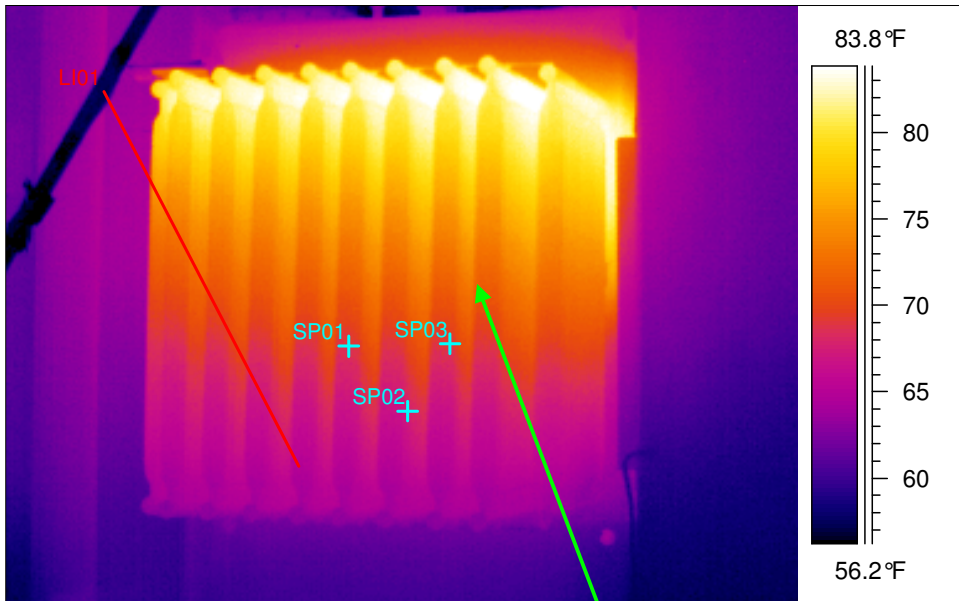
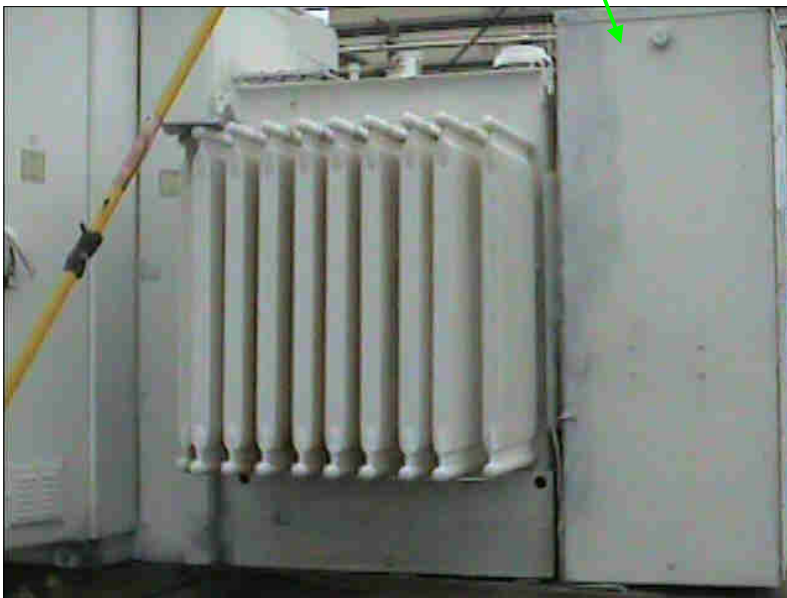
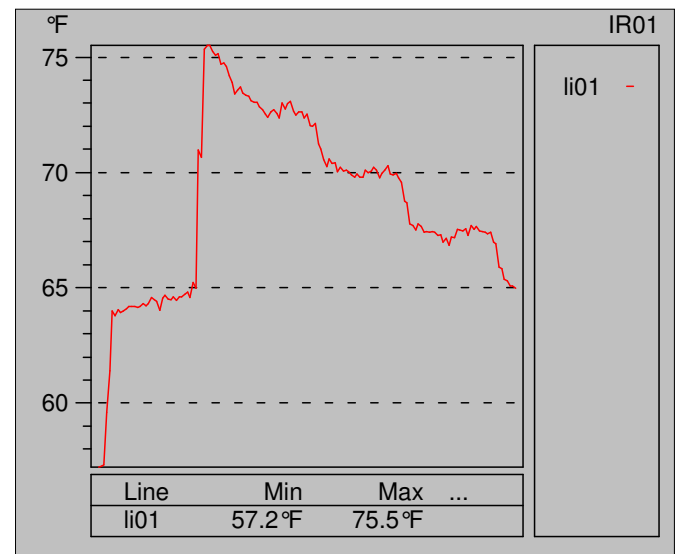
Component	Equipment/Bucket ID	Plant/Area	Date
Transformer	Sub 251 West Side	Chemours	10-28-19

Label	Value
IR : max	84.7°F
IR : min	55.4°F
SP01	69.0°F
SP02	67.8°F
SP03	69.2°F
LI01 : max	75.5°F
LI01 : min	57.2°F

<b>Fault</b>	None
<b>Defect Rating</b>	NA

Unit West radiator appears to be operating normally.

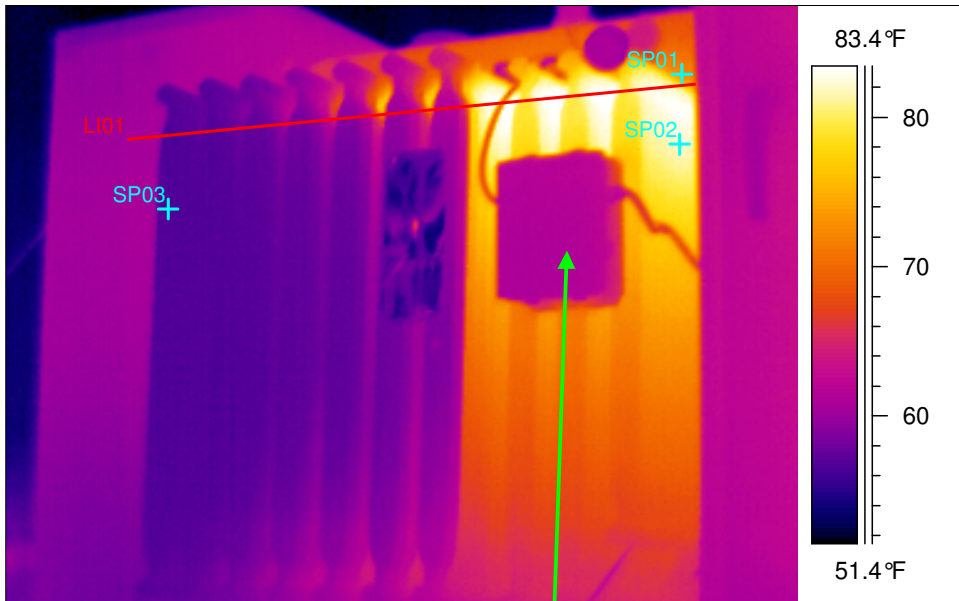
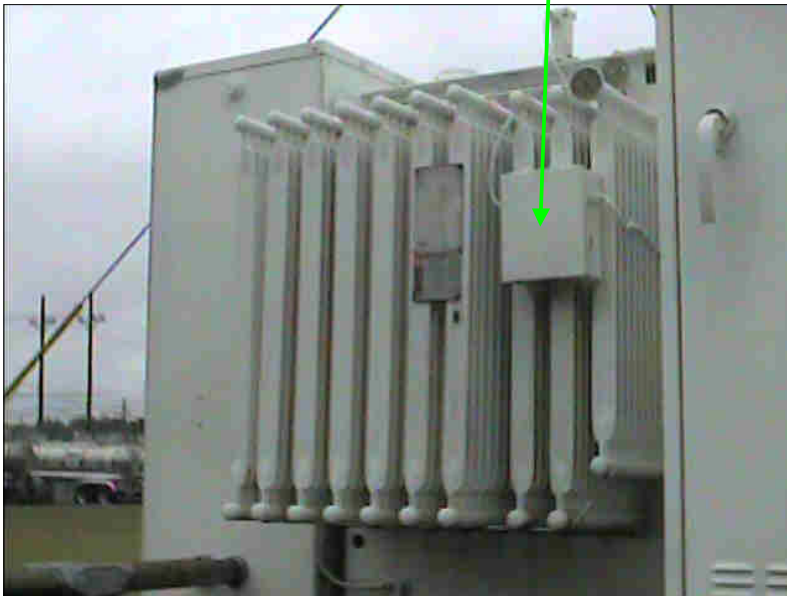
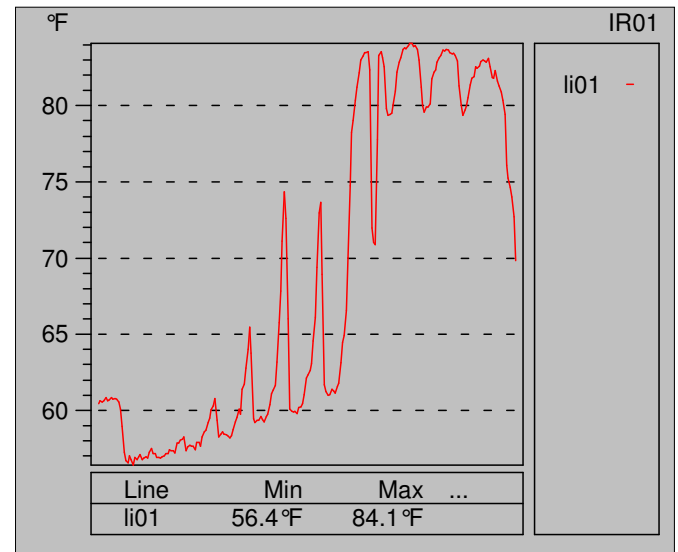
Component	Equipment/Bucket ID	Plant/Area	Date
Transformer	Sub 251 East Side	Chemours	10-28-19

Label	Value
IR : max	84.5°F
IR : min	50.5°F
SP01	72.8°F
SP02	82.3°F
SP03	56.8°F
LI01 : max	84.1°F
LI01 : min	56.4°F

<b>Fault</b>	Blocked fins or low oil.
<b>Defect Rating</b>	Class II

Multiple outboard cooling fins in the South radiator appear to be blocked. Low oil level in the transformer could also be responsible for defect. Inspect in the near future.

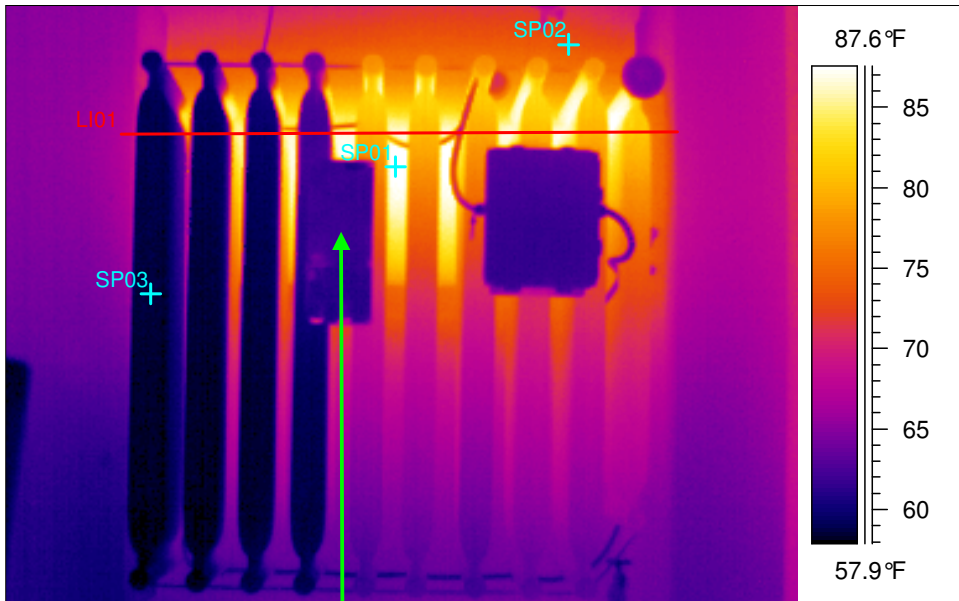
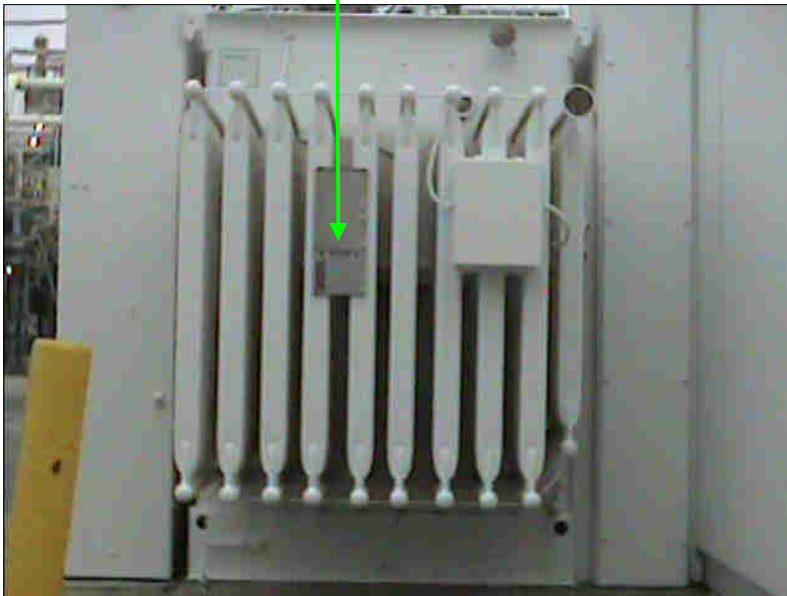
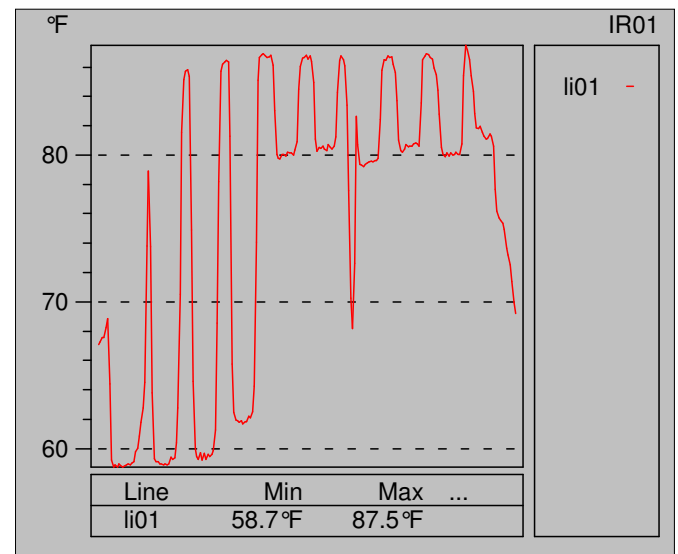
Component	Equipment/Bucket ID	Plant/Area	Date
Transformer	Sub 258 North Side	Chemours	10-28-19

Label	Value
IR : max	88.4°F
IR : min	57.6°F
SP01	88.0°F
SP02	73.5°F
SP03	58.6°F
LI01 : max	87.5°F
LI01 : min	58.7°F

<b>Fault</b>	Blocked fins or low oil
<b>Defect Rating</b>	Class II

Multiple outboard cooling fins in the North radiator appear to be blocked. Another possibility is low oil level. Please inspect the unit during the next opportunity.

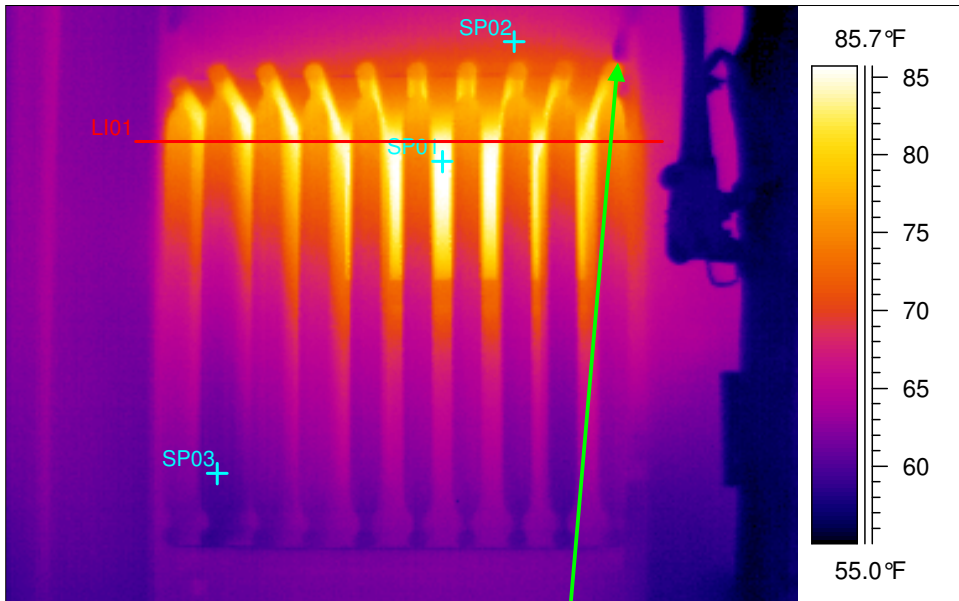
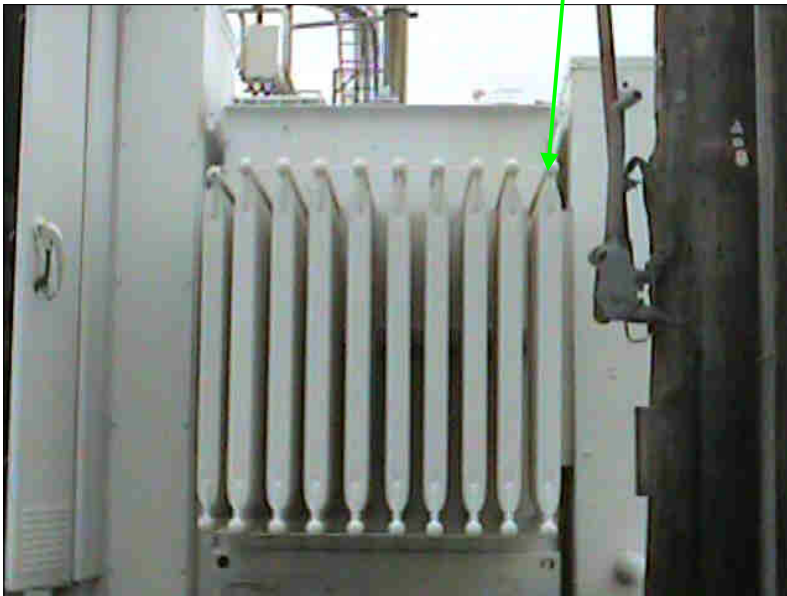
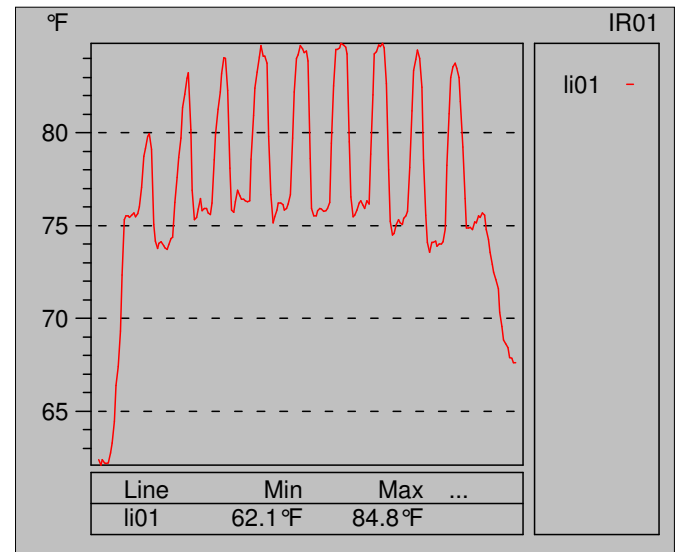
Component	Equipment/Bucket ID	Plant/Area	Date
Transformer	Sub 258 South Side	Chemours	10-29-19

Label	Value
IR : max	86.4°F
IR : min	54.3°F
SP01	86.0°F
SP02	69.3°F
SP03	60.1°F
LI01 : max	84.8°F
LI01 : min	62.1°F

<b>Fault</b>	None
<b>Defect Rating</b>	NA

Unit South radiators appears to be operating normally

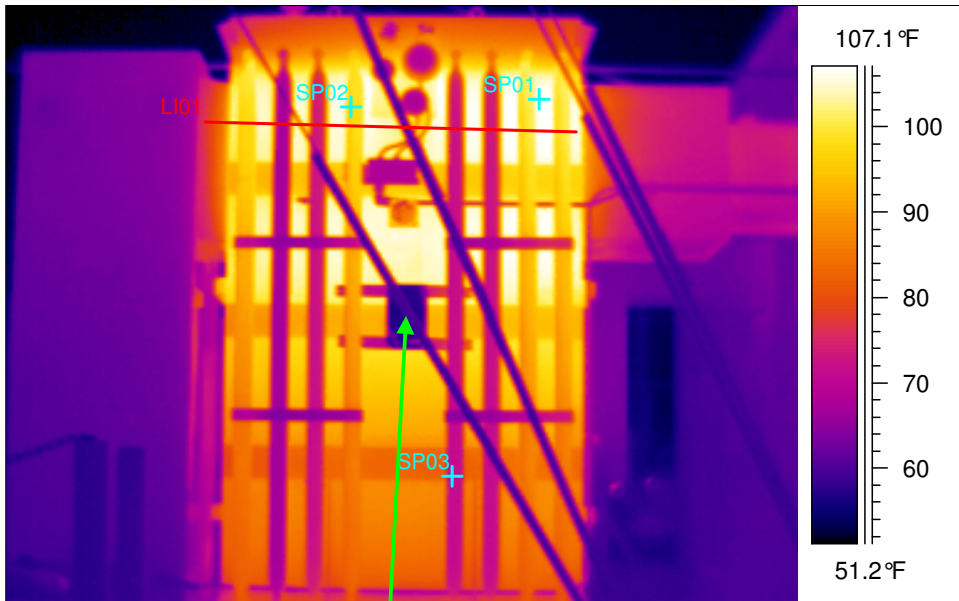
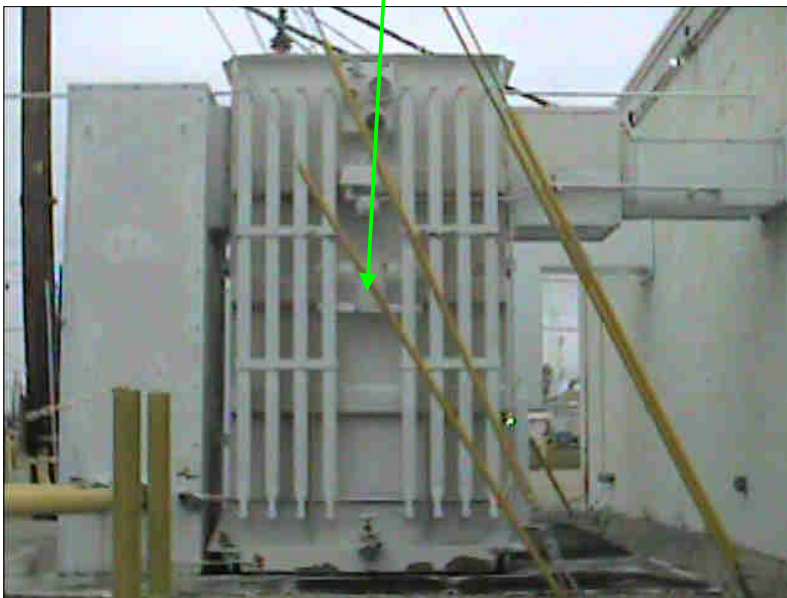
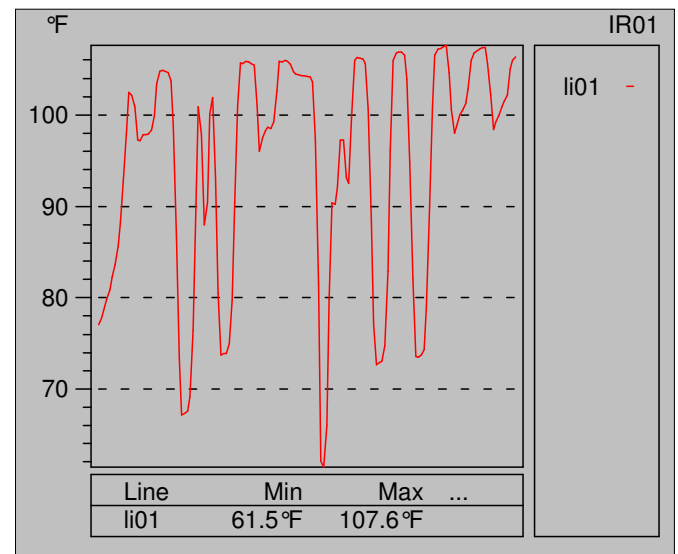
Component	Equipment/Bucket ID	Plant/Area	Date
Transformer	Sub E3 West	Chemours	10-28-19

Label	Value
IR : max	108.2°F
IR : min	50.8°F
SP01	107.0°F
SP02	97.6°F
SP03	71.1°F
LI01 : max	107.6°F
LI01 : min	61.5°F

<b>Fault</b>	Blocked cooling fins
<b>Defect Rating</b>	Class II

About half of the North radiator cooling fins appear to be blocked. Inspect at the next praticle time.  
Have the oil level checked also just to be safe.
