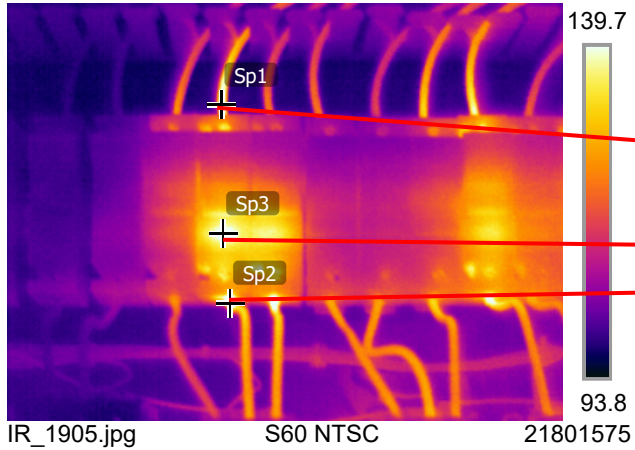
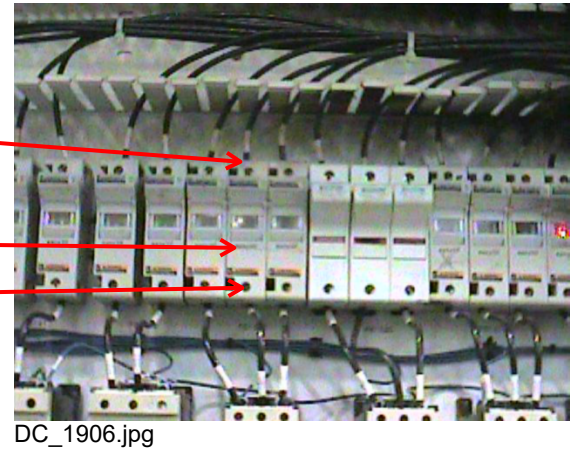
| Sp1 | 145.3 °F |
| Sp2 | 151.5 °F |
| Sp3 | 141.8 °F |

Infrared data indicates a high resistance connection on the load side and line side of phase B. The data also shows that the load side of the fuse is overheating. Replace the fuse and clean the fuse holder with sandpaper. Check the wire for damage. Replace if necessary, and repair as necessary tighten to proper torque.
