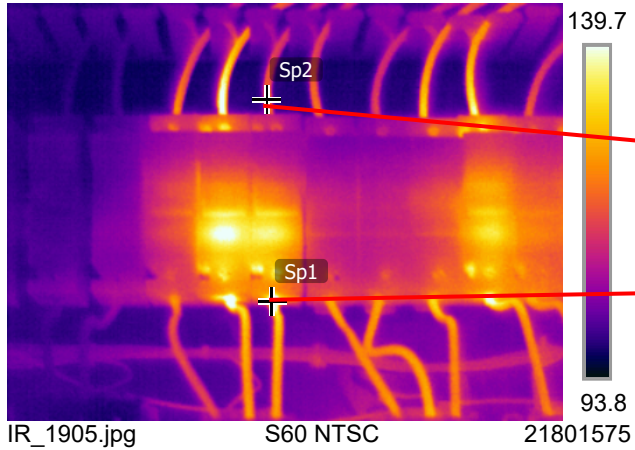
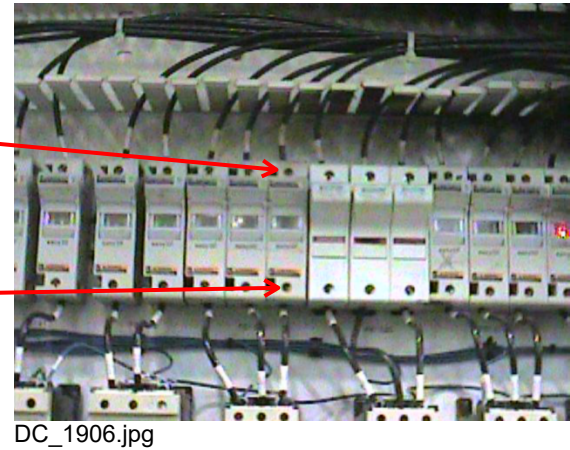
Sp1	151.7 °F
Sp2	122.6 °F

Infrared data indicates a high resistance connection on the line side of phase B. The data also shows that the load side of the fuse is overheating. Replace the fuse and clean the fuse holder with sandpaper. Check the wire for damage. Replace if necessary, and repair as necessary tighten to proper torque.
