D.C. Motor Maintenance Inspection Form

94379

Bridgestone

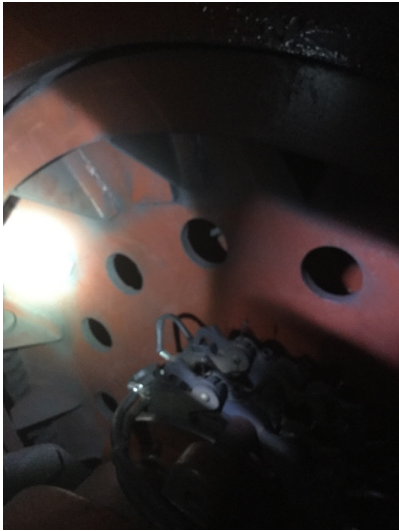
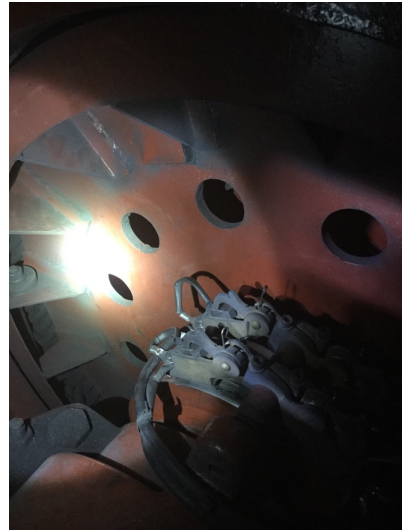
Internal photo

Dusty

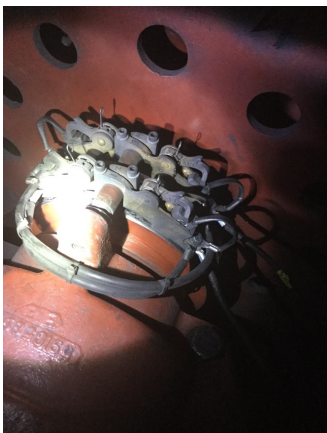
Brush holder

Good

Bad

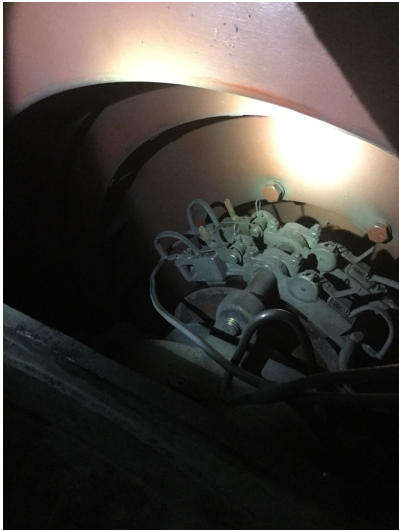
Internal photo

Dusty

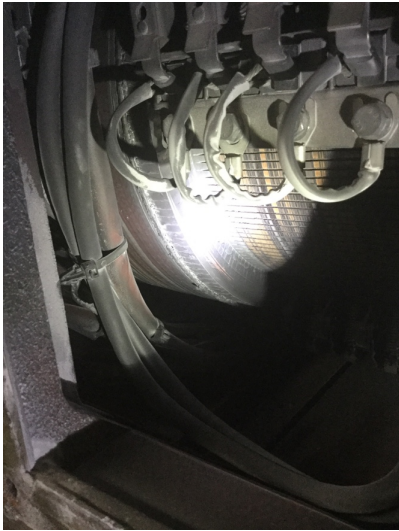
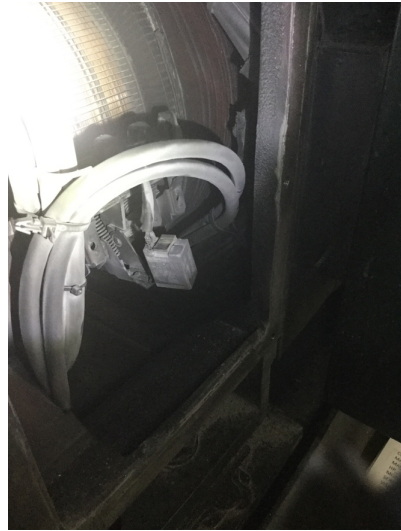
Internal photo

Dusty

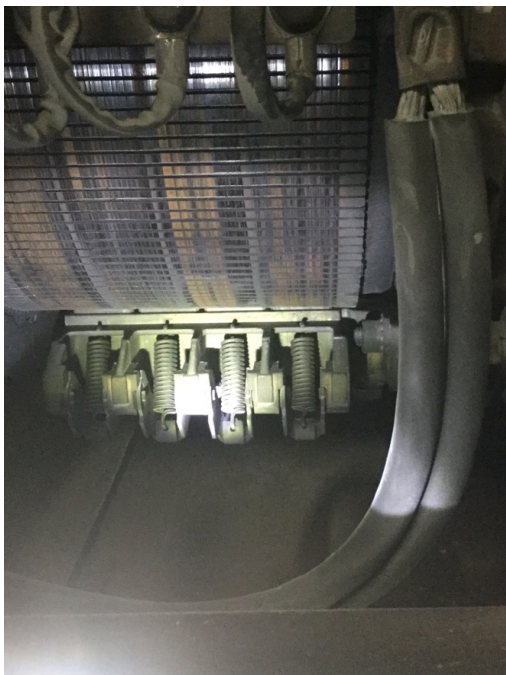
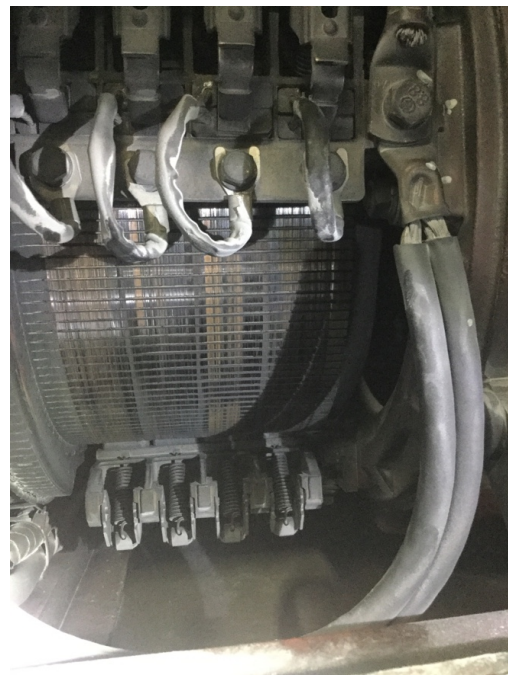
Commutator : Fair show unevenness

Comments : Commutator slot depth $<.050''$
By next evaluation will need to be pulled and TUC commutator

Brushes at 50%. Commutator Worn will need a TUC by next evaluation

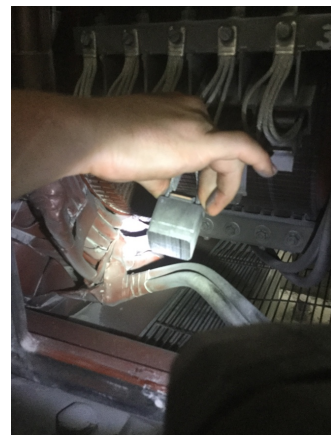
Brush photo

50%

Motor good. Suggest brush change at next evaluation
Commutator has some light threading

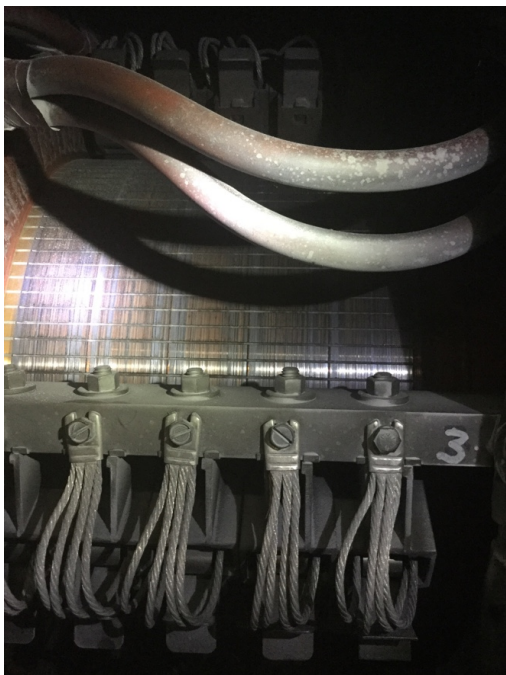
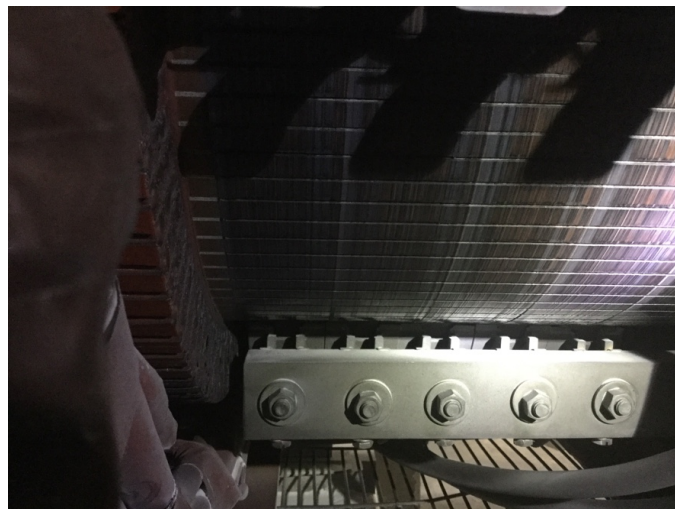
Good Mild wear

Commutator has some light threading

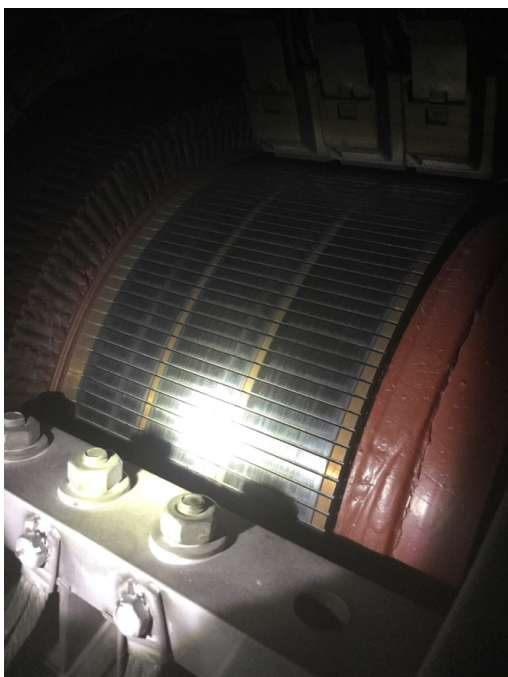
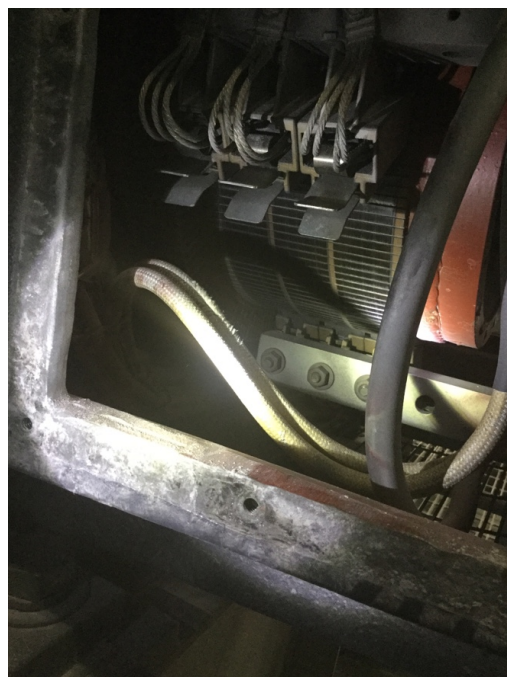
Commutator : Good Smooth Film

Comments : Commutator slot depth .060"
Good film on commutator
