## D.C. Motor Maintenance Inspection Form

Bridgestone

#2 Extruder

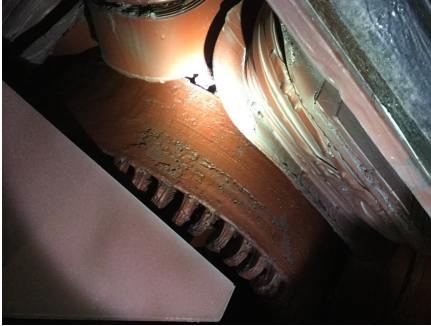
Internal photo

Internal visual appearance :

Dusty

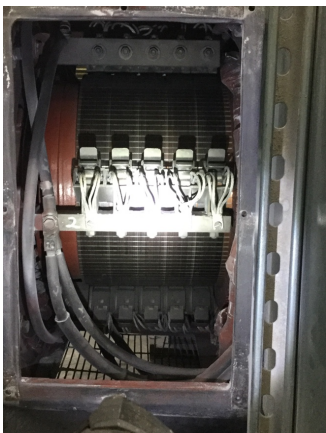
Brush holder

Brush Holders:

Good

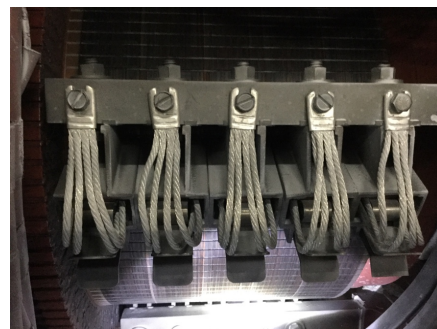
Brush photo

Brushes :

50%

Motor has dust inside but overall it looks good. Brushes looked good but we will probably have to change them on the next inspection

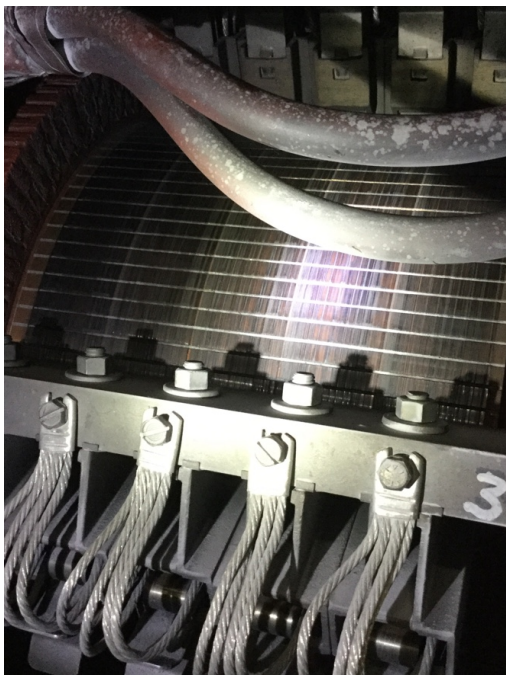
Commutator : Fair show unevenness

Comments : Commutator has some "treading" on the surface. This has been present since previous inspections.
