## D.C. Motor Maintenance Inspection Form

Job#: 95710

Customer : Bridgestone

Machine: Bandbury

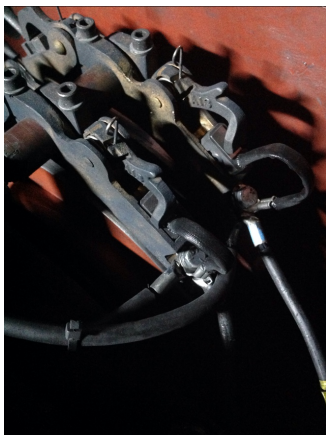
Brush holder

Brush Holders:

Bad

The brush rack springs are worn causing the spring to set on top of the brush rack once the brush is worn so far down preventing the spring from pushing the brush down on to the ring through the slot.

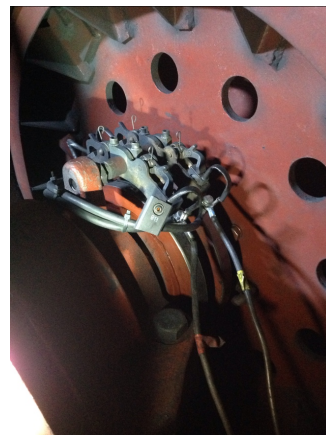
Brush photo

Brushes :

75%

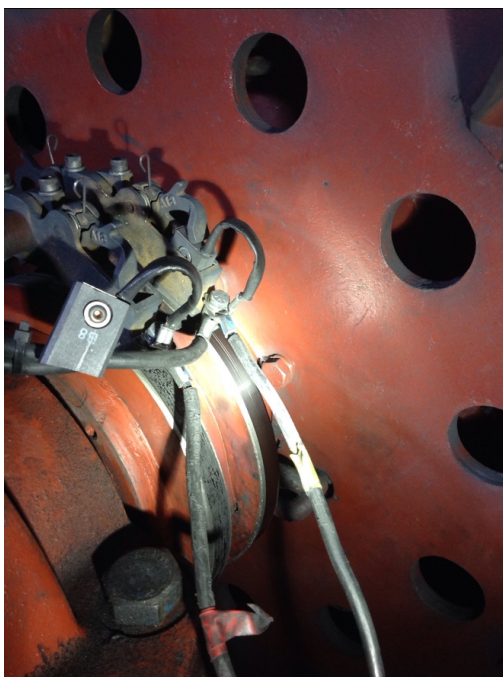
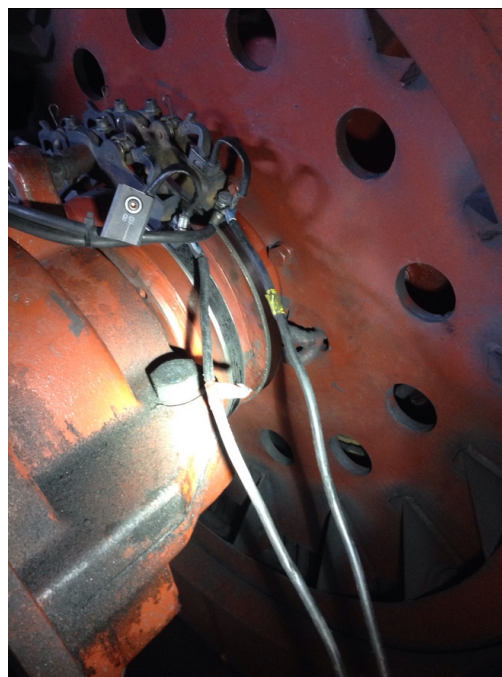
Commutator : Fair show unevenness

Comments : First ring is showing to have an uneven wear pattern.

Stoned Com: ☒ Yes ☐ No
