D.C. Motor Maintenance Inspection Form

Job#: 94379

Customer : Bridgestone

Machine: #1 Extruder

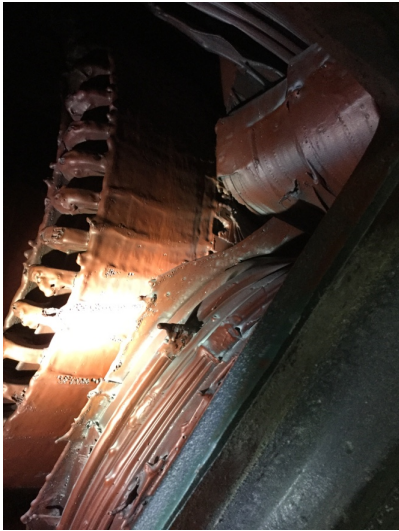
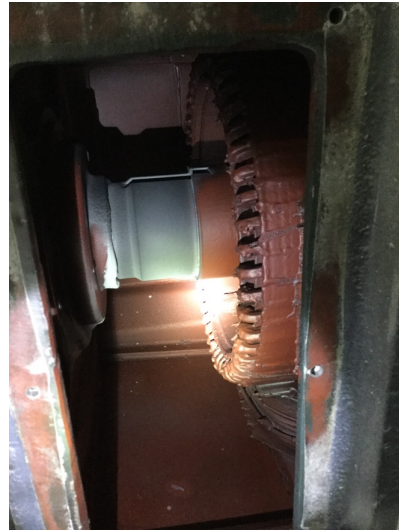
Internal photo

Dusty

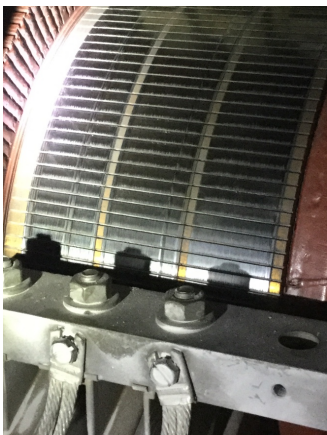
Brush holder

Good

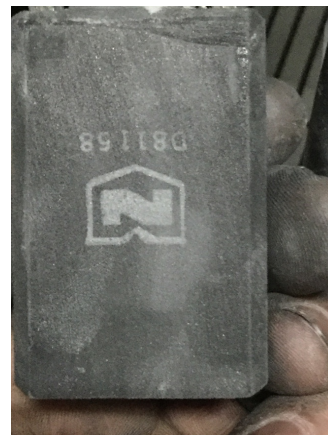
Brush photo

50%

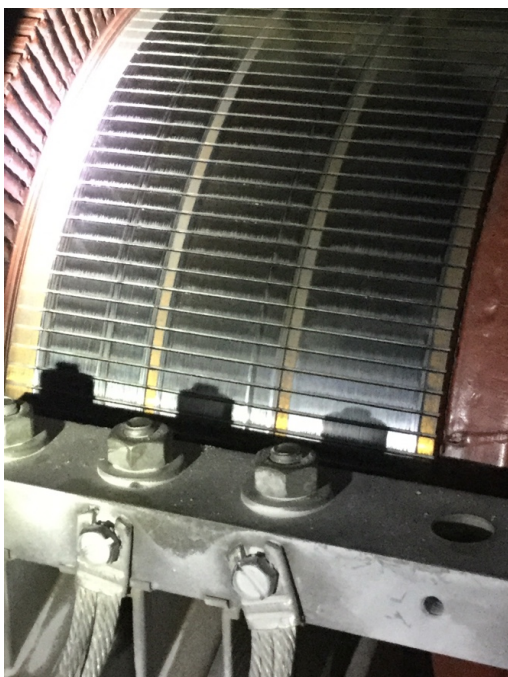
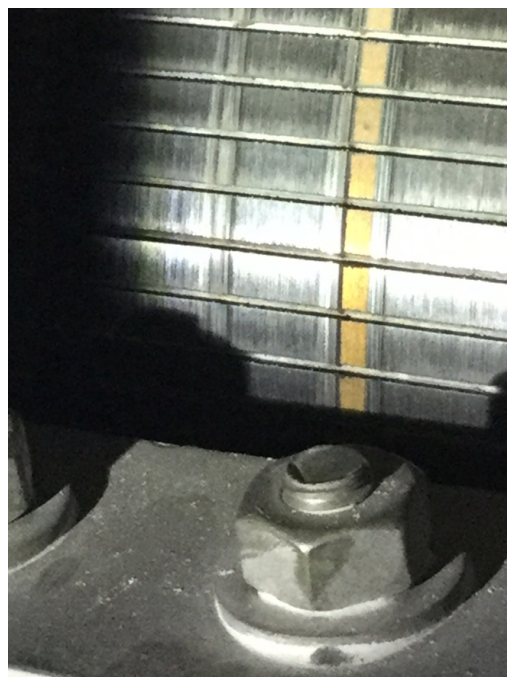
Commutator : Good Mild wear

Comments : Commutator looks good it has a couple grooves worn on it that have been there on previous inspections. Also there is some trailing edge burning on the commutator bars. This is typically caused by a light load or by contamination getting between the commutator and brushes
