## D.C. Motor Maintenance Inspection Form

Job#: 96937

Customer : Firestone 1

Machine: Bandburry

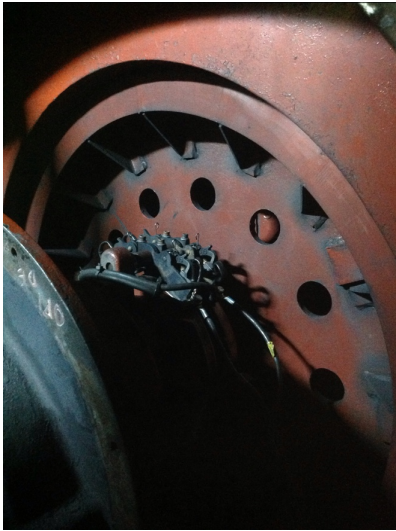
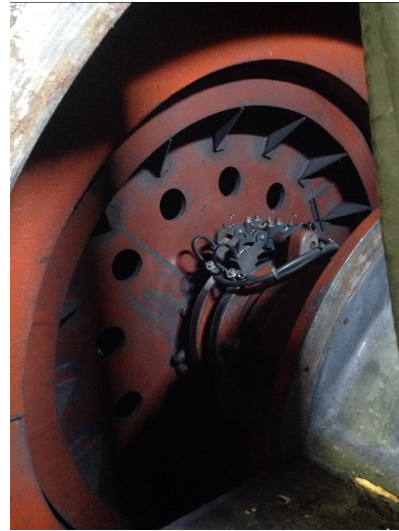
Internal photo

Internal visual appearance :

Mildly dirty

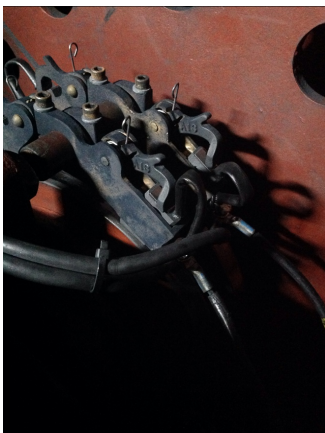
Brush holder

Brush Holders:

Bad

Rings and pole pieces on rotor are grounded at 0.7 megaohms. Rings meg good at 180 and 324 megaohms. Suggest recondition of motor and fixing brushrack.

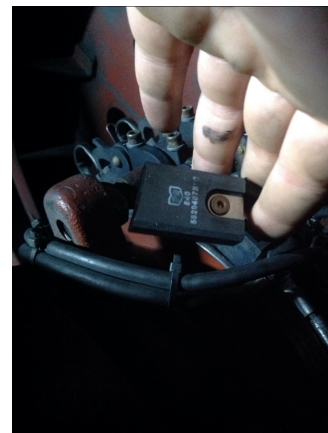
Brush photo

Brushes :

100%

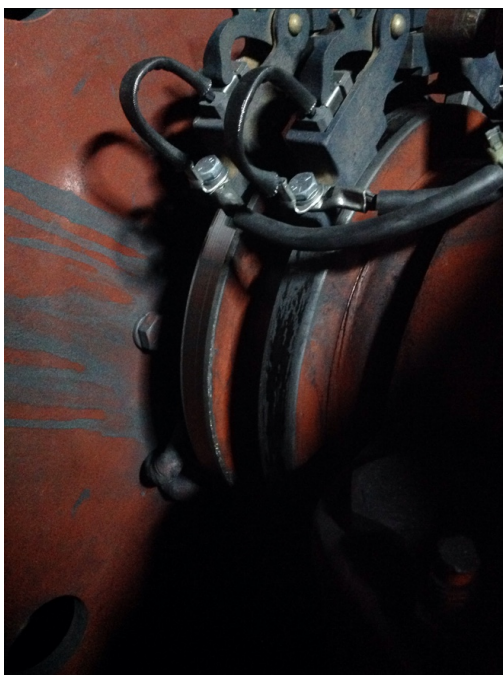
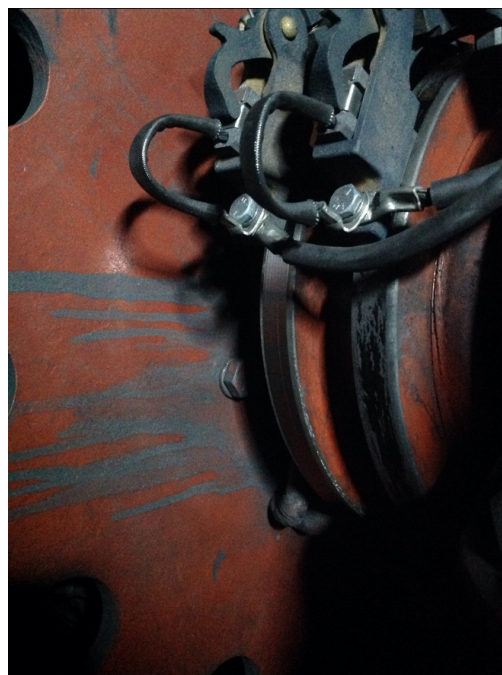
Commutator :

Good Mild wear

Front ring is a little discolored and uneven from the brush not being able to make contact because of the bad brushrack causing arching.
