D.C. Motor Maintenance Inspection Form

Job#: 96937

Customer : Firestone 2

Machine: 1 extruder

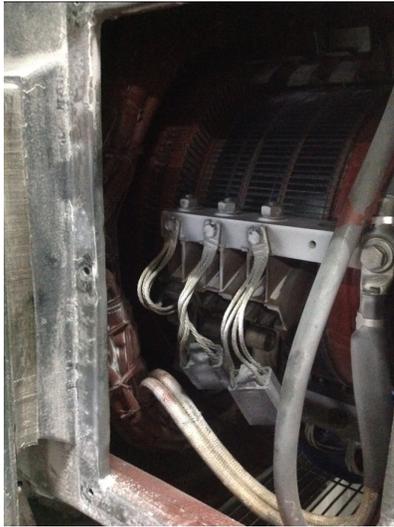
Internal photo

Armature is 600 megaohms
Brushes look great and have little wear
Fields are 46 ohms and have 98 megaohms at 500 volts
Interpoles, brushrack and leads have 1000 megaohms
Motor is dusty so I blew it out.
Commutator has slight grooving
There is a lot of humidity in the motor

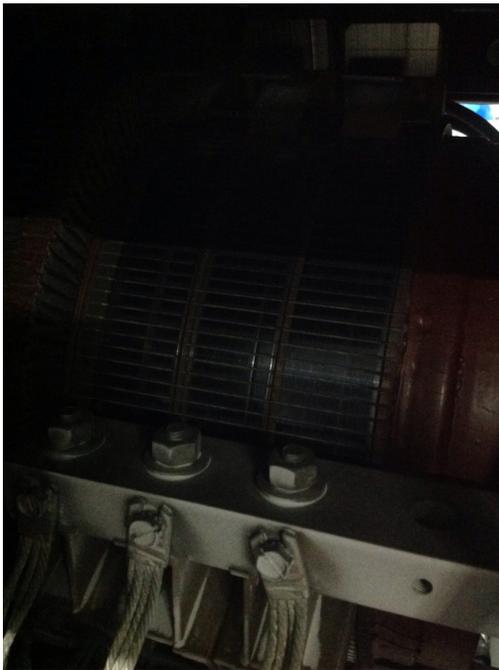
Comments : Commutator has even grooving and a good film. Recommend turning when pulled for rebuild.
