## D.C. Motor Maintenance Inspection Form

Job#: 96937

Customer : Firestone 3

Machine: Extruder

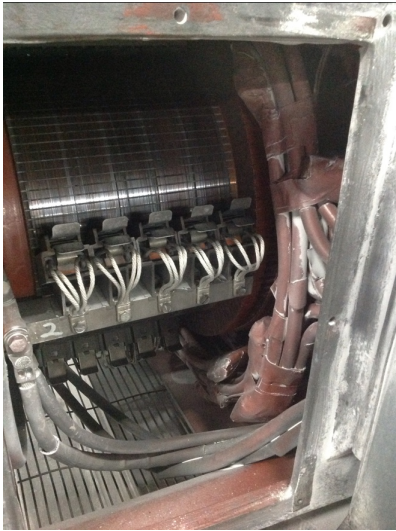
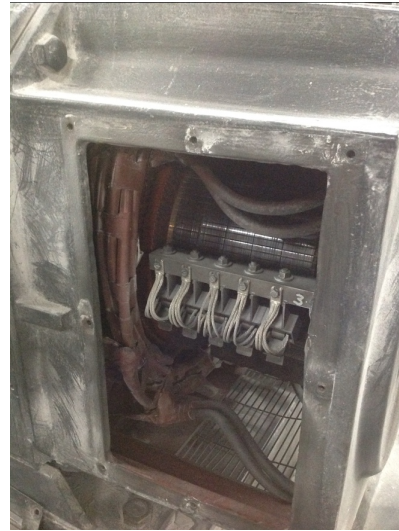
Internal photo

Internal visual appearance :

Dusty

Motor is dusty so I blew it out.  
Recommend turning commutator  
Armature has 6.5 megaohms at 500 volts  
Fields are at 550 megaohms and have 47 ohms  
Brushrack, interpoles and leads are at 1 megaohm

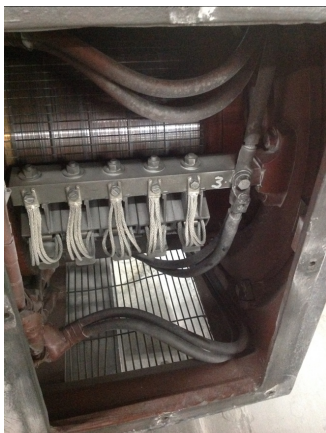
Brush holder

Brush Holders:

Good

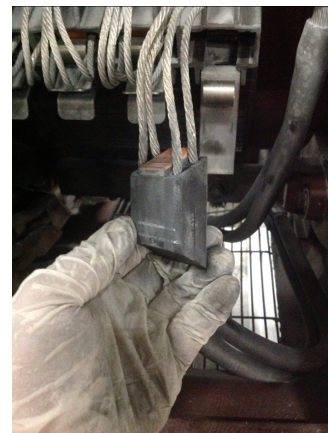
Brush photo

Brushes :

75%

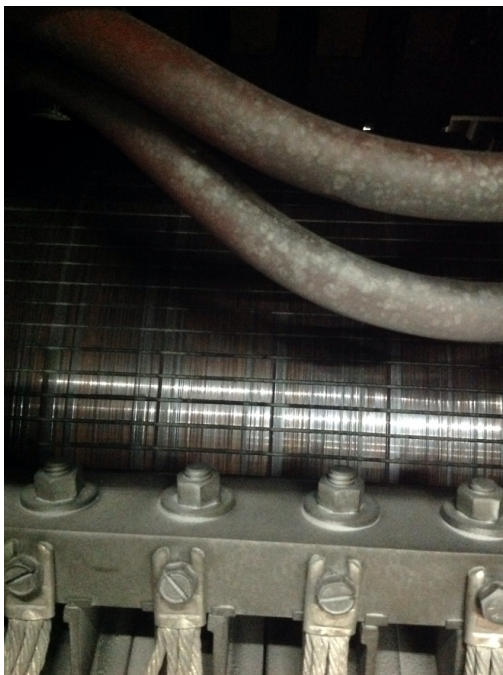
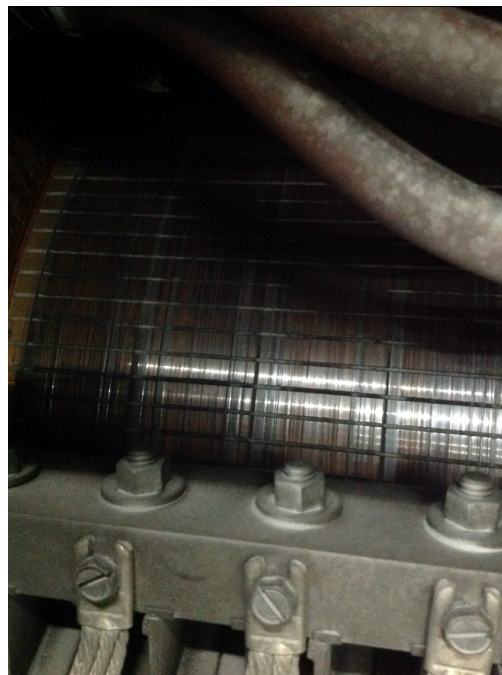
Commutator : Fair show unevenness

Comments : Commutator has a lot of grooving. Recommend getting it turned and undercut.
