D.C. Motor Maintenance Inspection Form

Job#: 96937

Customer : Firestone 3

Machine: Extruder

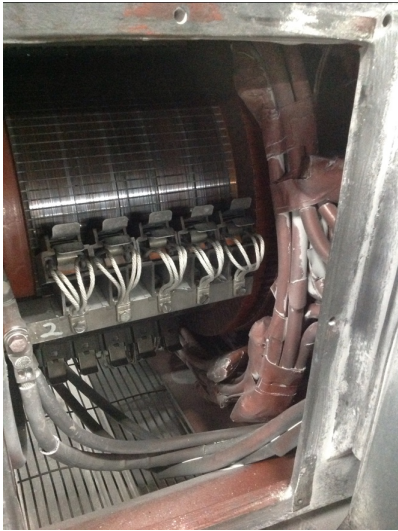
Internal photo

Internal visual appearance :

Dusty

Motor is dusty so I blew it out.
Recommend turning commutator
Armature has 6.5 megaohms at 500 volts
Fields are at 550 megaohms and have 47 ohms
Brushrack, interpoles and leads are at 1 megaohm
