7 February 2020

D.C. Motor Maintenance Inspection Form

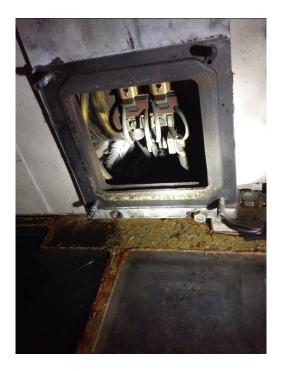
Commutator :	Good Smooth Film
Stoned Com:	🗆 Yes 🕱 No
Comments :	Commutator looks very good. No grooving and has a good carbon film.
