EverCompound  
Olive Branch, MS  
June 2022 Infrared  
Thermography Report

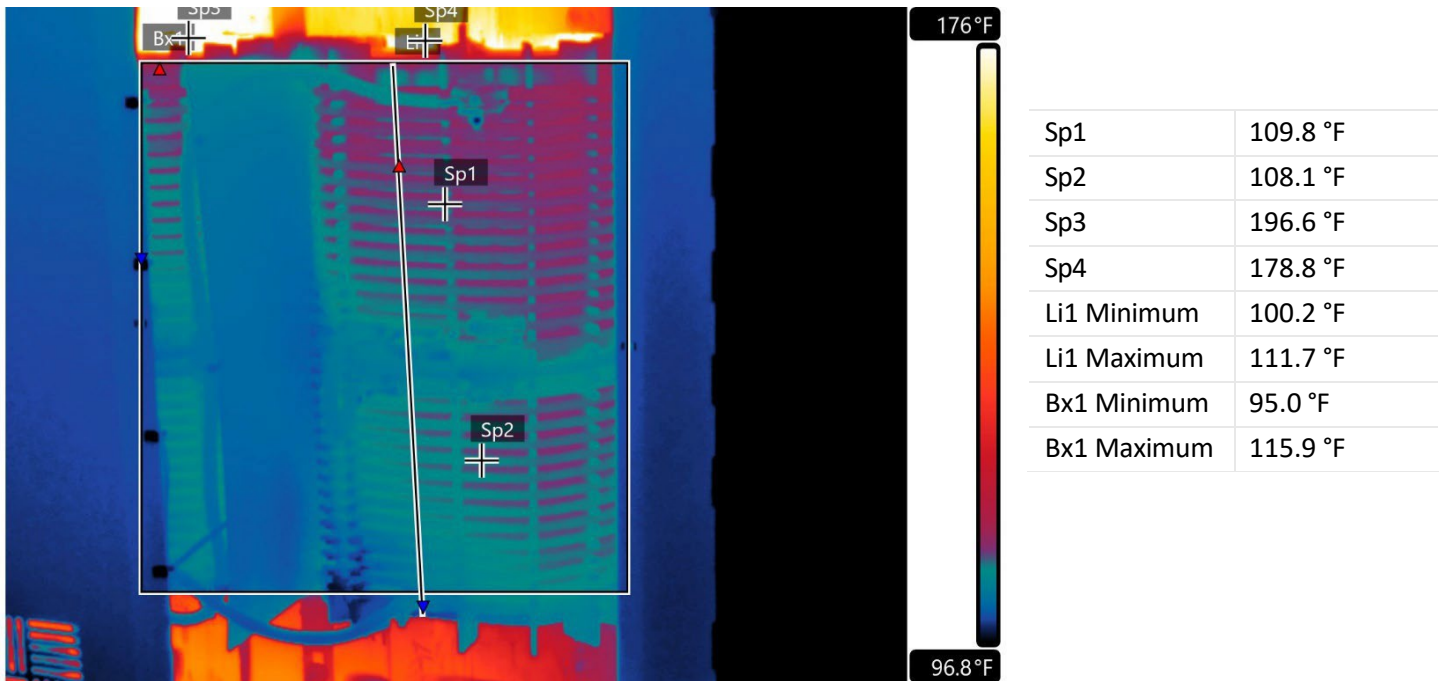
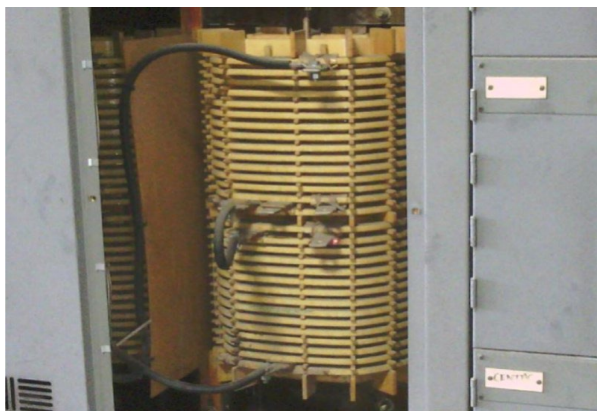
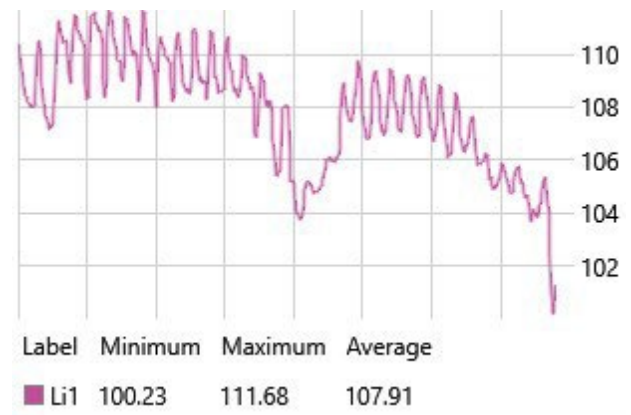
Component	Transformer
Equipment/Bucket ID	Outside Switch Gear Room

Fault	None (Info Only)
Defect Rating	None

Recommendations	IR image taken shows temps of transformer coils. No issues found. Info only.
-----------------	--

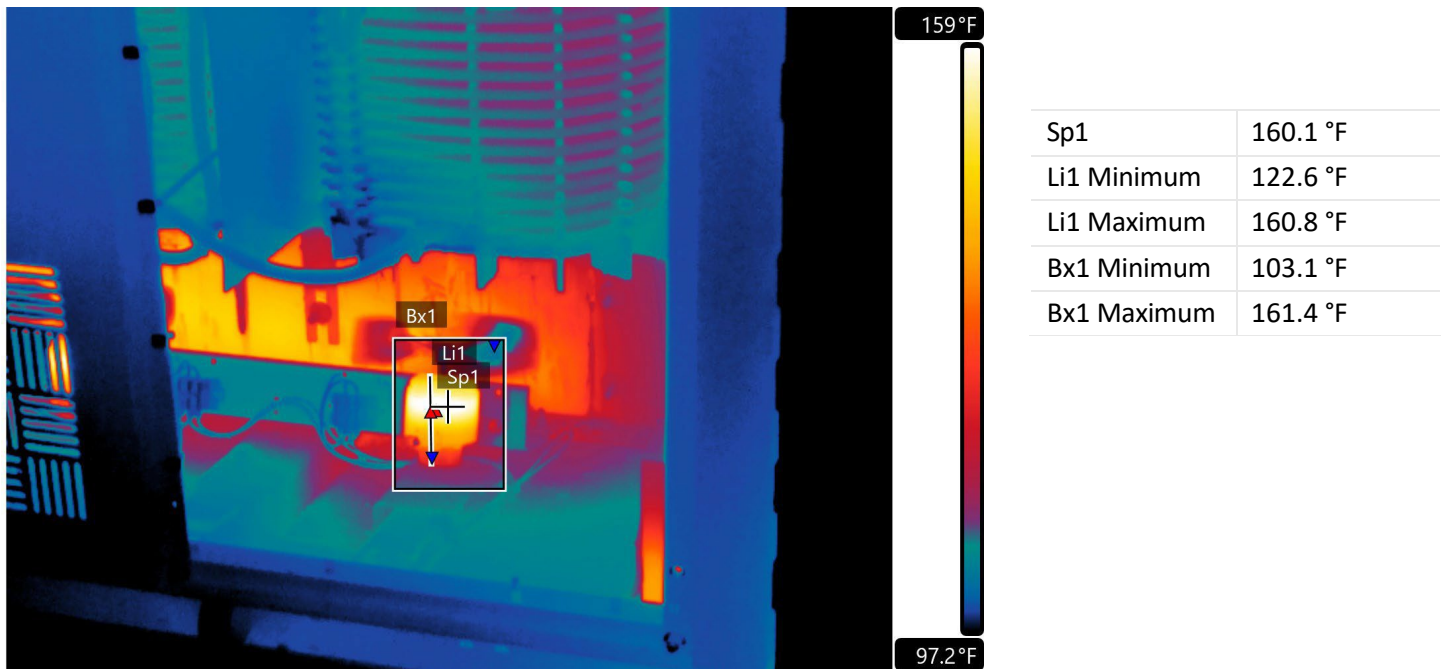
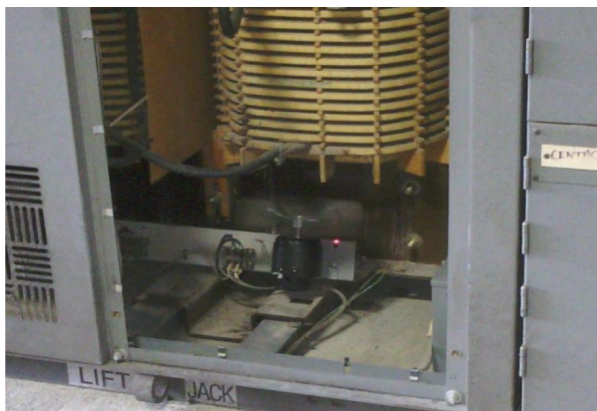
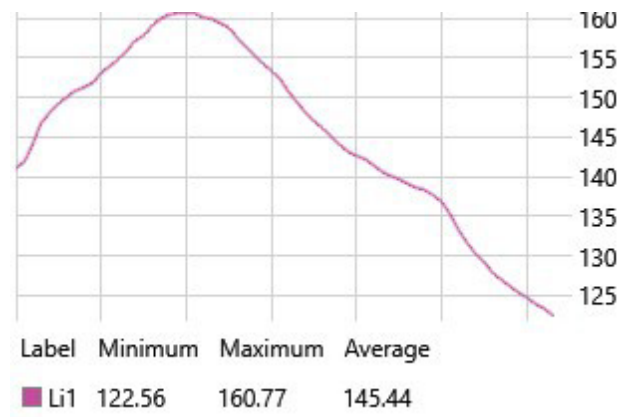
Component	Cooling Fan Motor
Equipment/Asset ID	Transformer Panels in Switchgear Room

Fault	None (Info Only)
Defect Rating	None

Recommendations
IR Image shows temp of cooling fan motor. Info only. All other fans seemed to be operating around this temp.

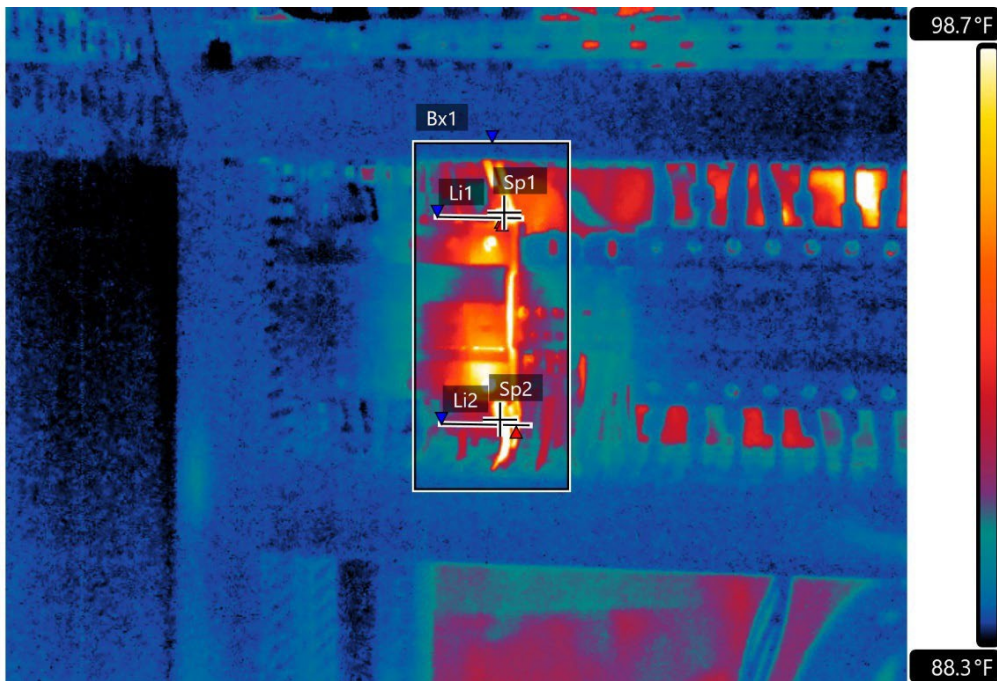
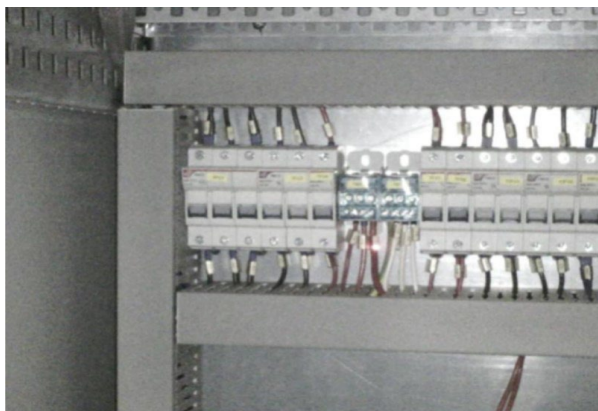
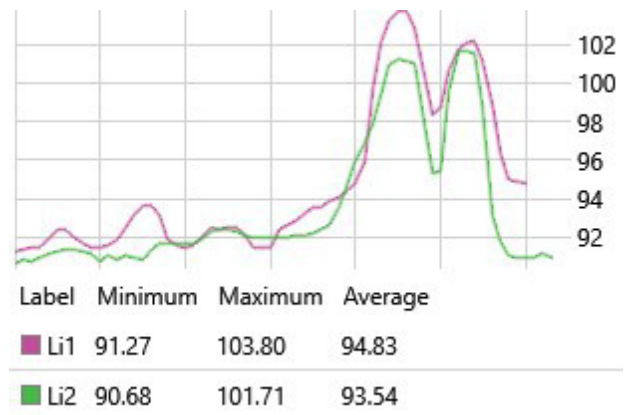
Component	F7U4 Fuse
Equipment/Bucket ID	L1.250.Q2 Cabinet

Sp1	97.6 °F
Sp2	99.1 °F
Li1 Minimum	91.3 °F
Li1 Maximum	103.8 °F
Li2 Minimum	90.7 °F
Li2 Maximum	101.7 °F
Bx1 Minimum	88.4 °F
Bx1 Maximum	104.5 °F

Fault	Faulty Fuse/Connection issue
Defect Rating	<b>CLASS I</b>

Recommendations	Fuse labeled F7U4 appears to have excessive heat un fuse body and at lead connections. Inspect/repair as needed as scheduling allows. Ensure all connections are tight.
-----------------	---

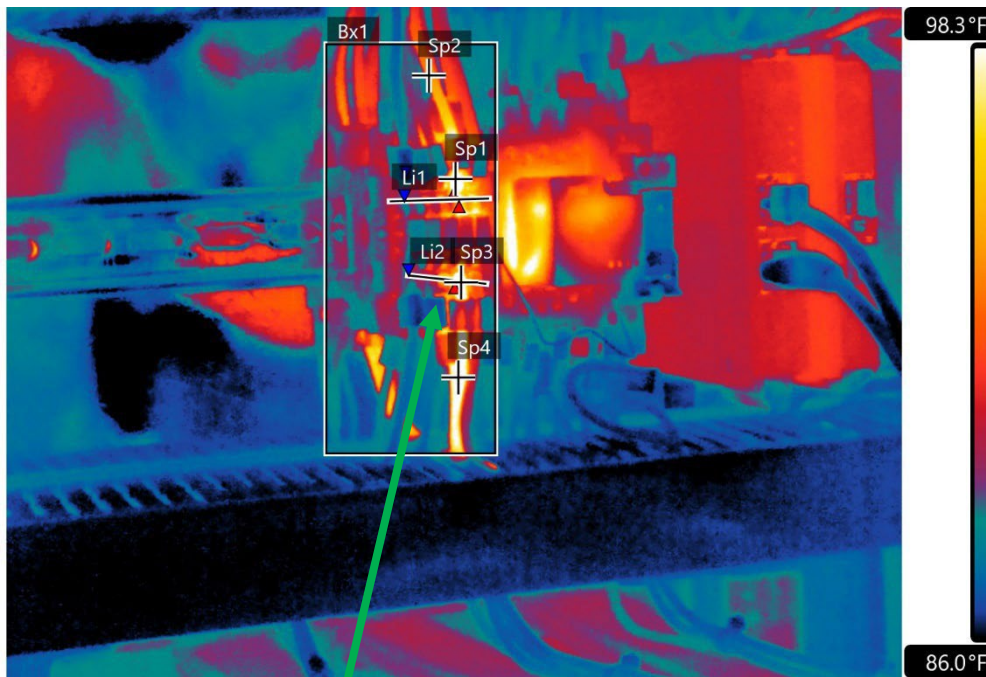
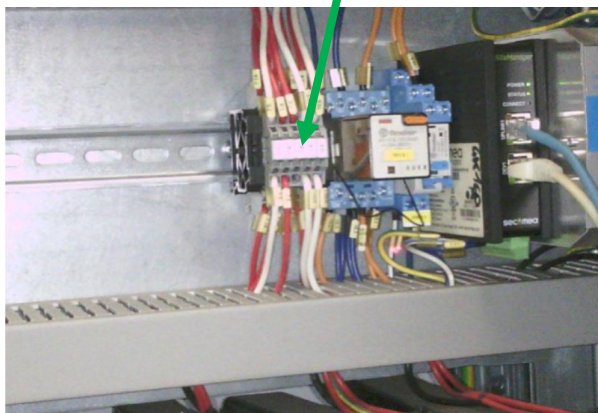
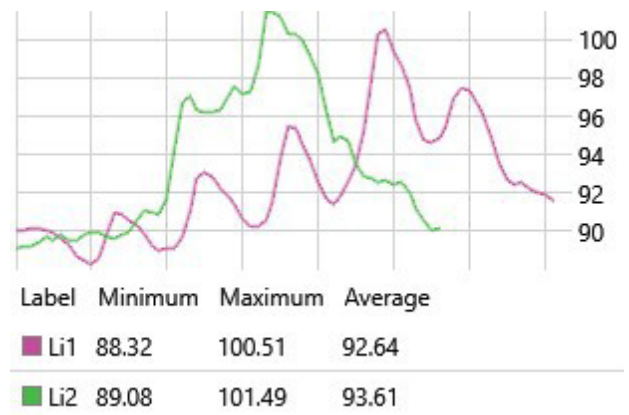
Component	First Cabinet From Left (lead connections)
Equipment/Bucket ID	L1.MX2.Q2

Sp1	99.3 °F
Sp2	94.0 °F
Sp3	99.9 °F
Sp4	98.9 °F
Li1 Minimum	88.3 °F
Li1 Maximum	100.5 °F
Li2 Minimum	89.1 °F
Li2 Maximum	101.5 °F
Bx1 Minimum	86.1 °F
Bx1 Maximum	102.4 °F

Fault	Lead connection issue
Defect Rating	<b>CLASS I</b>

Recommendations	Lead connections show high temps at connections. Check connections ensuring a clean tight connection. Inspect as scheduling allows.
-----------------	---

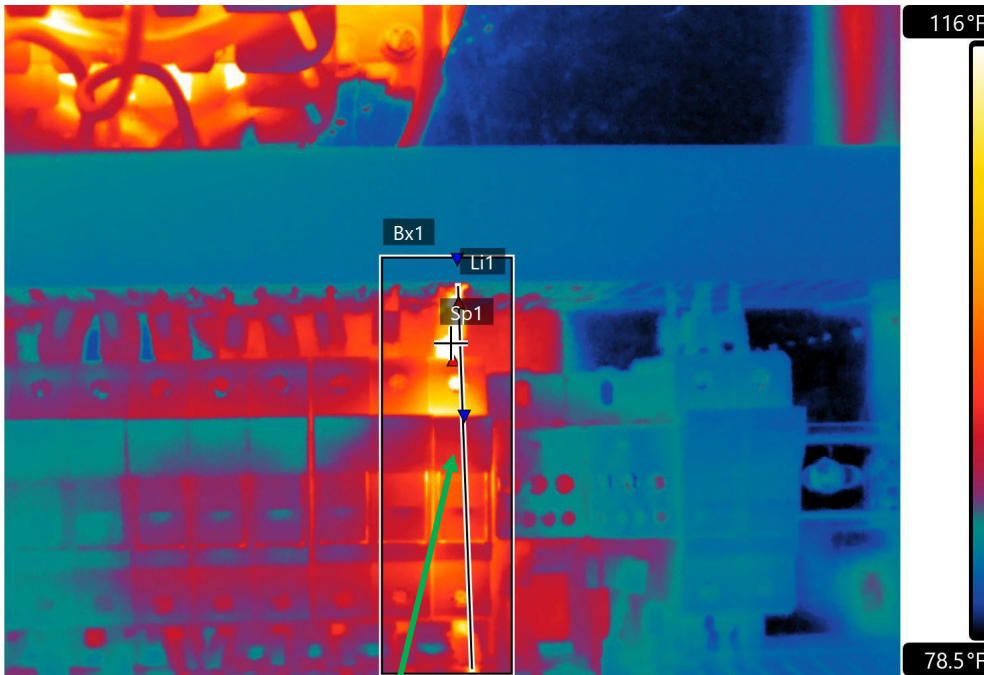
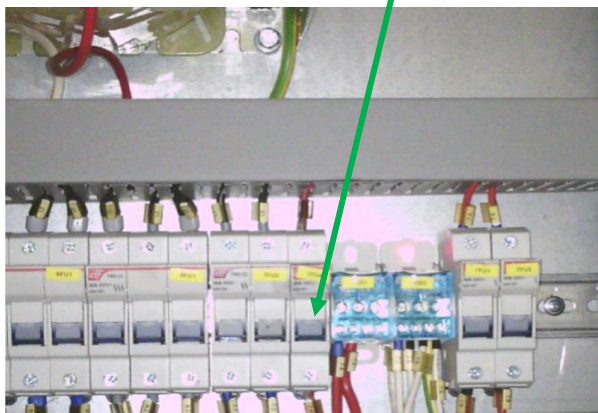
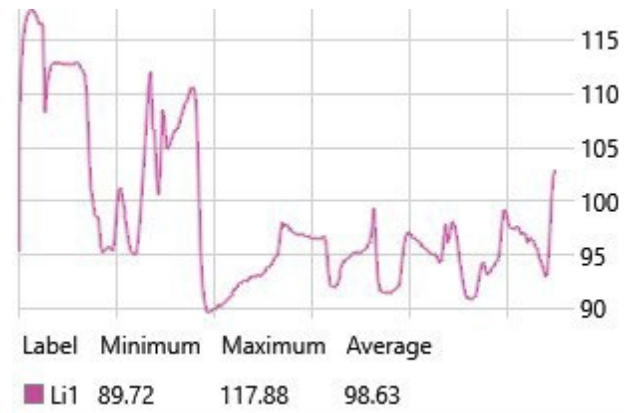
Component	Fuse
Equipment/Bucket ID	L2.160.Q1 (third cabinet from left)

Sp1	130.6 °F
Li1 Minimum	89.7 °F
Li1 Maximum	117.9 °F
Bx1 Minimum	82.9 °F
Bx1 Maximum	133.8 °F

Fault	Connection issue/Fuse issue
Defect Rating	<b>CLASS II</b>

Recommendations	IR image suggests that the top lead connection may be the issue here. Inspect and clean/tighten connection soon. Fuse may also be weak or heavily loaded.
-----------------	---

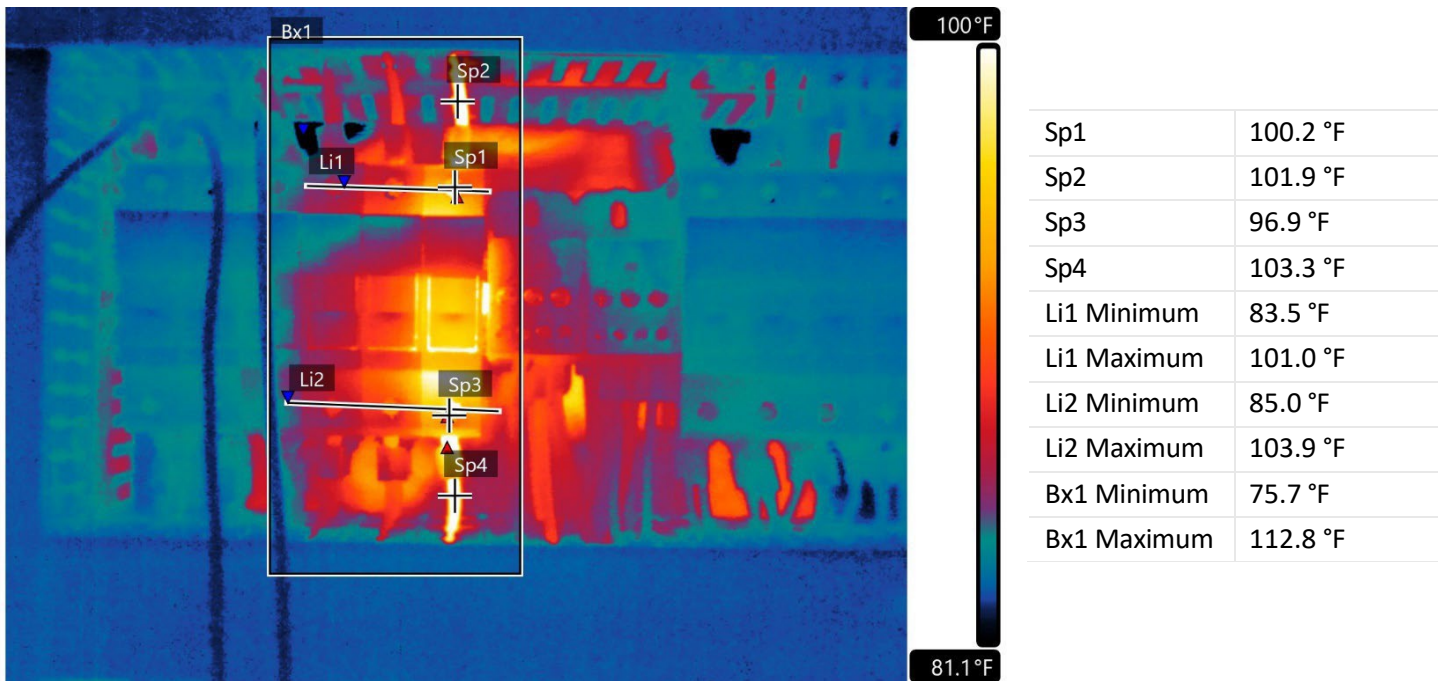
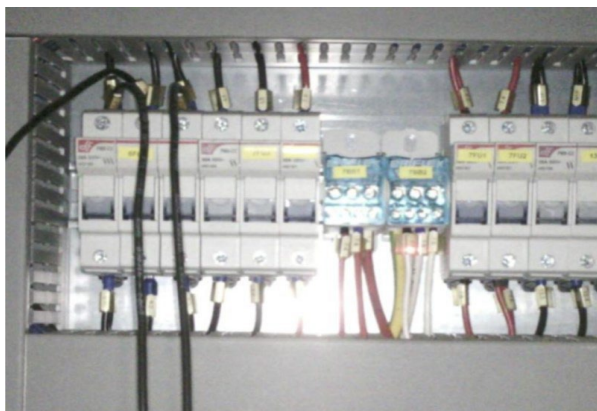
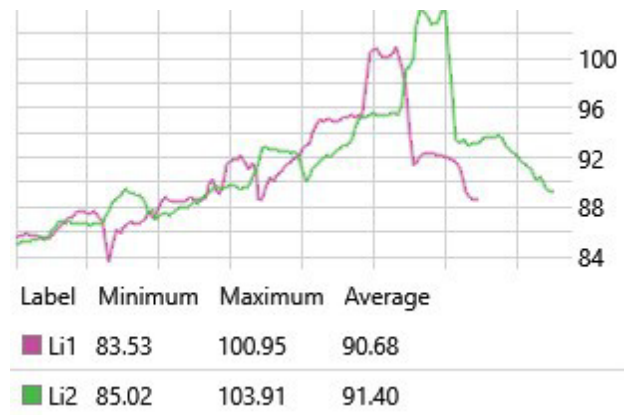
Component	Small fuse
Equipment/Bucket ID	L2.MX1.Q1 (first cabinet from left)

Fault	Loose connection/fuse issue/heavy load
Defect Rating	<b>CLASS I</b>

Recommendations	IR image indicates that the lead connections to the fuse body have issues. Inspect and clean/tighten connection soon. Fuse may also be weak or heavily loaded.
-----------------	--

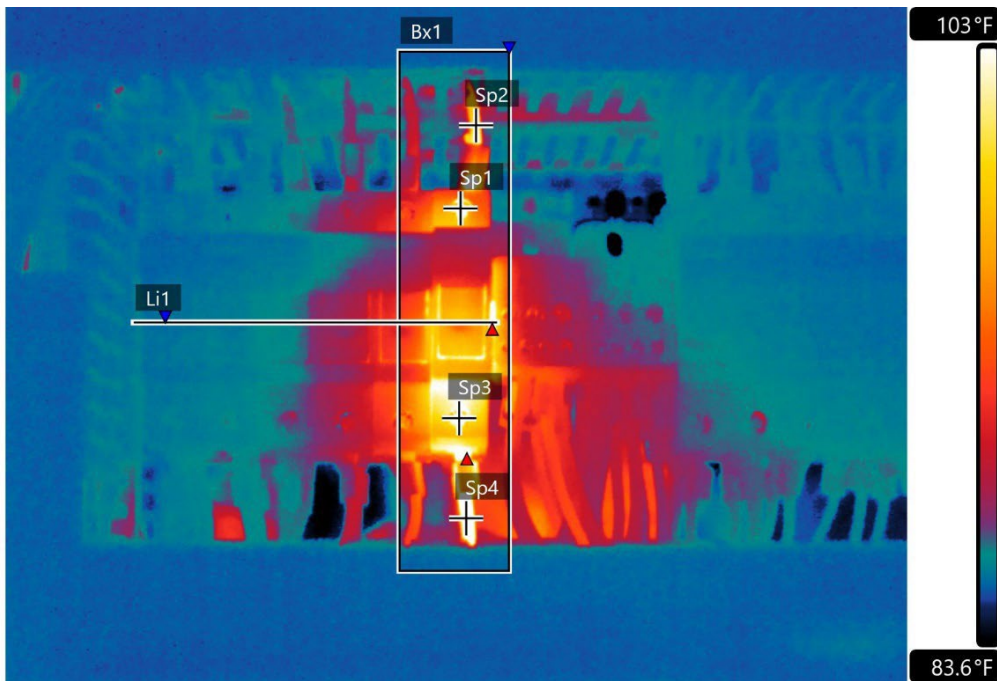
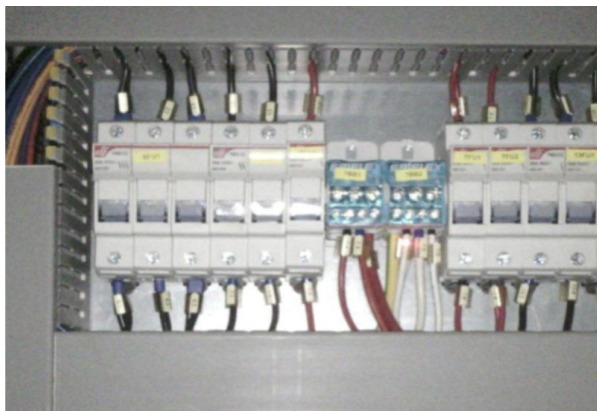
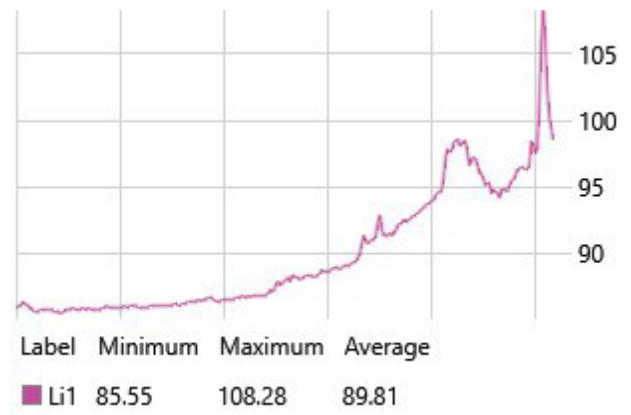
Component	Fuse/Connections(first cabinet from left)
Equipment/Bucket ID	L2.MX2.Q1

Sp1	102.5 °F
Sp2	99.9 °F
Sp3	106.6 °F
Sp4	106.7 °F
Li1 Minimum	85.6 °F
Li1 Maximum	108.3 °F
Bx1 Minimum	85.2 °F
Bx1 Maximum	115.3 °F

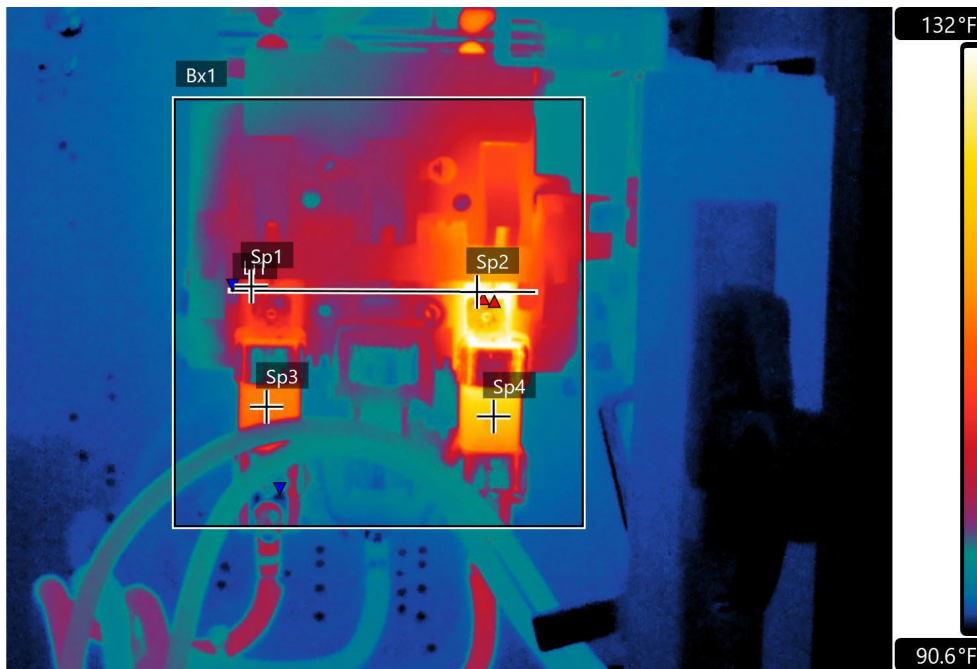
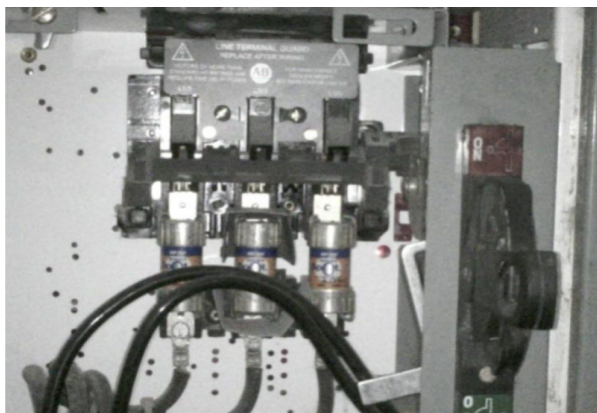
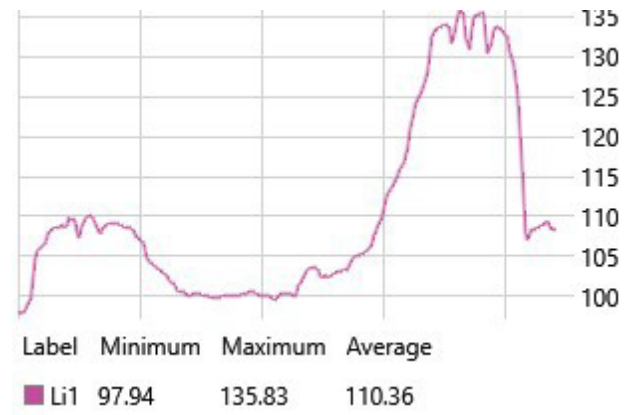
Component	Fuse/Clip
Equipment/Bucket ID	MCC-30/Production Office Panel

Sp1	108.0 °F
Sp2	131.6 °F
Sp3	113.5 °F
Sp4	119.8 °F
Li1 Minimum	97.9 °F
Li1 Maximum	135.8 °F
Bx1 Minimum	91.1 °F
Bx1 Maximum	136.8 °F

Fault	Loose fuse connection/Clip issue
Defect Rating	<b>CLASS II</b>

Recommendations	Fuse and or clip appear to have issues. Inspect fuse and clip ensuring a good clean and tight connection. Replace part as needed.
-----------------	---

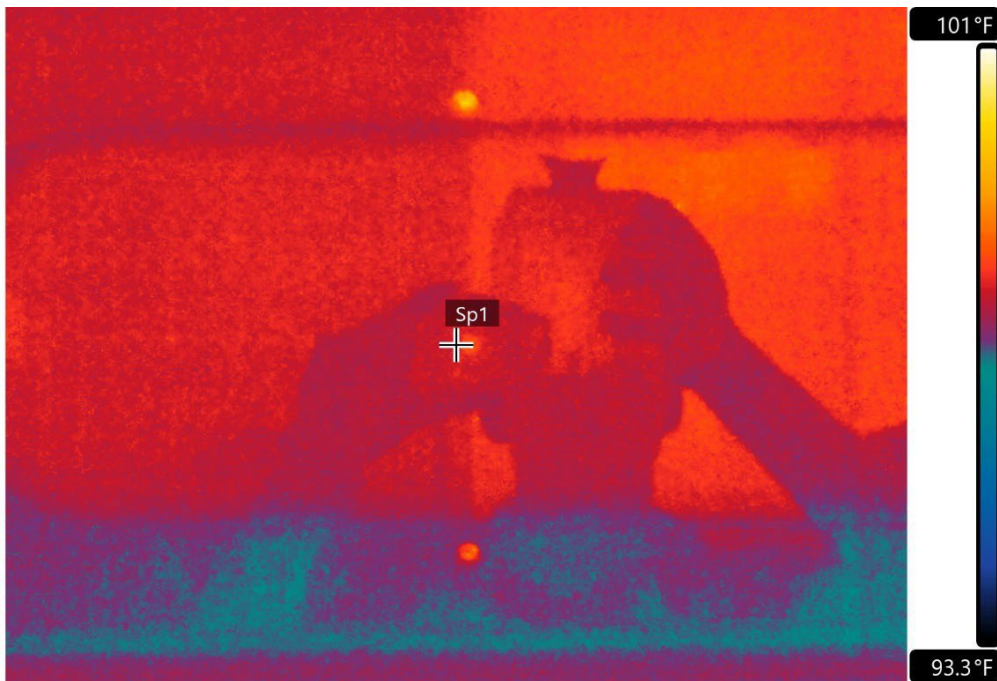
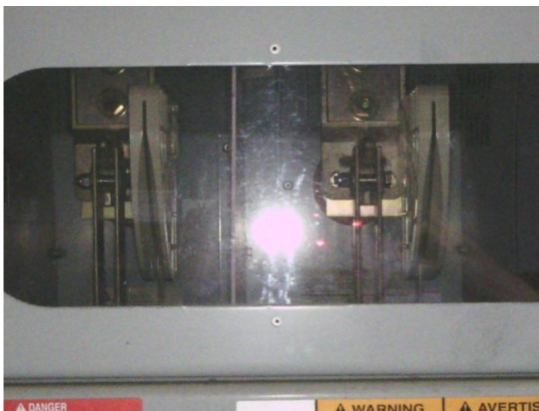
Component	Info Only
Equipment/Bucket ID	Switch gear windows

Sp1	97.7 °F
Lines	-
Areas	-

Fault	Info only
Defect Rating	none

Recommendations
IR image is just to show that IR can not be detected through acrylic cover lens for switchgear. Need true IR windows installed to see through cabinet.

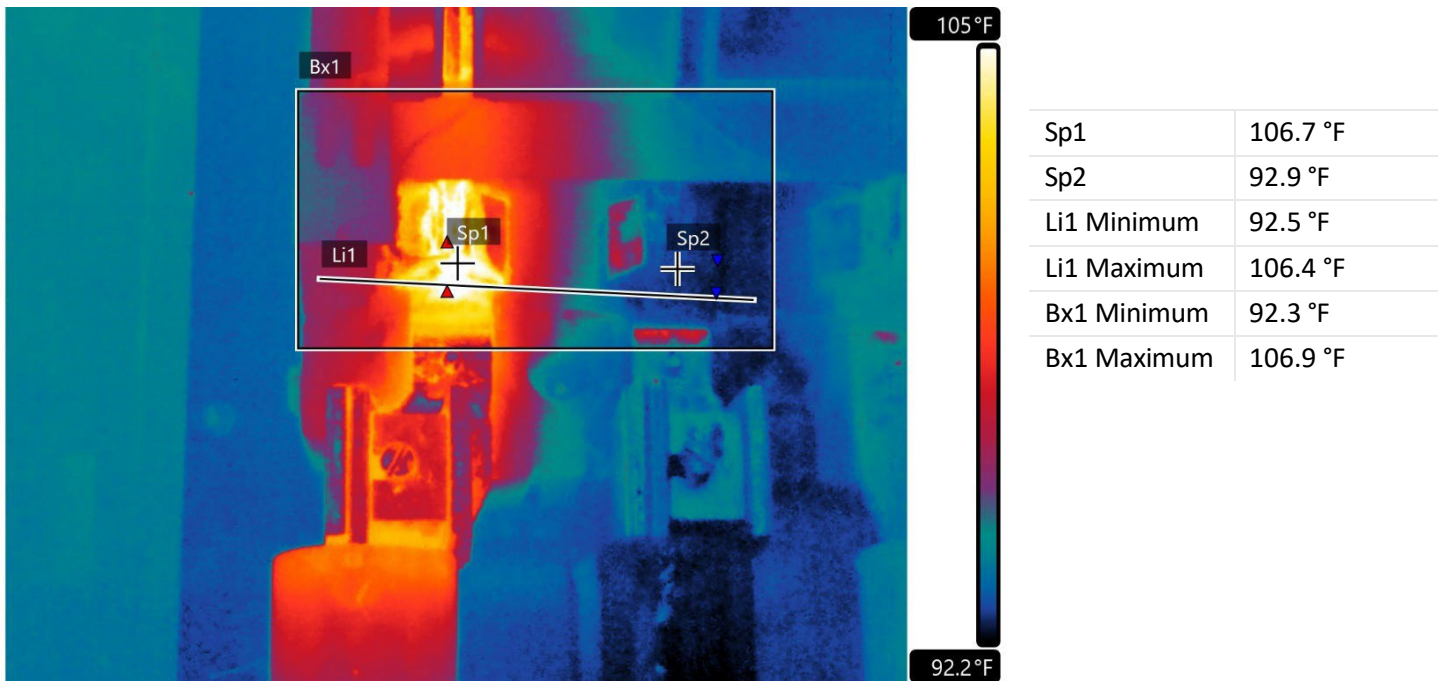
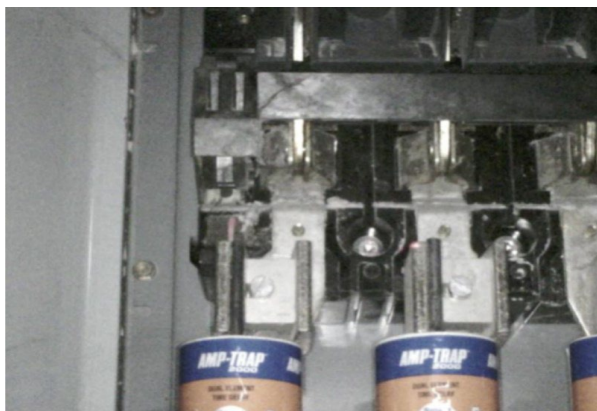
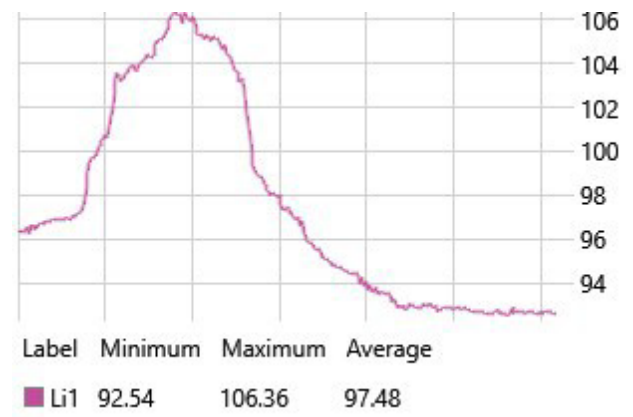
Component	Fuse knife components
Equipment/Bucket ID	PDC-10 /Panel M1

Fault	Dirty/loose knife components
Defect Rating	<b>CLASS I</b>

Recommendations	Fuse knife switch likely has issue with the A phase switch components. Inspect/repair as needed and as time allows.
-----------------	---

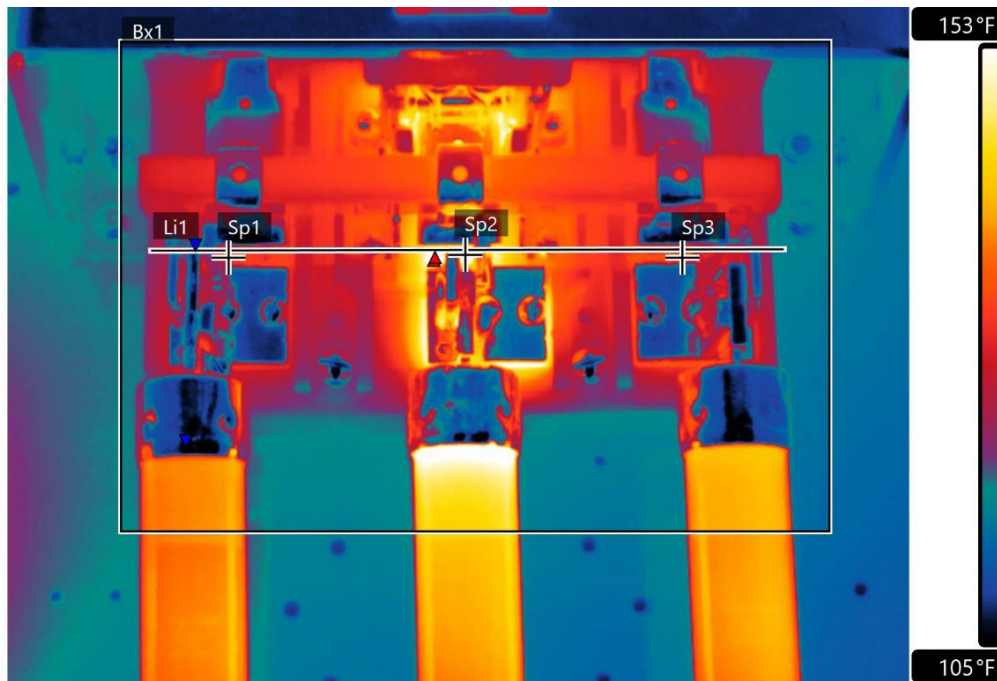
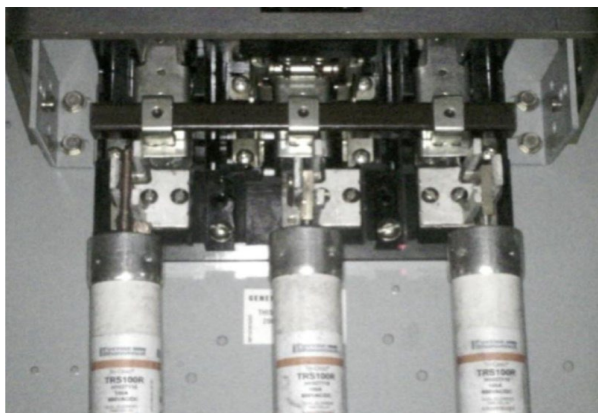
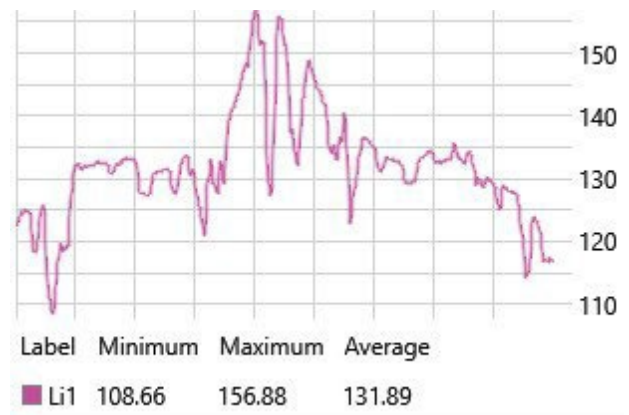
Component	B phase Fuse knife components
Equipment/Bucket ID	Line 1 480V from DPI

Sp1	133.4 °F
Sp2	156.6 °F
Sp3	135.1 °F
Li1 Minimum	108.7 °F
Li1 Maximum	156.9 °F
Bx1 Minimum	98.8 °F
Bx1 Maximum	160.1 °F

Fault	Fuse knife issue
Defect Rating	<b>CLASS II</b>

Recommendations	Fuse knife switch likely has issue with the B phase switch components. Inspect/repair as needed and as time allows.
-----------------	---
