Infrared Thermography Report

USG Greenville, MS

February 2021

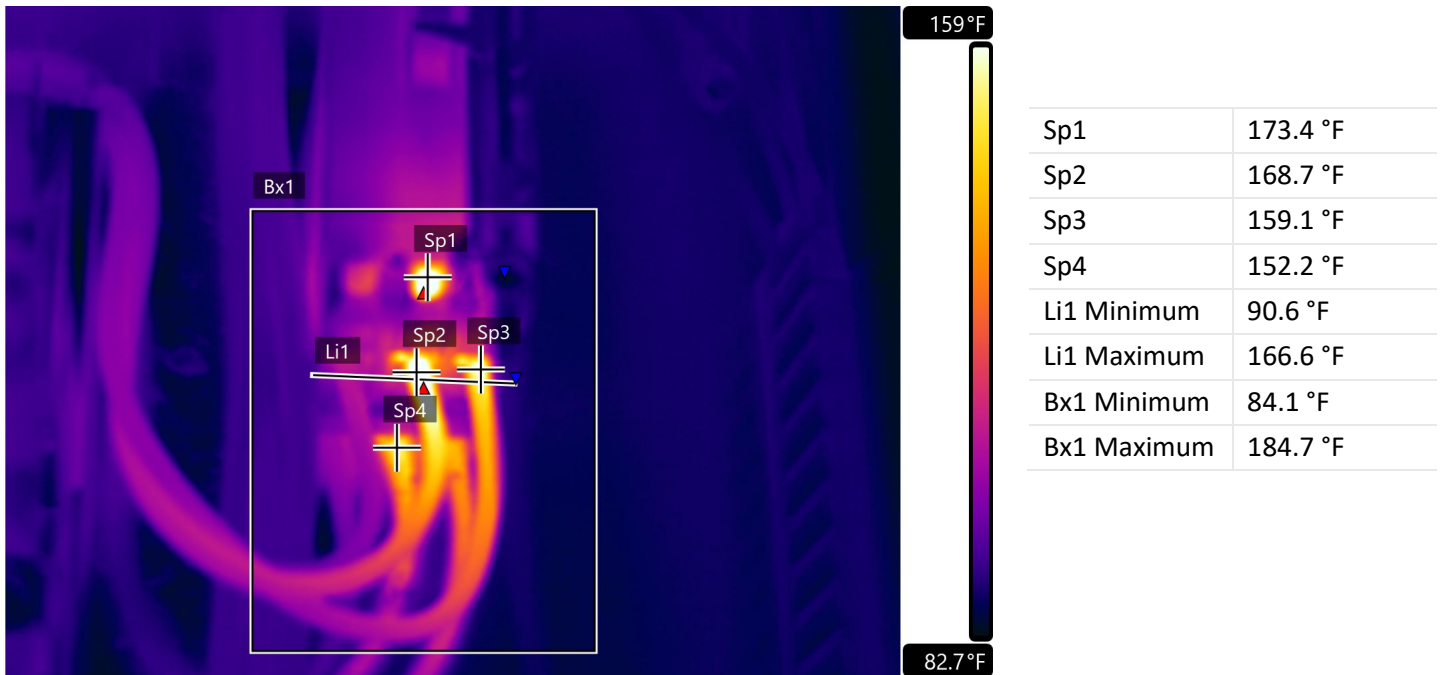
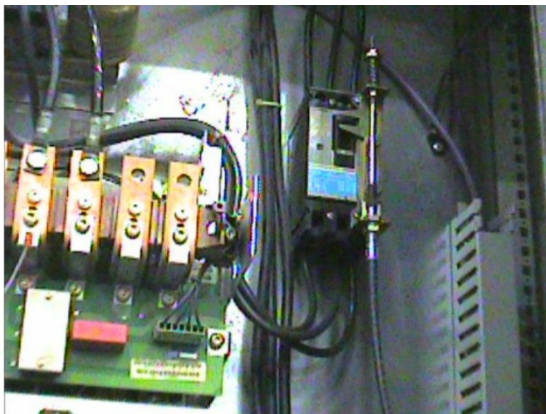
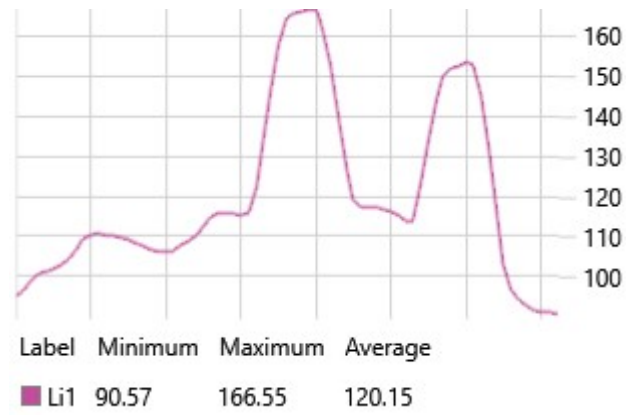
Component	Lead/Lug Connection
Equipment/Bucket ID	MCC-7C1 VFD-HTA Main Power (Board Line Area)

Fault	Load Imbalance/Loose Connections
Defect Rating	CLASS I

Recommendations
IR image suggests a possible load imbalance and/or loose connections. Inspect connections and measure current on each phase.

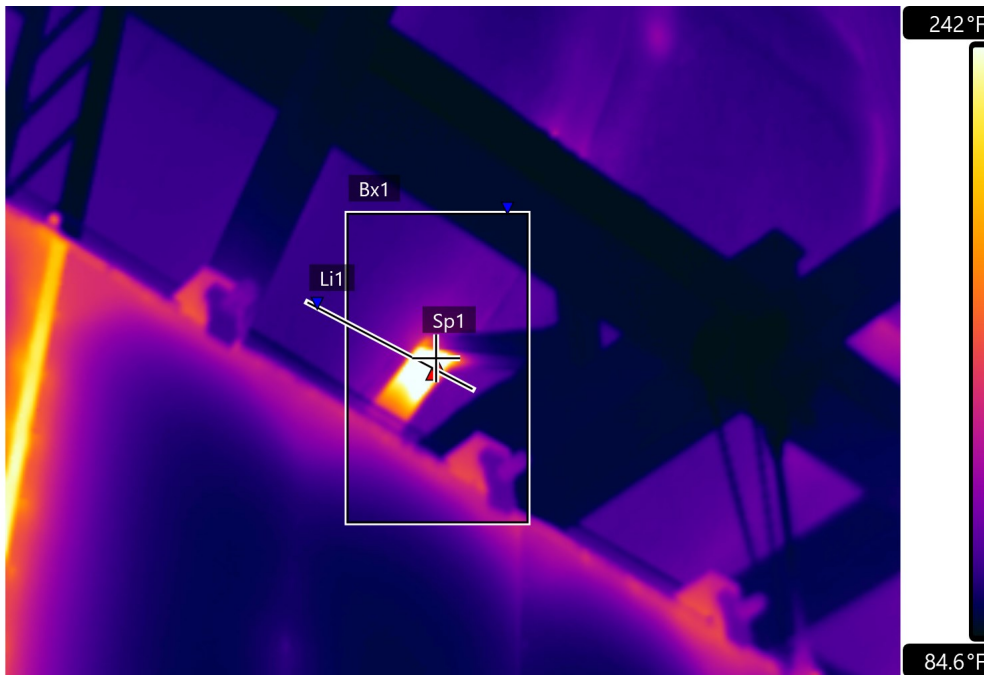
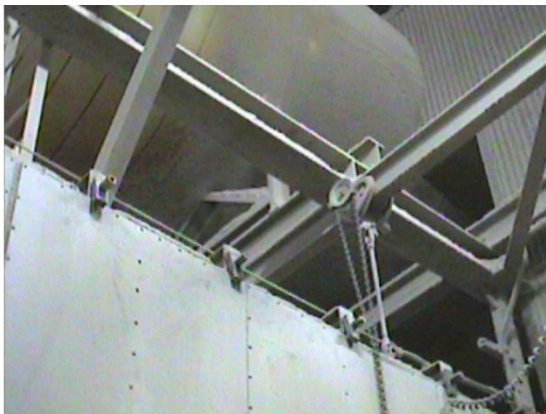
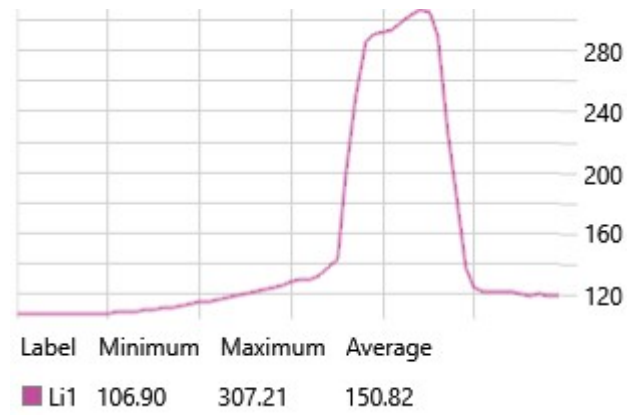
Component	Kiln Ducting
Equipment/Bucket ID	Board Line Kiln just above door 10 on right side of Kiln.

Sp1	318.5 °F
Li1 Minimum	106.9 °F
Li1 Maximum	307.2 °F
Bx1 Minimum	88.6 °F
Bx1 Maximum	318.5 °F

Fault	Missing or damaged insulation
Defect Rating	CLASS II

Recommendations	While performing the electrical IR survey, we decided to scan the kiln. We noticed an extreme amount of heat in the ducting above the kiln. It appears that there is missing or damaged insulation at this area. We recommend inspecting this area during the next down time.
-----------------	---

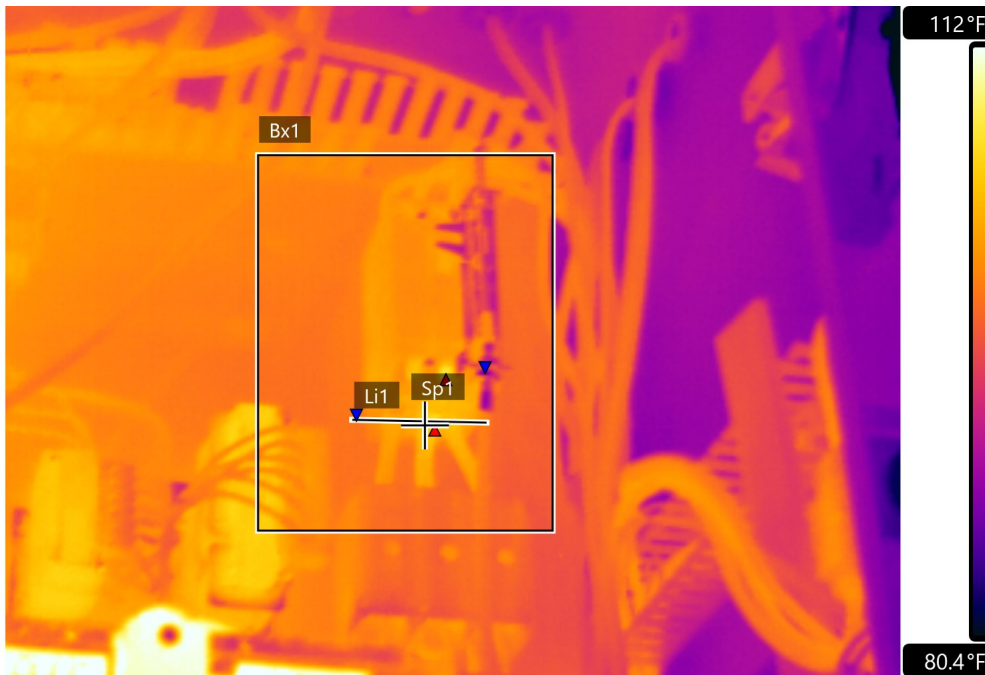
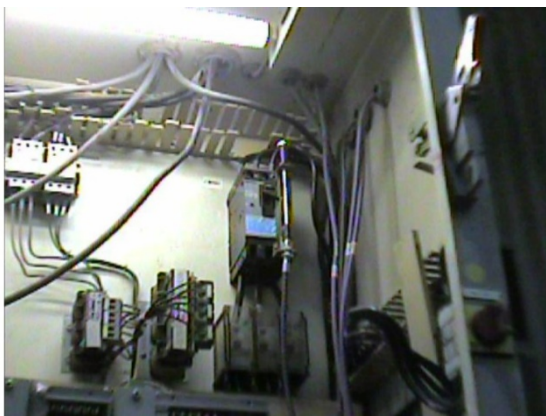
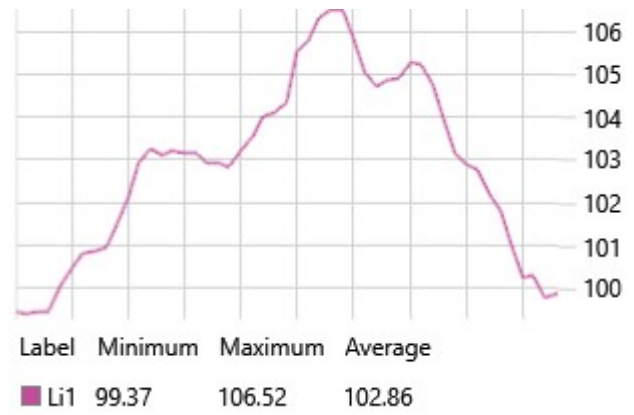
Component	Breaker/Connections
Equipment/Bucket ID	Kiln Jack VFD Panel

Sp1	105.8 °F
Li1 Minimum	99.4 °F
Li1 Maximum	106.5 °F
Bx1 Minimum	87.5 °F
Bx1 Maximum	108.7 °F

Fault	None
Defect Rating	None

Recommendations	This is a recheck after repairs. Issue resolved.
-----------------	--
