Infrared Thermography Report

Fitzgerald's Hotel and Casino

June 2021

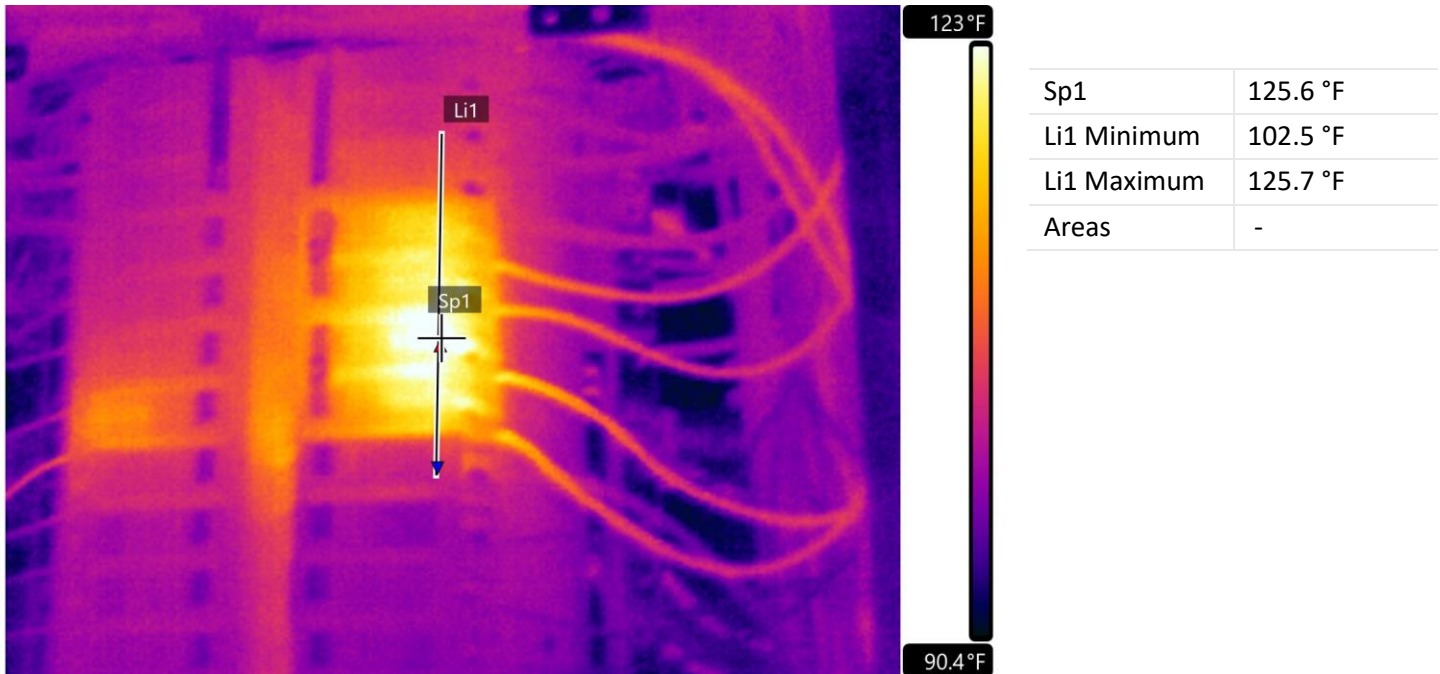
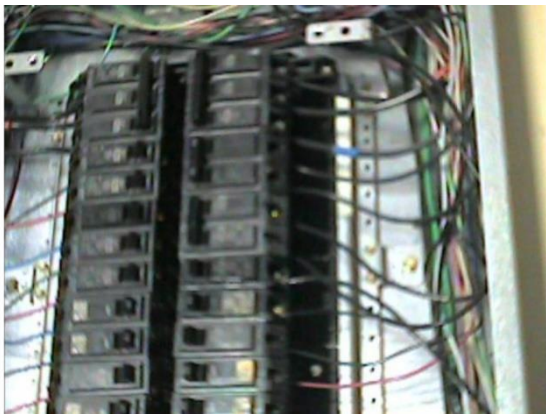
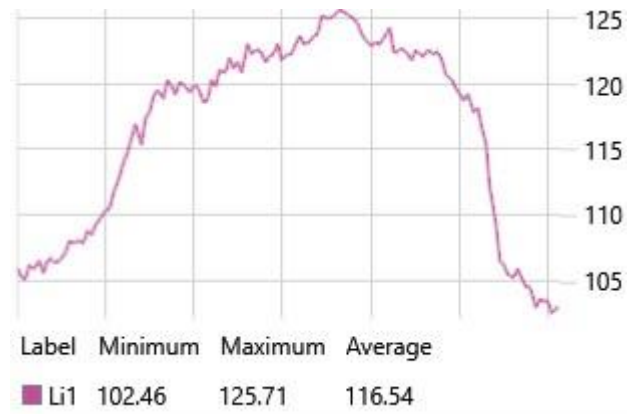
Component	Gen Block Heater Circuit Breaker slot 12/14
Equipment/Bucket ID	Buzz Room Panel SBLA-1

Fault	Weak breaker possible connection issue
Defect Rating	Class I

Recommendations	Replace the breaker and ensure all connections are clean and tight. Check adjacent circuit breaker connections and current draw.
-----------------	--

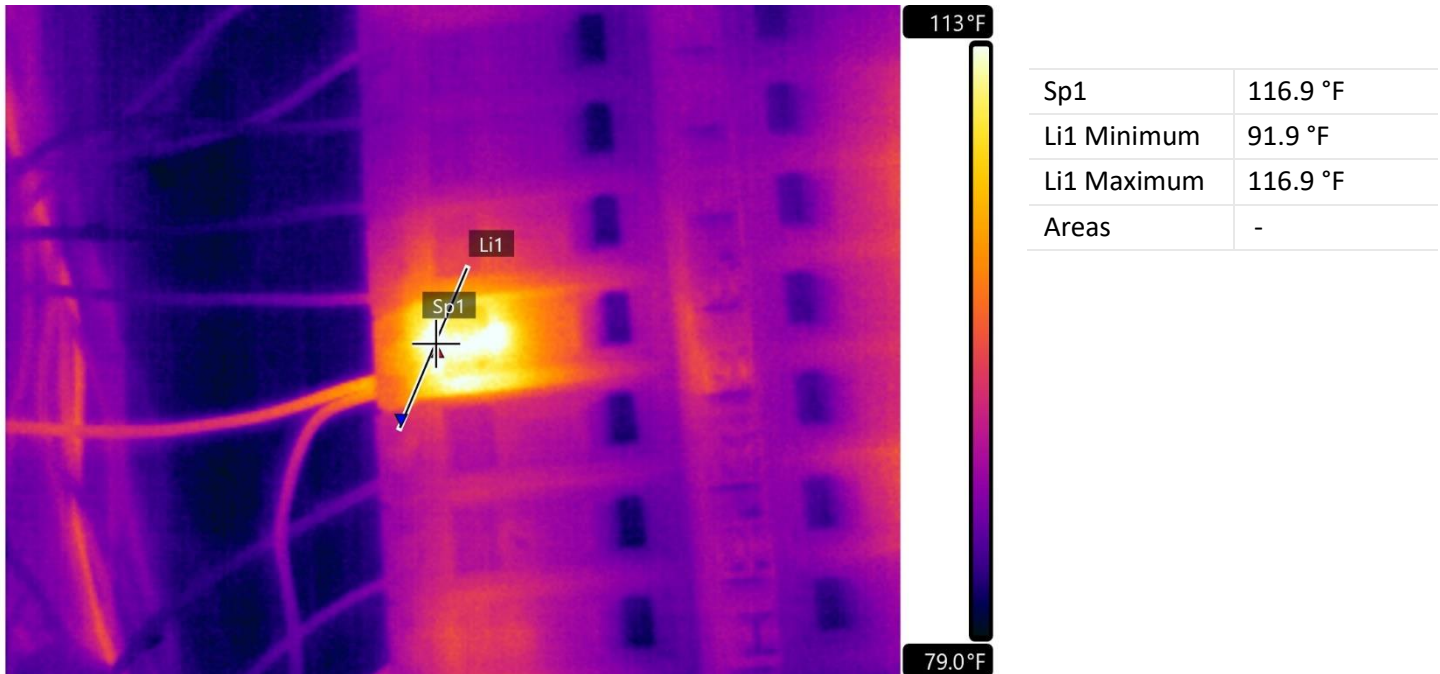
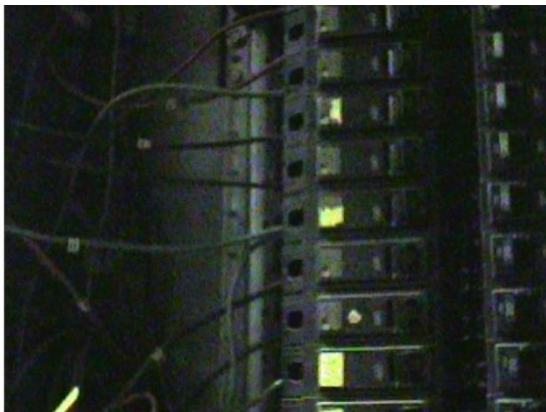
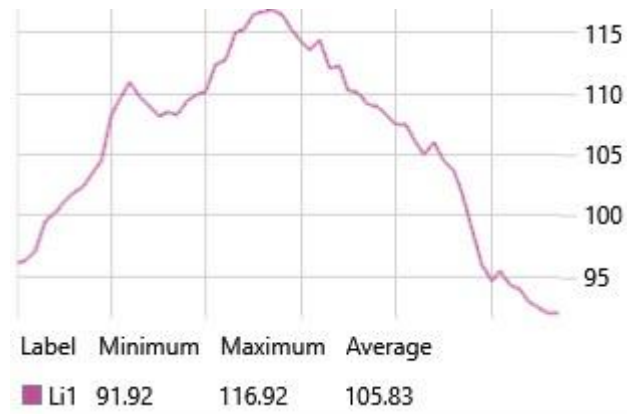
Component	Circuit Breaker Slot 11
Equipment/Bucket ID	Casino 1 st Floor N.E. Equipment Room Panel GED

Fault	Overcurrent condition
Defect Rating	Class II

Recommendations	<p>Two wires are connected to this 20 amp breaker. The top wire is drawing 23 amps and the bottom one was not drawing any current at the time of the survey. The circuit breaker is defective and overloaded.</p> <p>Replace the circuit breaker and reduce the load to 80% or less on this circuit.</p>
-----------------	--

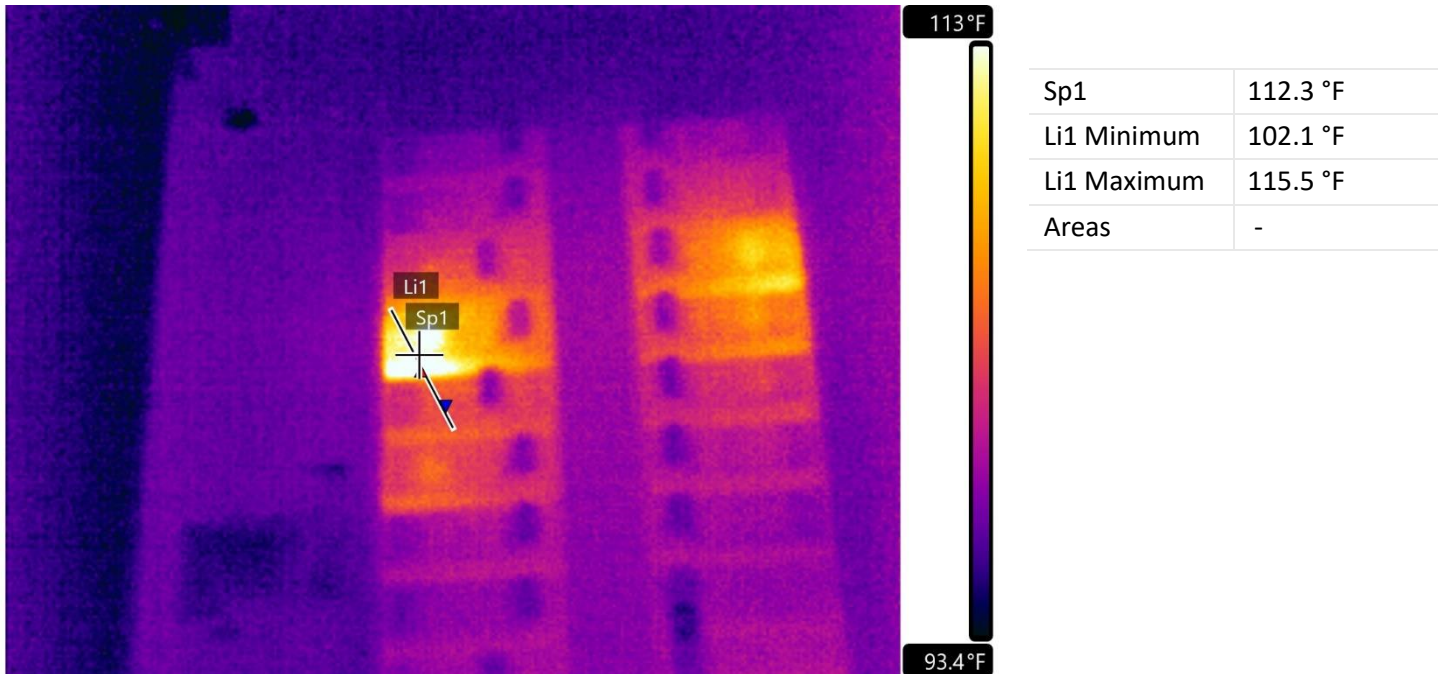
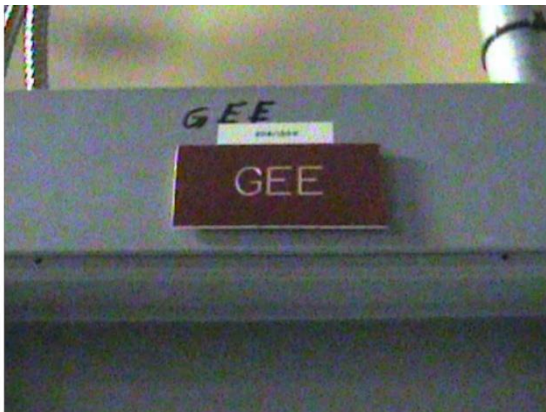
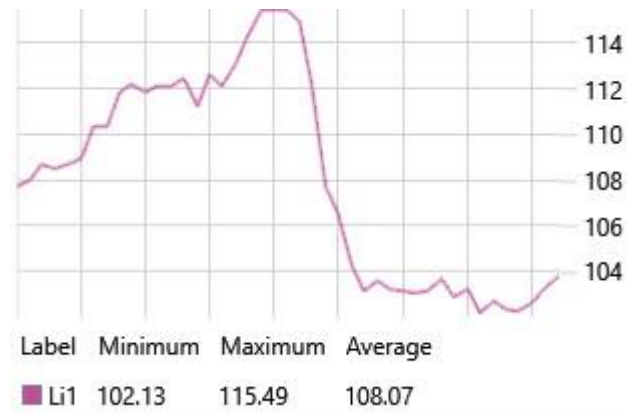
Component	Circuit Breaker 7
Equipment/Bucket ID	Casino 2 nd Floor Electrical Room by Elevator Panel GEE

Fault	Overloaded circuit
Defect Rating	Class I

Recommendations	Circuit breaker is slightly overloaded. It could also be defective and/or have poor connections. Replace the circuit breaker and reduce the loading to 80% or below rating.
-----------------	--

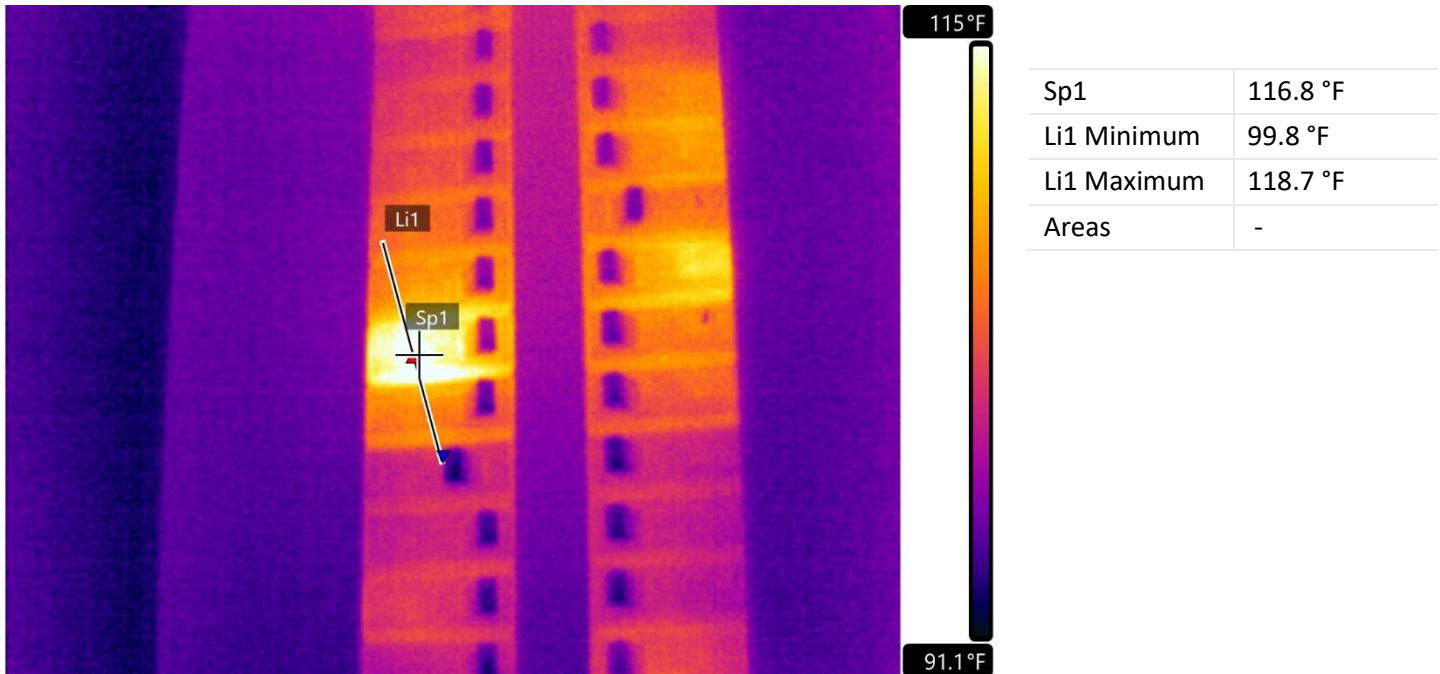
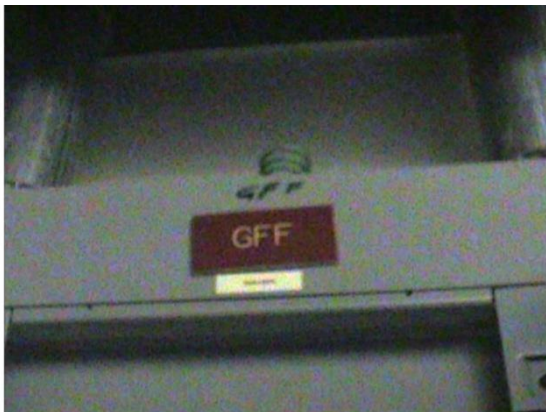
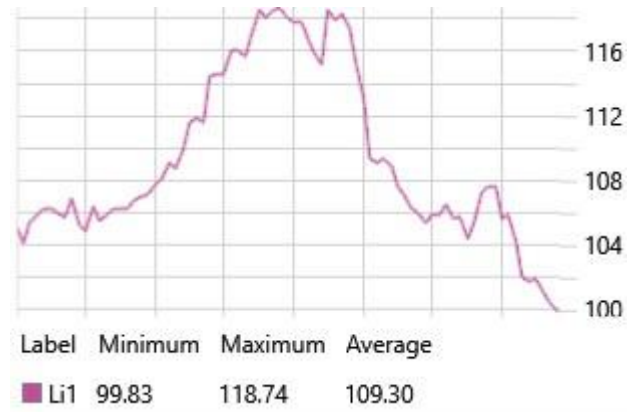
Component	Circuit Breaker 21 (same as next page)
Equipment/Bucket ID	Casino 2 nd Floor Electrical Room by Elevator Panel GFF

Fault	Some heat in breaker
Defect Rating	Class II

Recommendations	<p>The picture on the next pages shows why this breaker had an elevated temperature. The buss connection is poor. Recommend a thorough inspection and cleaning.</p>
-----------------	---

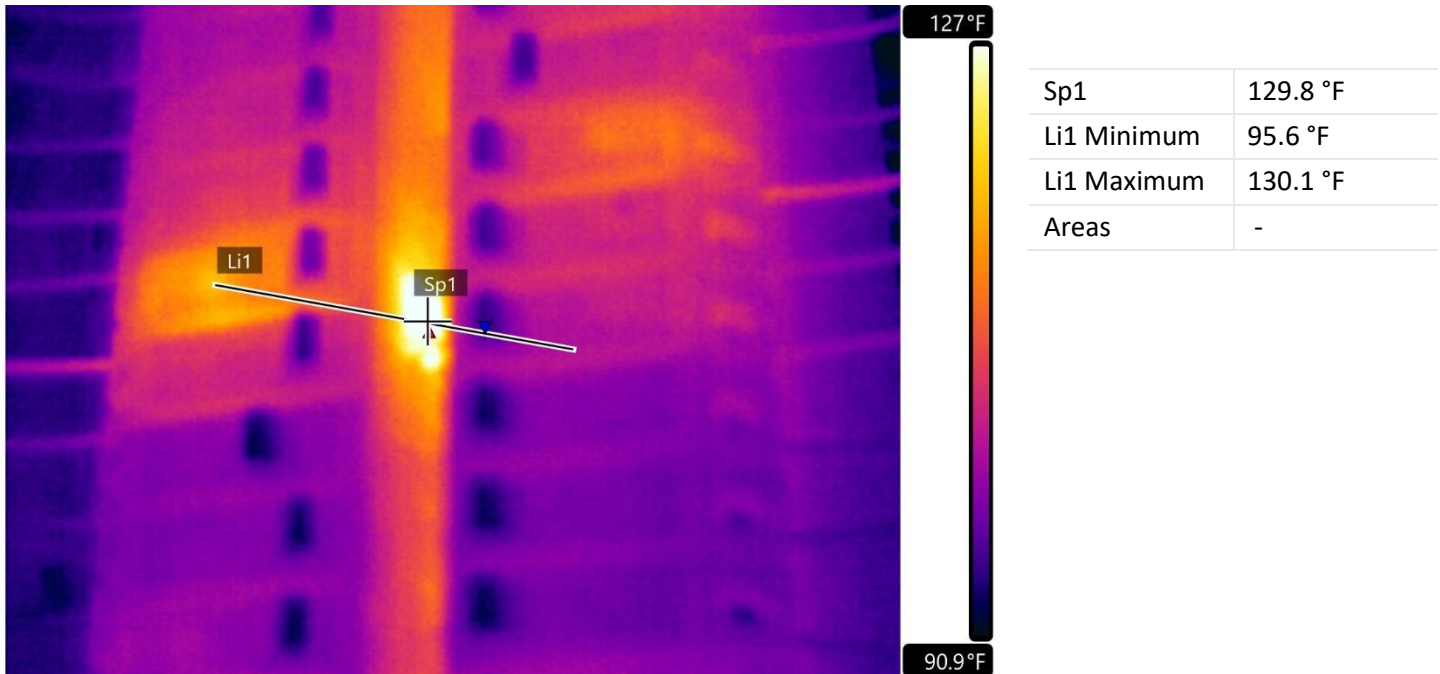
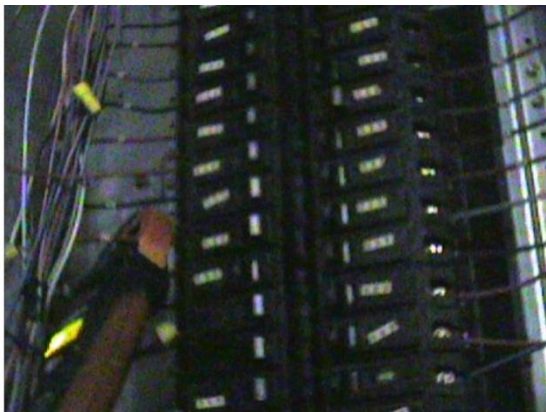
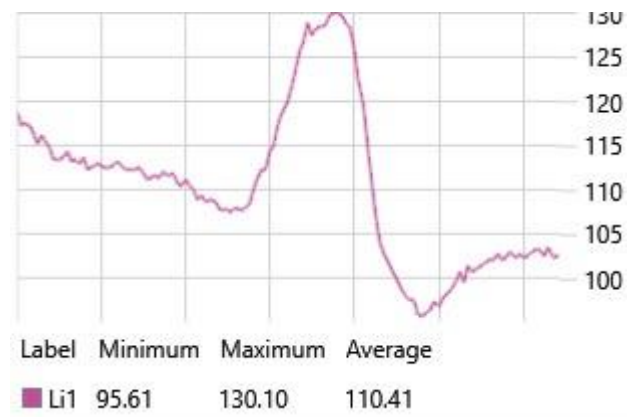
Component	Circuit Breaker 21 Buss Connection
Equipment/Bucket ID	Casino 2 nd Floor Electrical Room by Elevator Panel GFF

Fault	Loose buss connection on breaker 21. Same unit as previous page
Defect Rating	Class II

Recommendations	Check the circuit breaker and buss connection. Ensure they are clean and not heat damaged.
-----------------	--

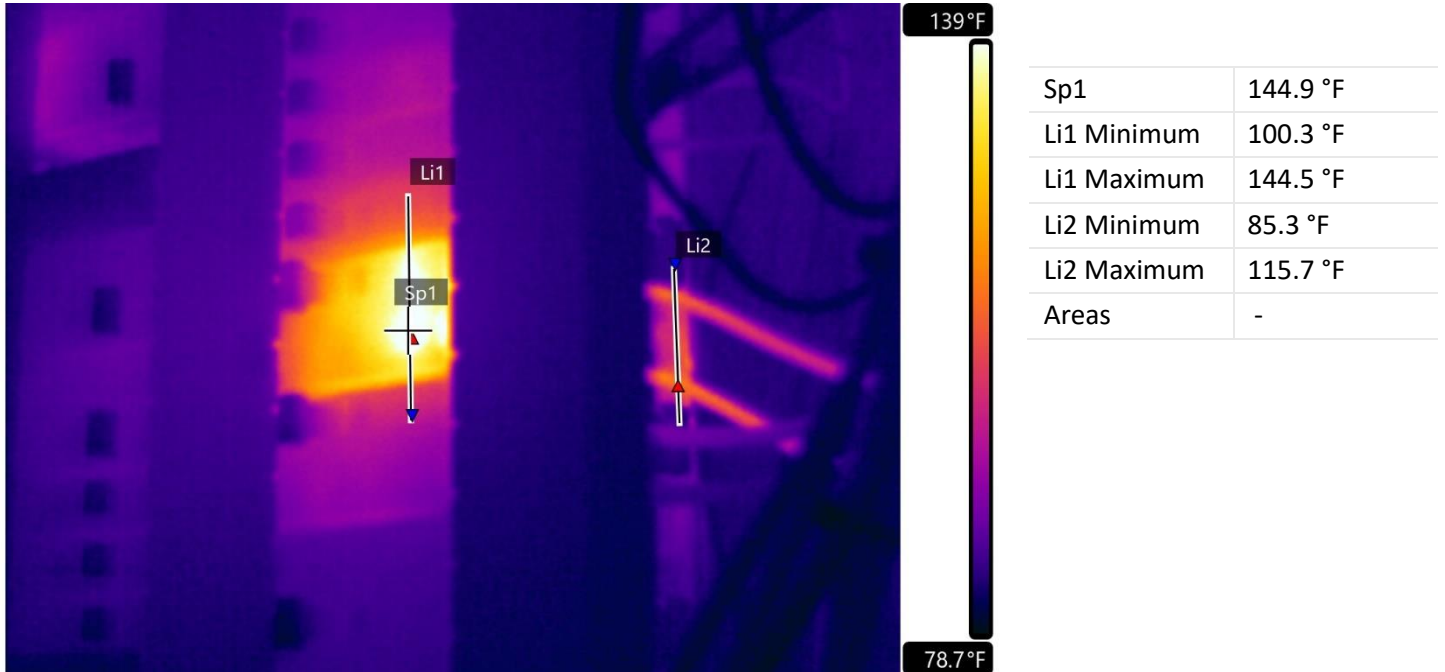
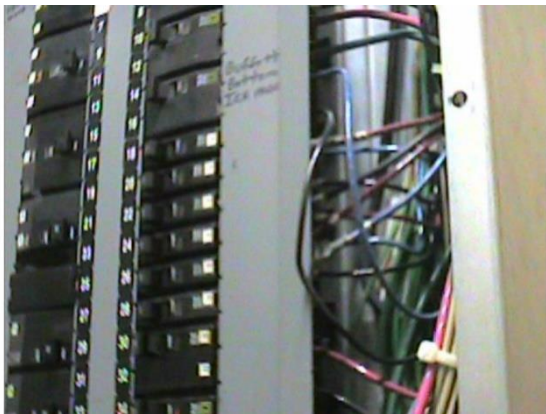
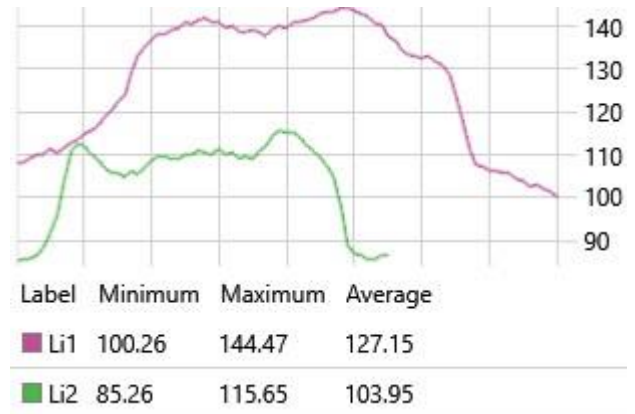
Component	Ice Maker Circuit Breaker slot 14/16
Equipment/Bucket ID	Casino 2 nd Floor Electrical Room by Service Elevator Panel CCT

Fault	Excessive Heat in Breaker
Defect Rating	Class II

Recommendations	Possible faulty breaker, poor buss connection, or overcurrent. Replace the breaker, clean, and inspect all connections.
-----------------	---

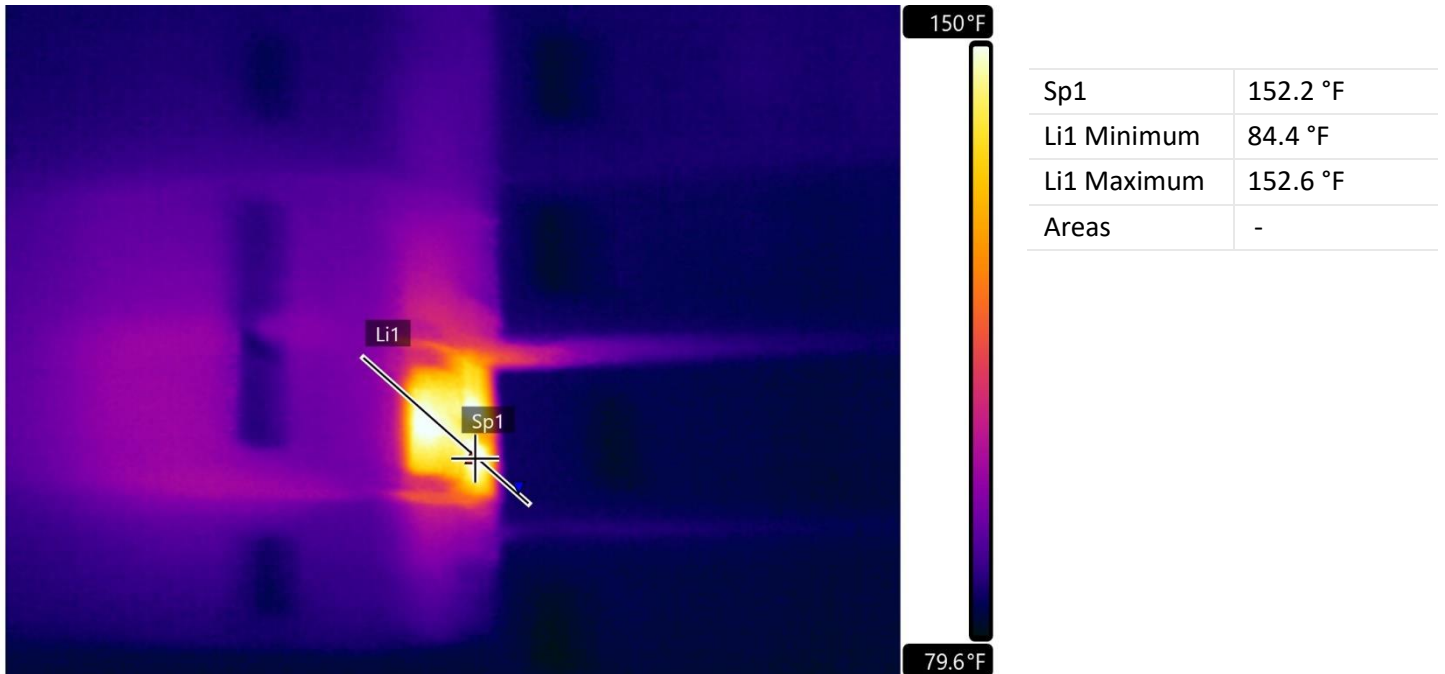
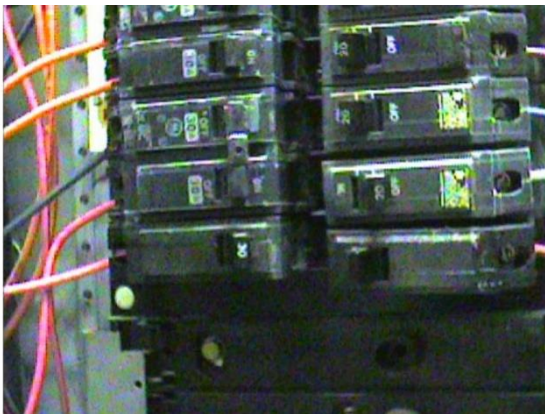
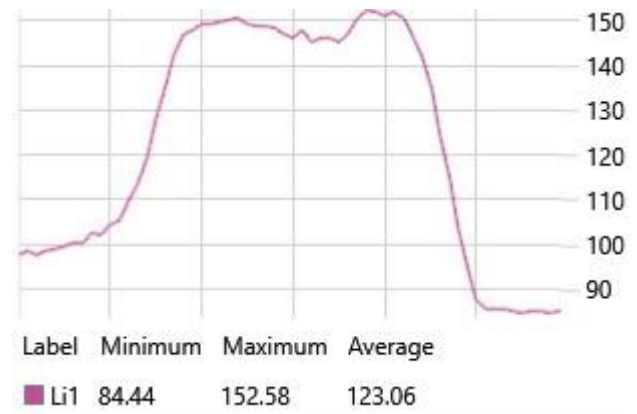
Component	Circuit Breaker in Slot 31/33
Equipment/Bucket ID	Casino Second Floor #1 Electrical Room Near Service Elevator Panel KA

Fault	Faulty connection at buss
Defect Rating	Class II

Recommendations	Breaker has excessive localized heating at the buss connection. Clean, inspect and tighten connection. Consider replacing the circuit breaker.
-----------------	--

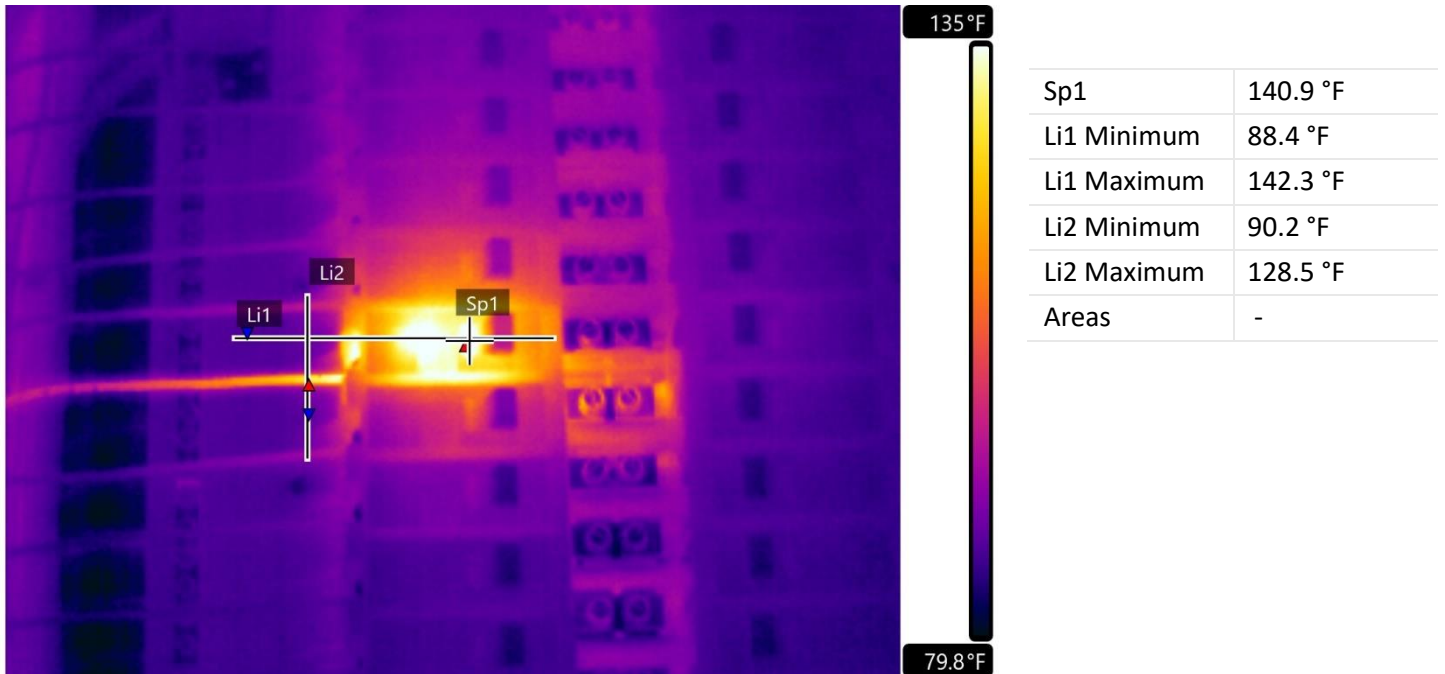
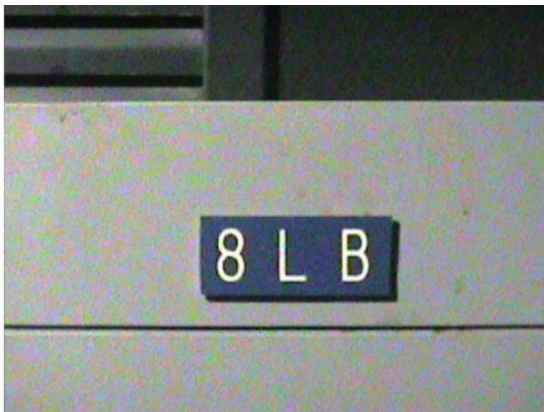
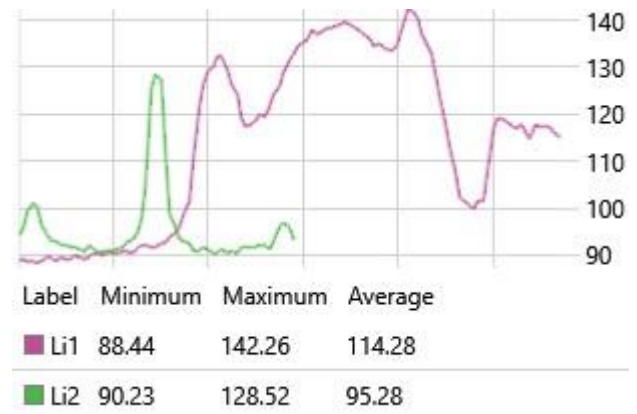
Component	Circuit Breaker in Slot 13
Equipment/Bucket ID	Hotel 8 th Floor Panel 8LB by Elevator

Fault	Overloaded and worn circuit breaker
Defect Rating	Class II

Recommendations	Current was measured at 20 amps on a 20 amp breaker. Breaker shows excessive localized heating. Replace the breaker and reduce loading to 80% or less of rating. Ensure all connections are clean and tight.
-----------------	--
