Job Information

Job #: 139071

Date: February 6, 2019

Name: Skyline

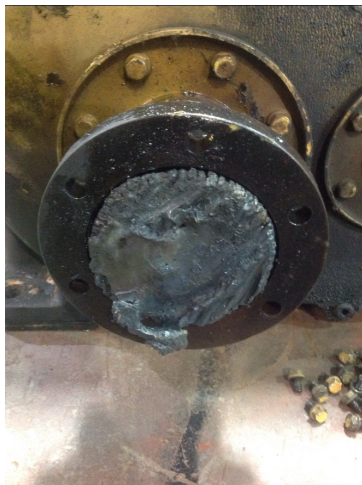
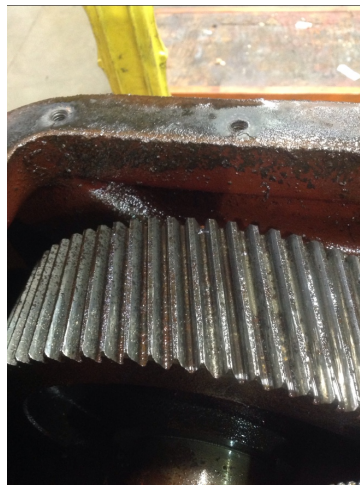
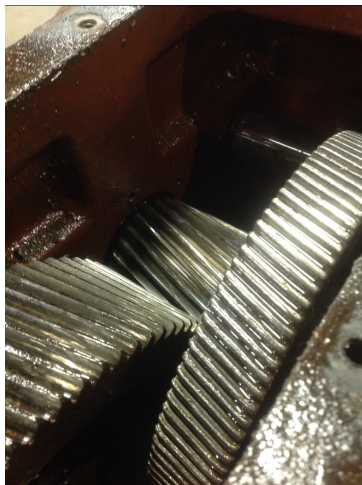
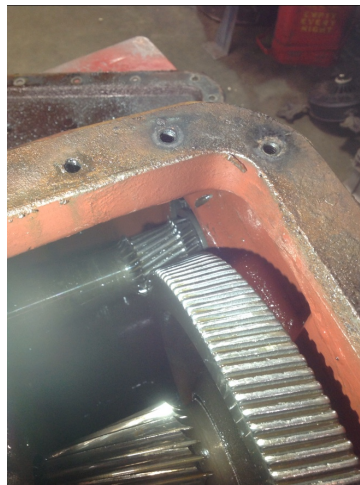
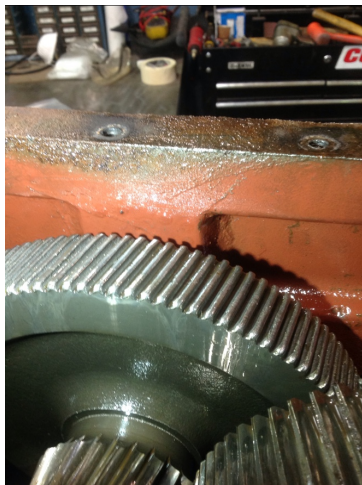
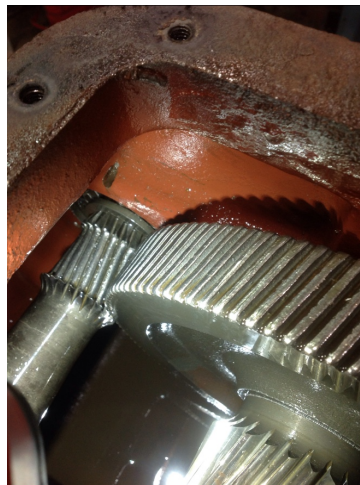
Output shaft no good. Output shaft bearing is completely destroyed. Output shaft coupling is no good. Output shaft gear is is worn and pitted caused from moisture inside gearbox. Intermediate gear is no good. Inboard shaft/spline is wiped out.
